# VEHICLE INSPECTION REPORT

**SN20XUB**

## Daf CF 320

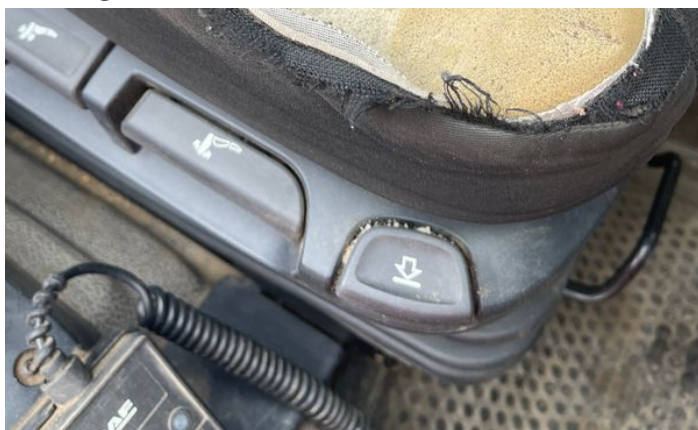
1: Seat Base Cover osf  
Torn  
Over 3mm

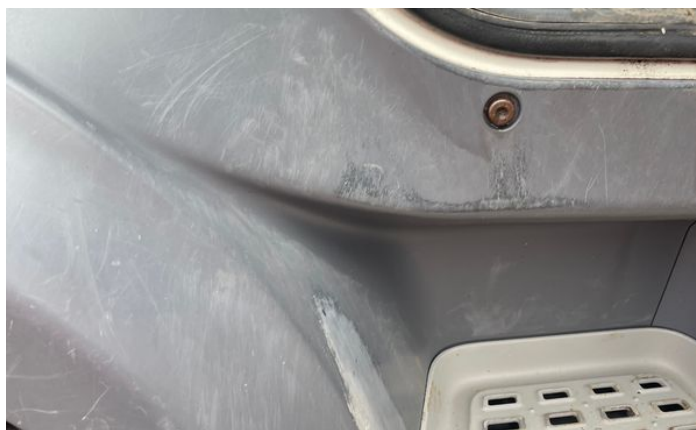
2: Door Moulding osf  
Scuffed (Unpainted)  
Over 100mm

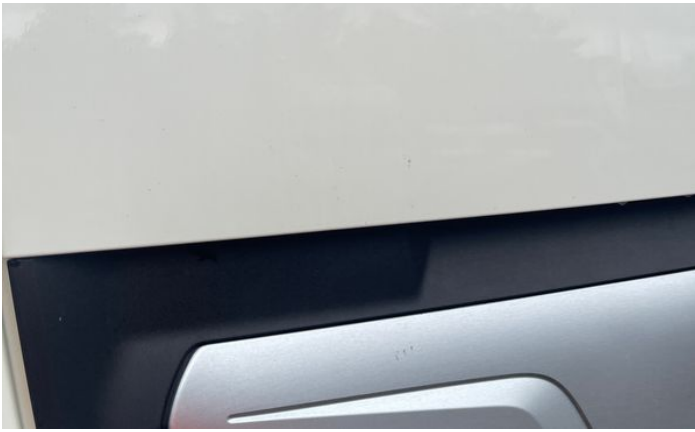
3: Bonnet  
Chipped  
Multiple Chips

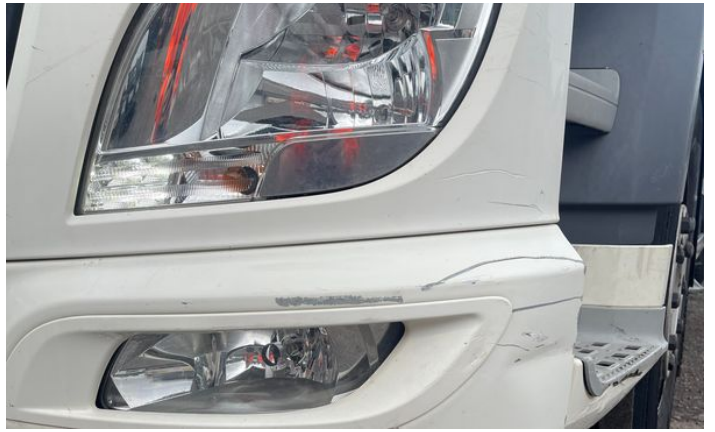
4: Bumper Front  
Dented  
With Paint Damage

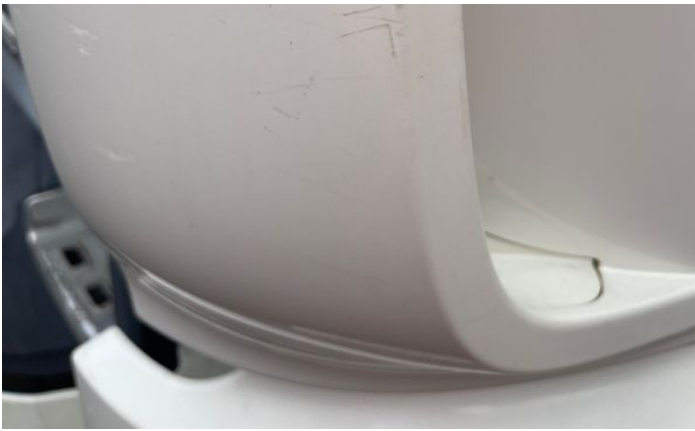
5: Wing osf  
Scratched  
Over 25mm Thru Paint

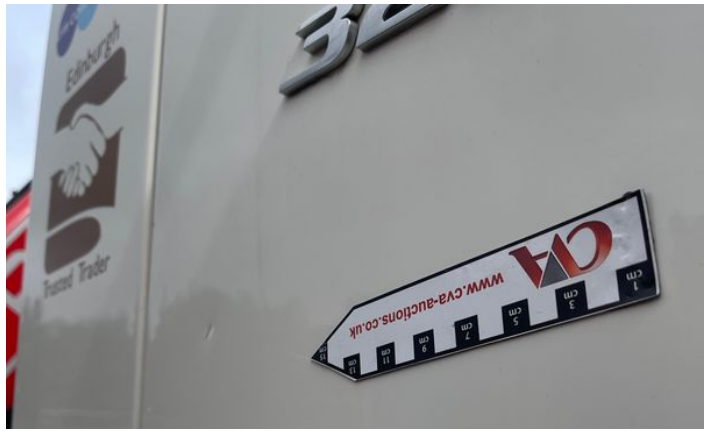
6: Door osf  
Dented  
With Paint Damage

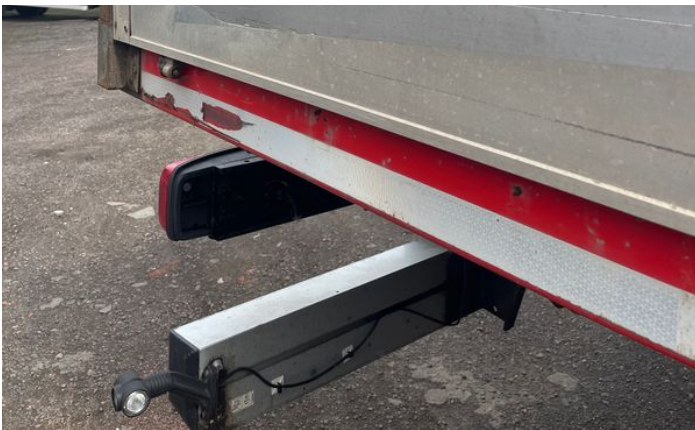
7: Qtr Panel osr  
Dented  
Over 30mm

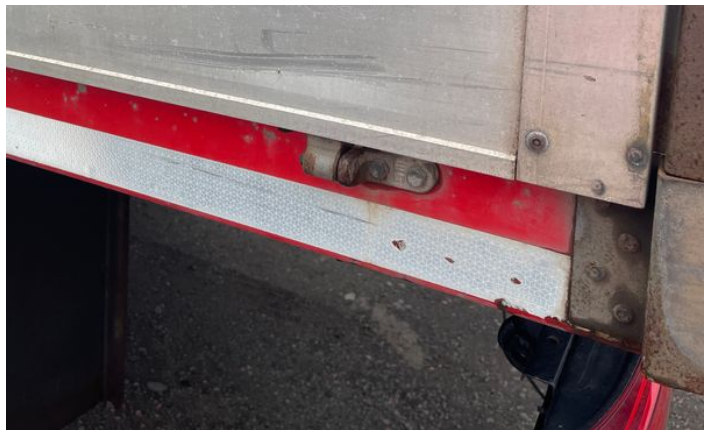
8: Qtr Panel nsr  
Dented  
With Paint Damage

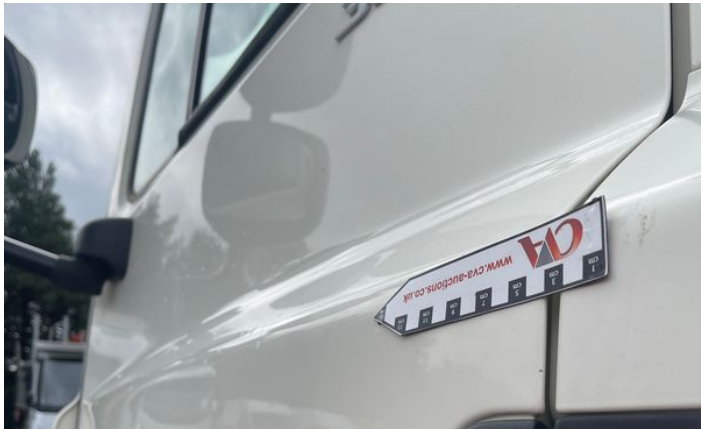
9: Door nsf  
Dented  
With Paint Damage

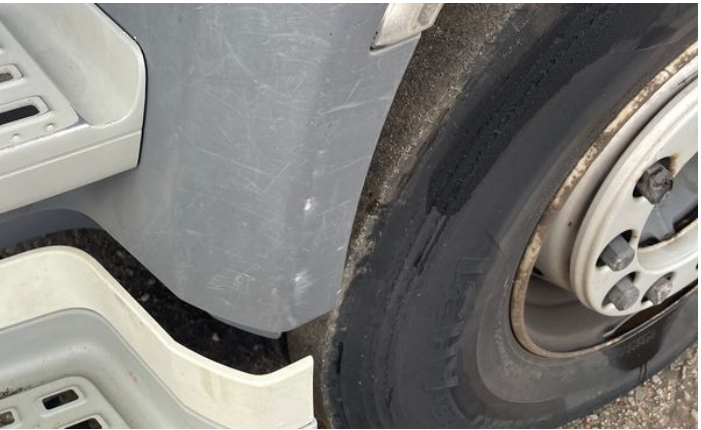
10: Door Moulding nsf  
Broken  
Replace
