# VEHICLE INSPECTION REPORT

**EK210ZG**

## Ford Transit 350 LEADER 2.0 ECOBLUE 130PS

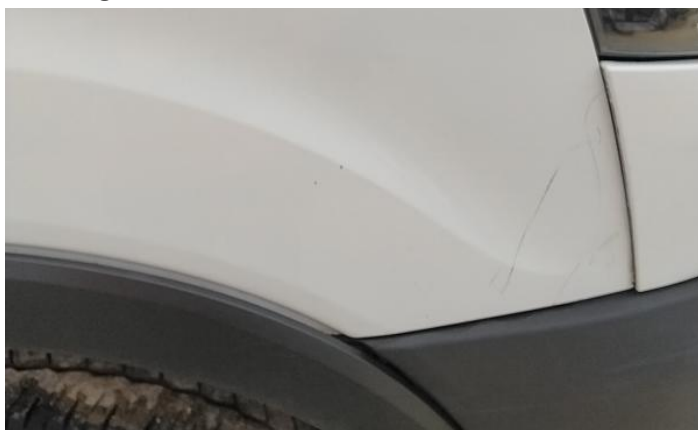
1: Wing osf  
 Scratched  
 Over 25mm Not Thru Paint

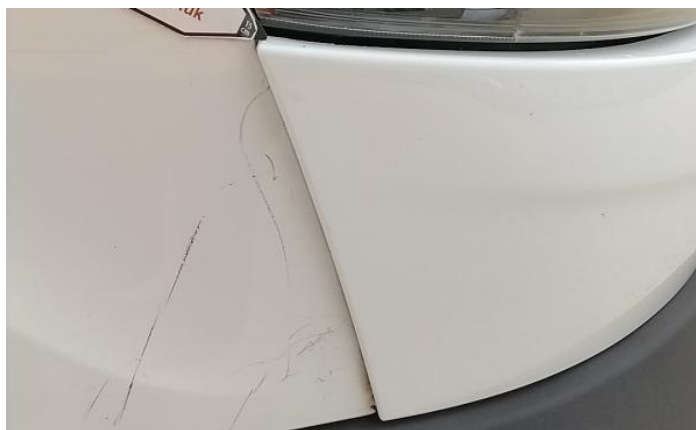
2: Panel Front  
 Dented  
 Between 10mm + 30mm

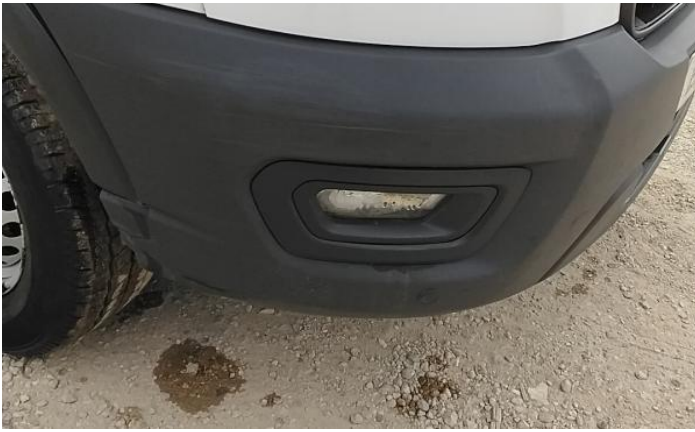
3: Bumper Front Moulding  
Scuffed (Unpainted)  
Over 100mm

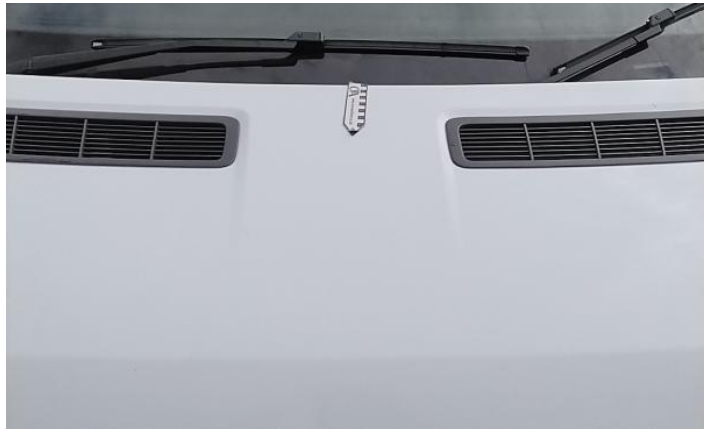
4: Bonnet  
Chipped  
Multiple Chips

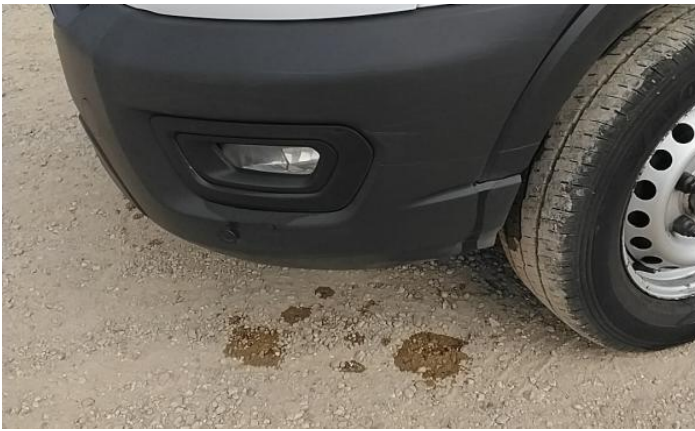
5: Bumper Front Moulding  
Scuffed (Unpainted)  
Over 100mm

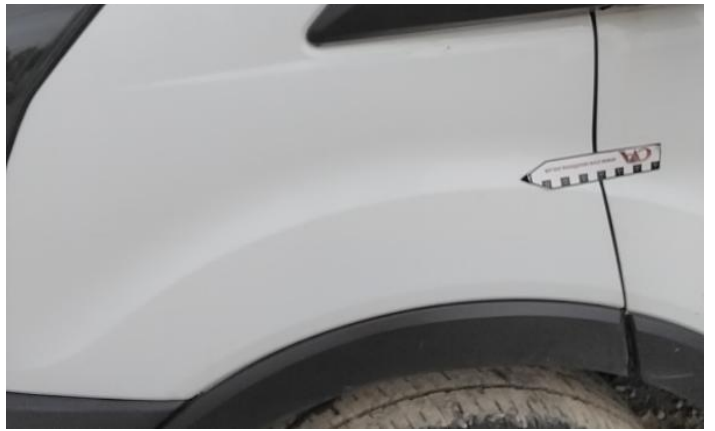
6: Wing nsf  
Scratched  
Over 25mm Not Thru Paint

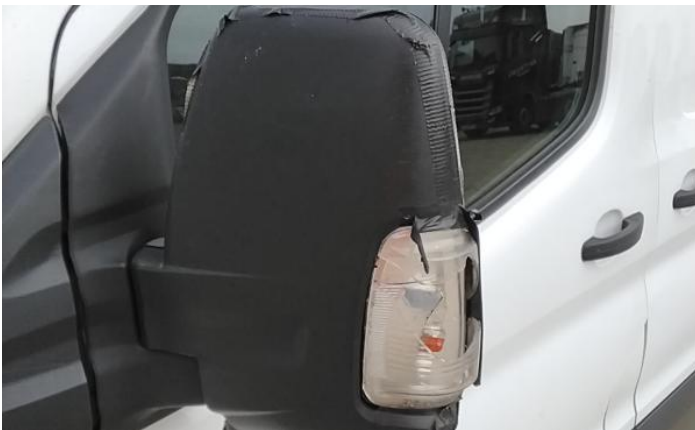
7: Door Mirror Assy nsf  
Broken  
Replace

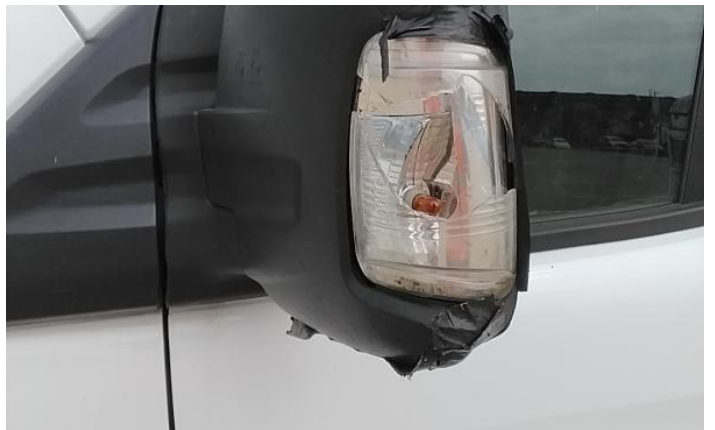
8: Flasher Side Repeater ns  
Broken  
Replace

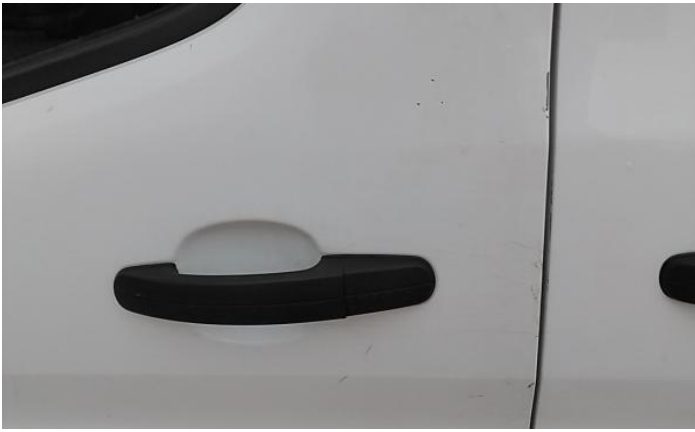
9: Door nsf  
Chipped  
Edge Chip

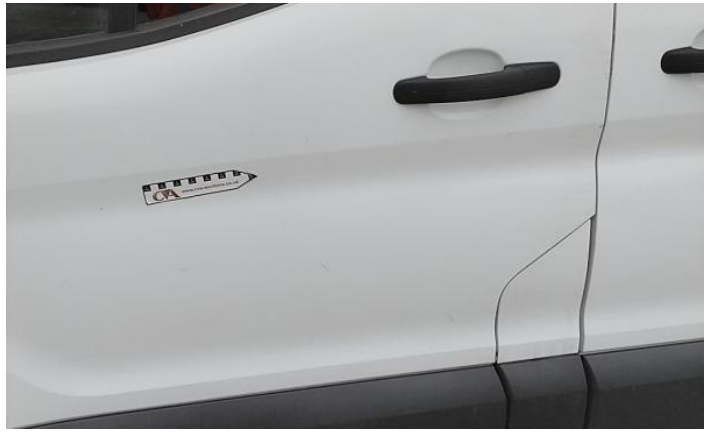
10: Door nsf  
Scratched  
Over 25mm Not Thru Paint

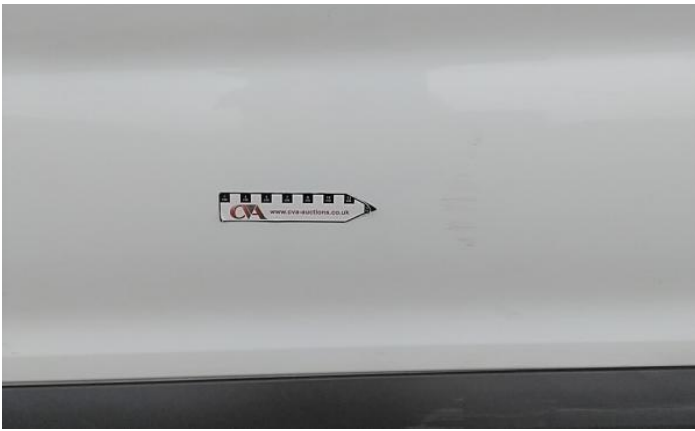
11: Door nsr  
Scratched  
Over 25mm Thru Paint

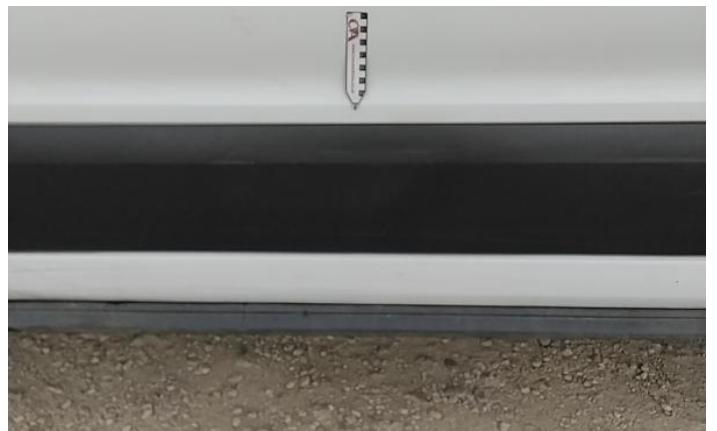
12: Door Moulding nsr  
Scuffed (Unpainted)  
Over 100mm

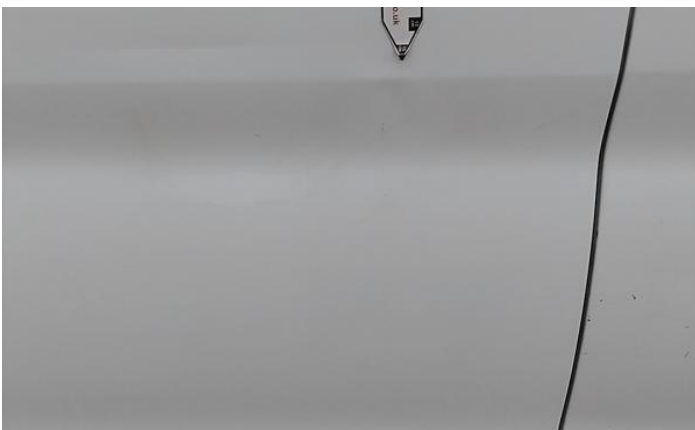
13: Door nsr  
Dented  
Between 10mm + 30mm

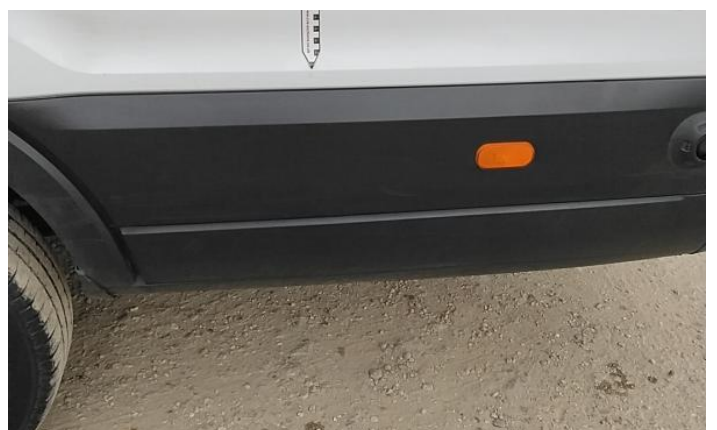
14: Qtr Panel Moulding ns  
Scuffed (Unpainted)  
Over 100mm

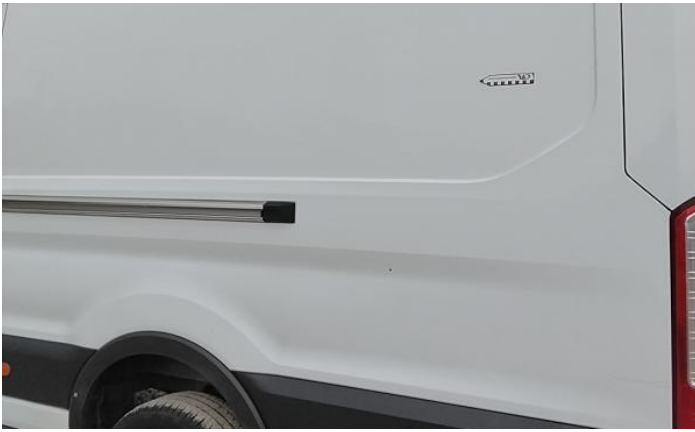
15: Qtr Panel nsr  
Scratched  
Over 25mm Not Thru Paint

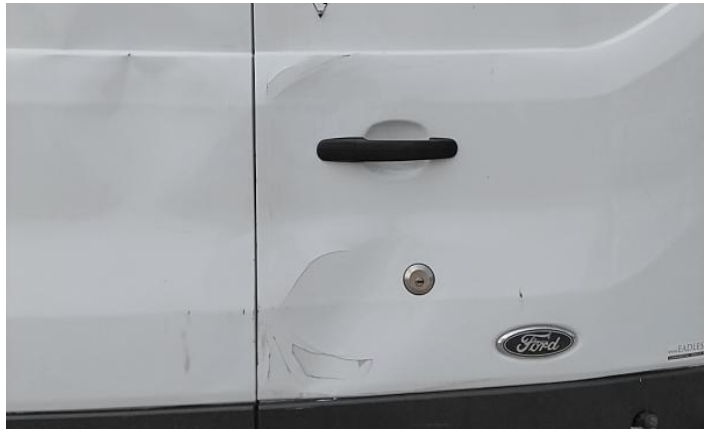
16: Door osr  
Dented  
With Paint Damage

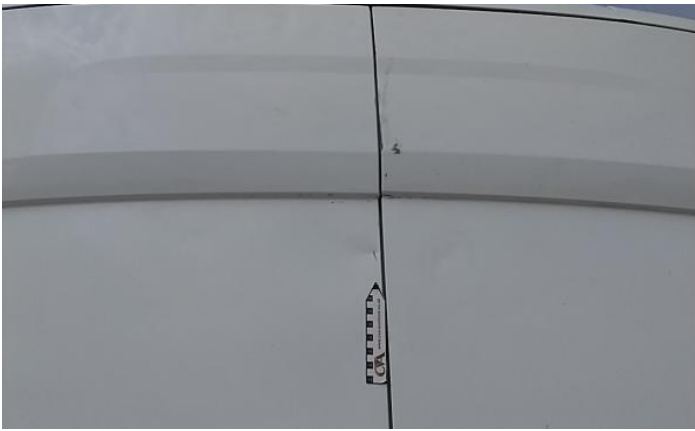
17: Door nsr  
Dented  
Over 2 UpTo 10mm

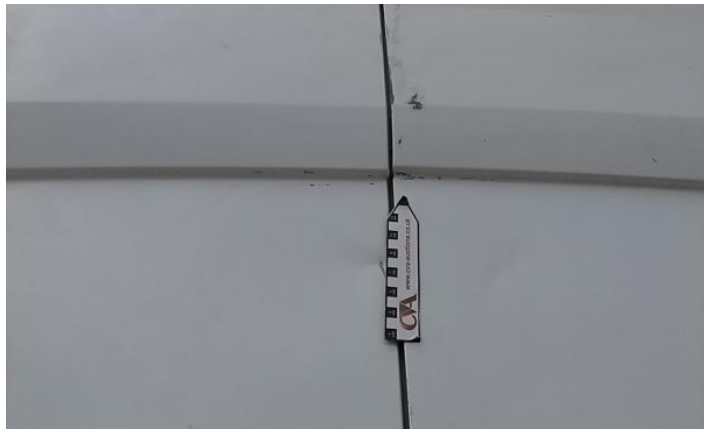
18: Door osr  
Scratched  
Over 25mm Thru Paint

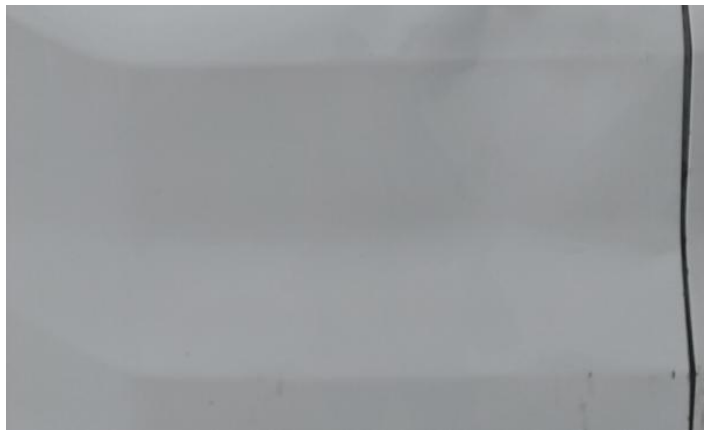
20: Door nsr  
Dented  
Over 30mm

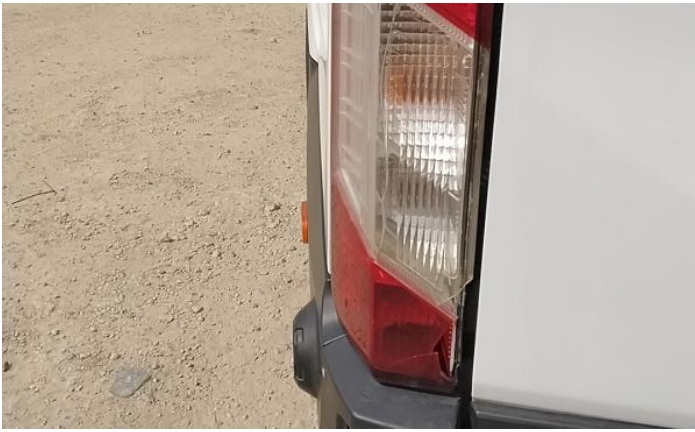
21: Lamp nsr  
Broken  
Replace

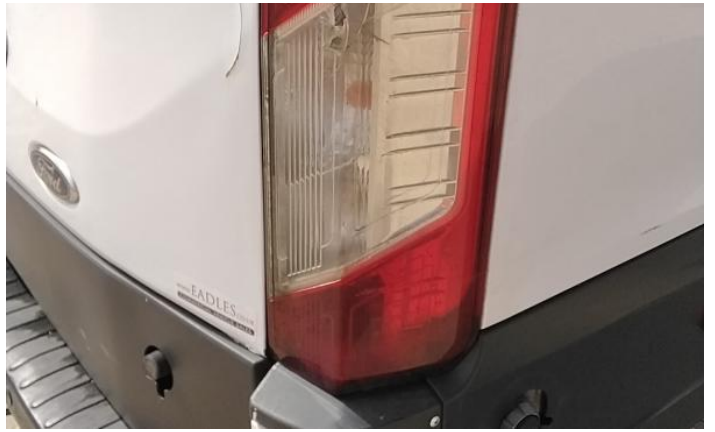
22: Lamp osr  
Broken  
Replace

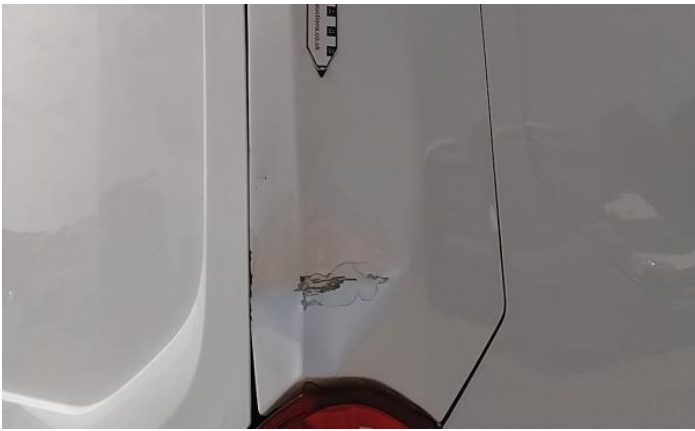
23: Qtr Panel osr  
Dented  
With Paint Damage

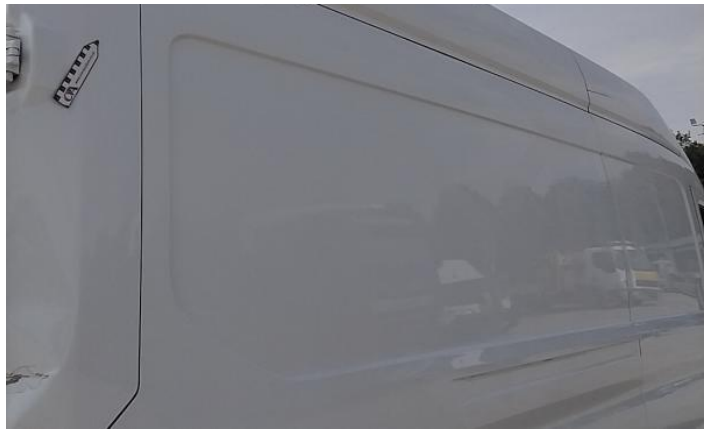
24: Qtr Panel osr  
Scratched  
Over 25mm Thru Paint

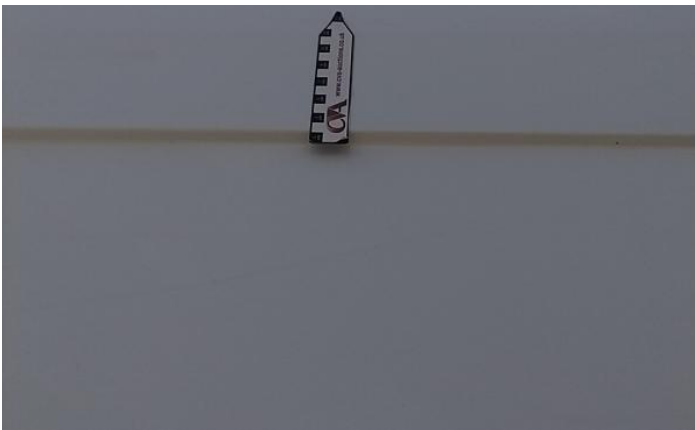
25: Qtr Panel osr  
Dented  
Between 10mm + 30mm

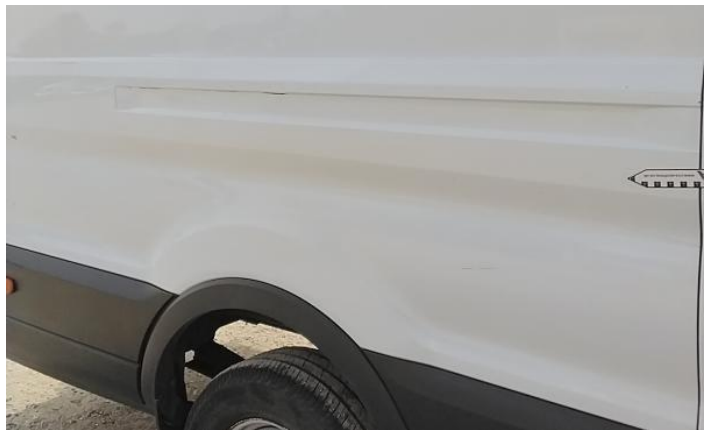
26: Qtr Panel osr  
Scratched  
Over 25mm Not Thru Paint

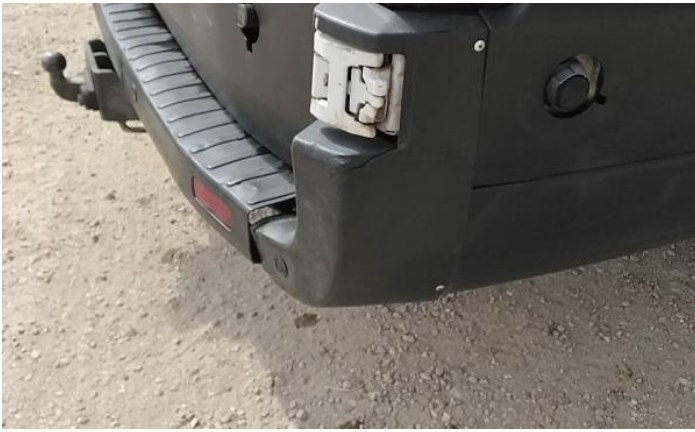
27: Bumper Rear Moulding  
Broken  
Replace

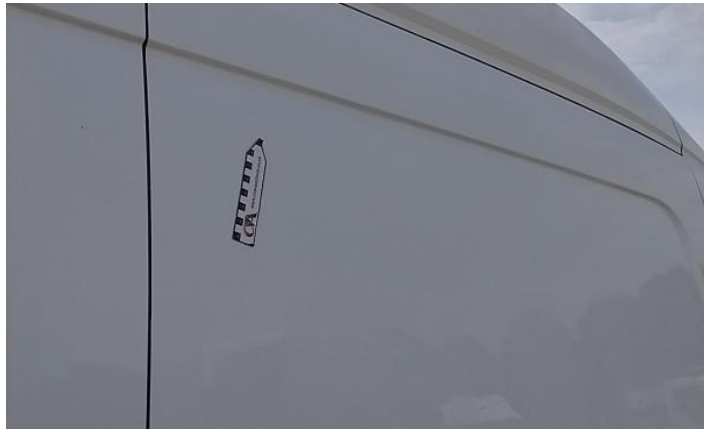
28: Qtr Panel osf  
Scratched  
Over 25mm Not Thru Paint

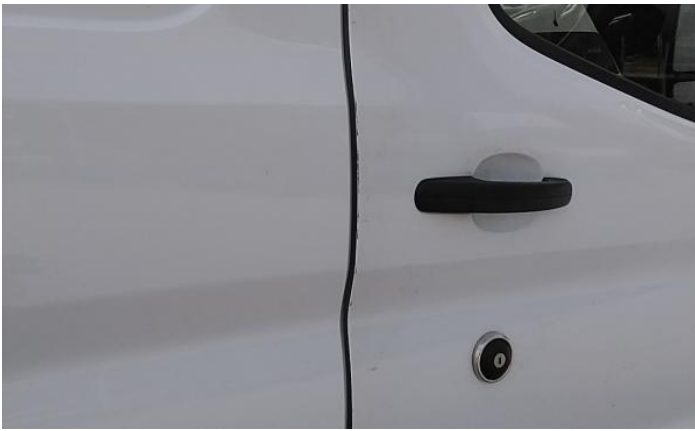
29: Door osf  
Chipped  
Edge Chip

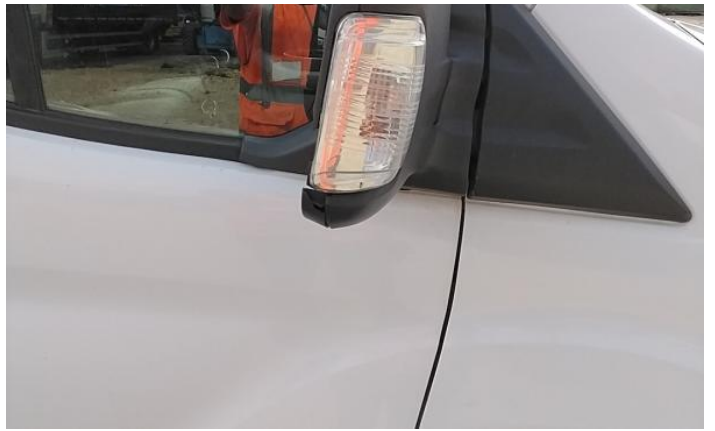
30: Door Mirror Assy osf  
Broken  
Replace

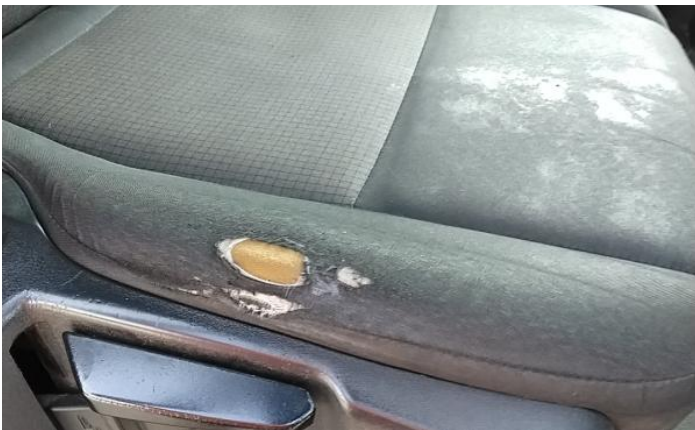
31: Seat Base Cover osf  
Holed  
Over 3mm

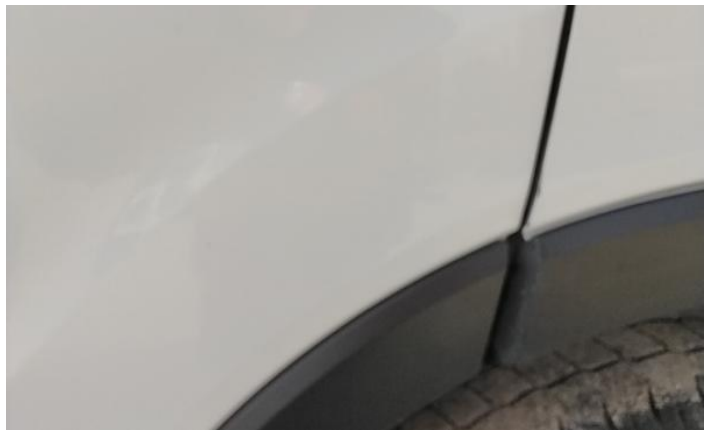
32: Door osf  
Dented  
Between 10mm + 30mm
