VEHICLE INSPECTION REPORT

MV69JGX

Daf LF 180

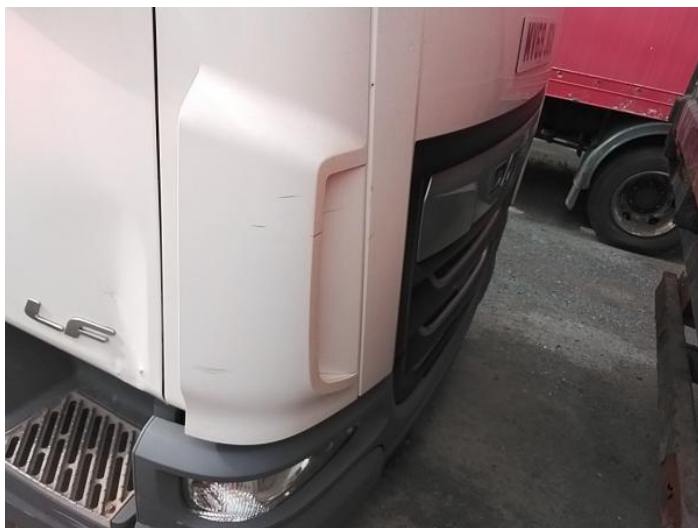
1: Panel Front
Scratched
Over 25mm Thru Paint

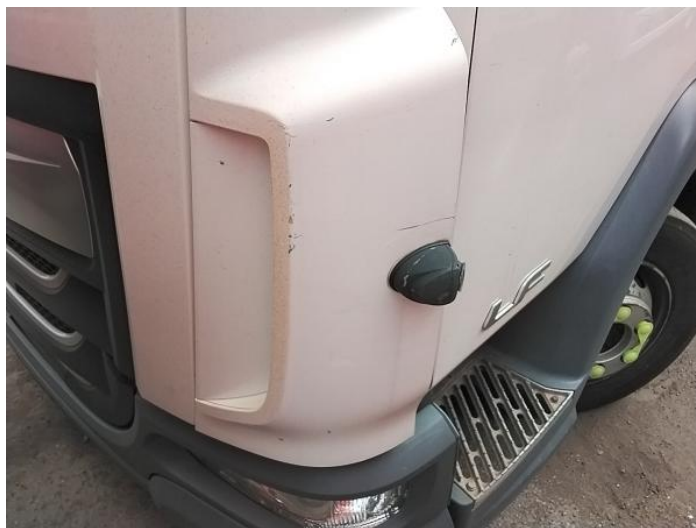
2: Panel Front
Scratched
Over 25mm Thru Paint

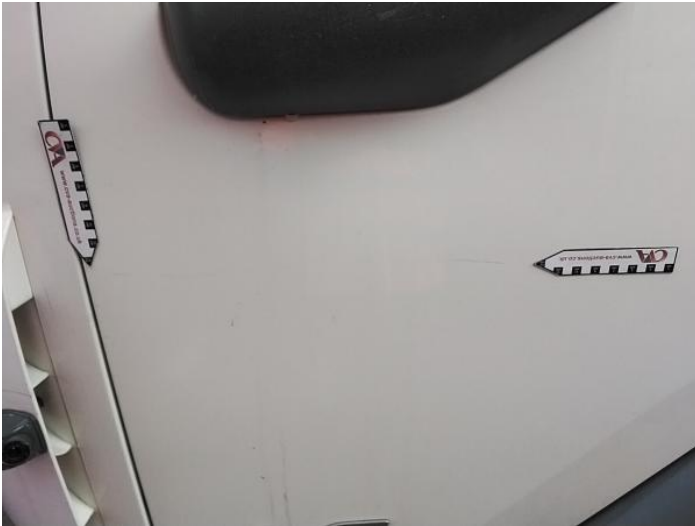
3: Door nsf
Scratched
Over 25mm Thru Paint

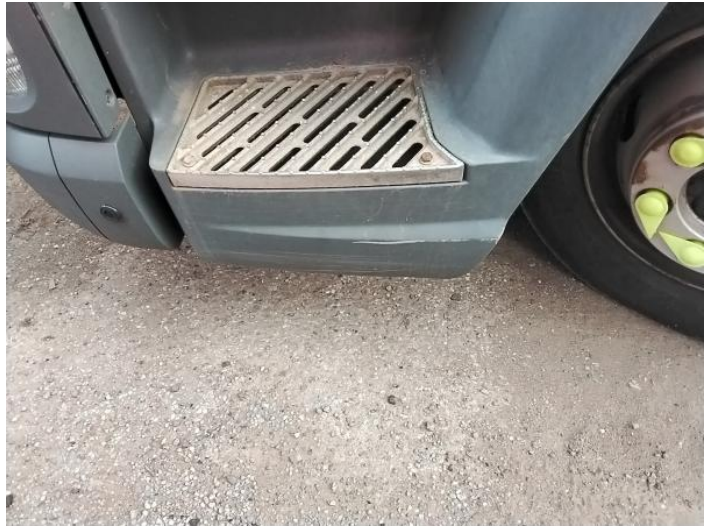
4: Bumper Front Moulding
Scuffed (Unpainted)
Over 100mm

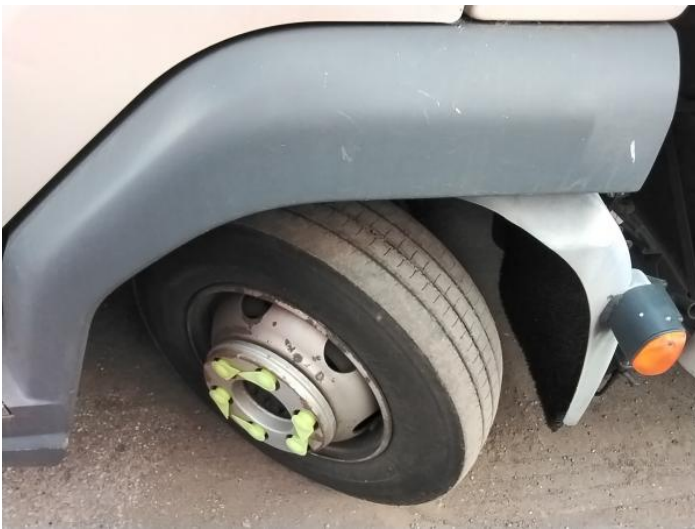
5: Wing nsf
Scratched
Over 25mm Thru Paint

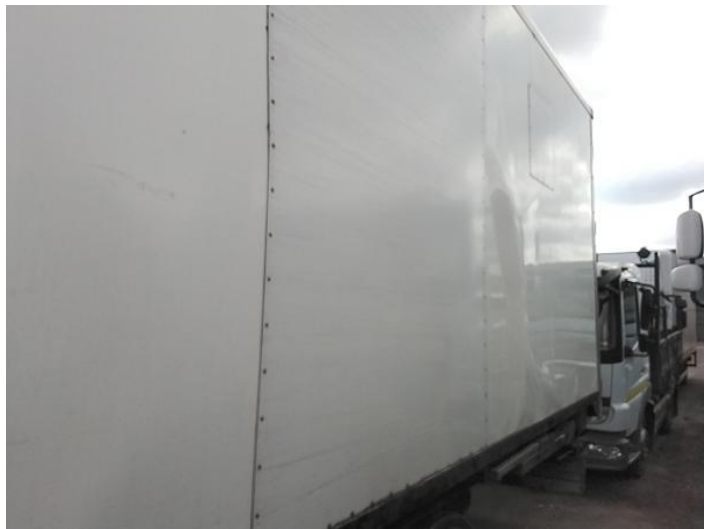
6: Qtr Panel nsr
Scratched
Over 25mm Thru Paint

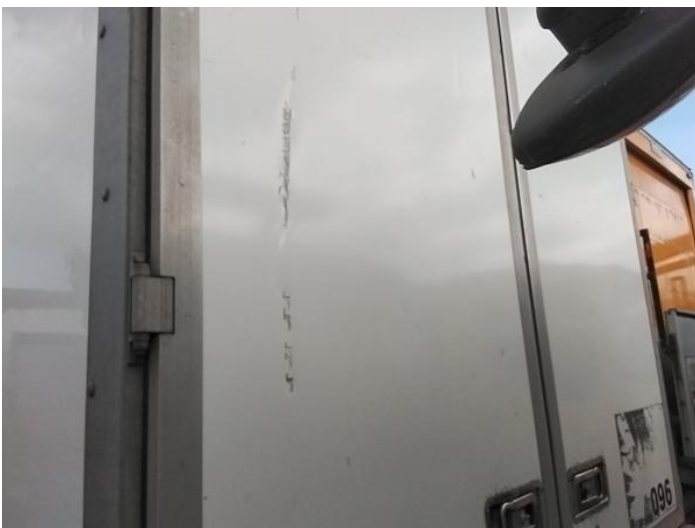
7: Door nsr
Dented
With Paint Damage

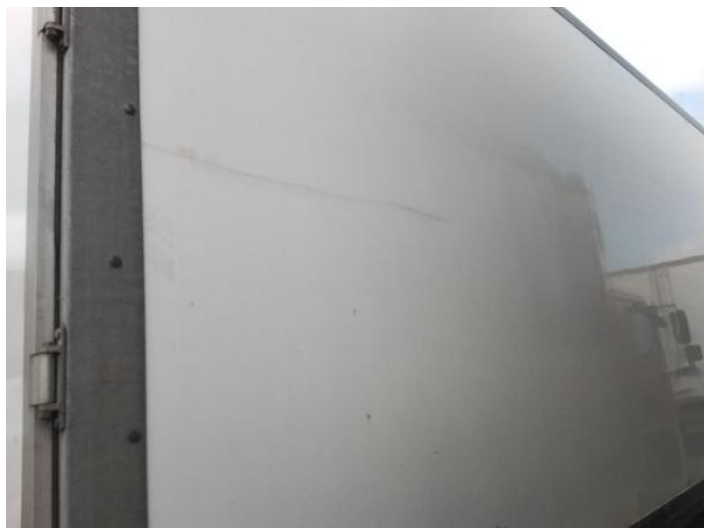
8: Qtr Panel osr
Scratched
Over 25mm Thru Paint

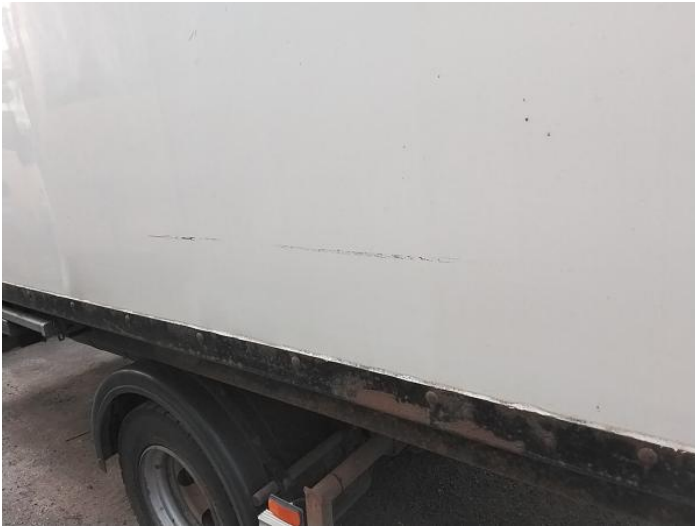
9: Qtr Panel osr
Scratched
Over 25mm Not Thru Paint

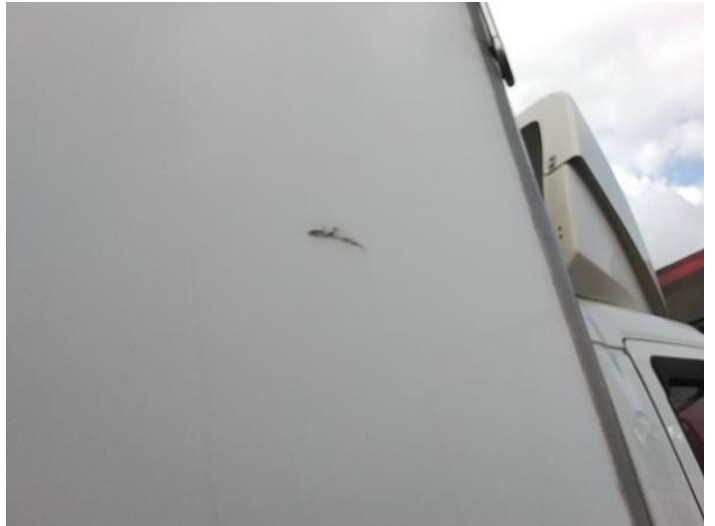
10: Qtr Panel osr
Cracked
Replace

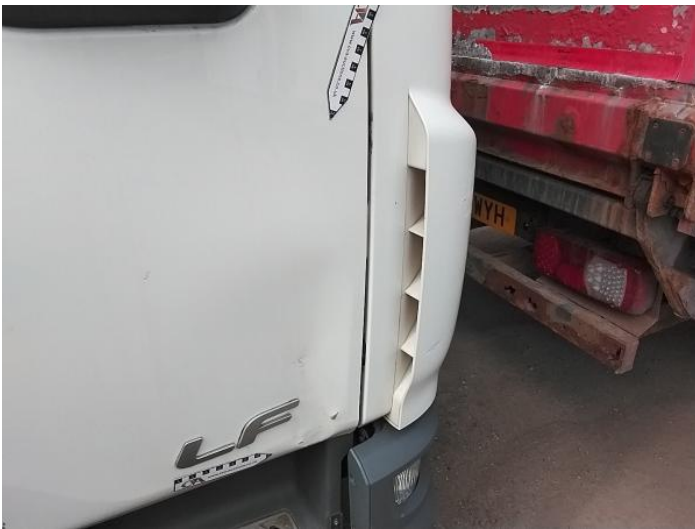
11: Door osf
Dented
With Paint Damage

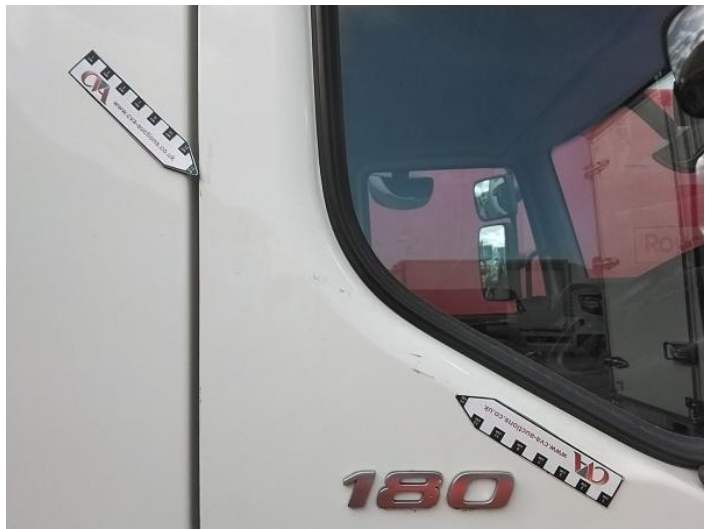
12: Door osf
Scratched
Over 25mm Thru Paint

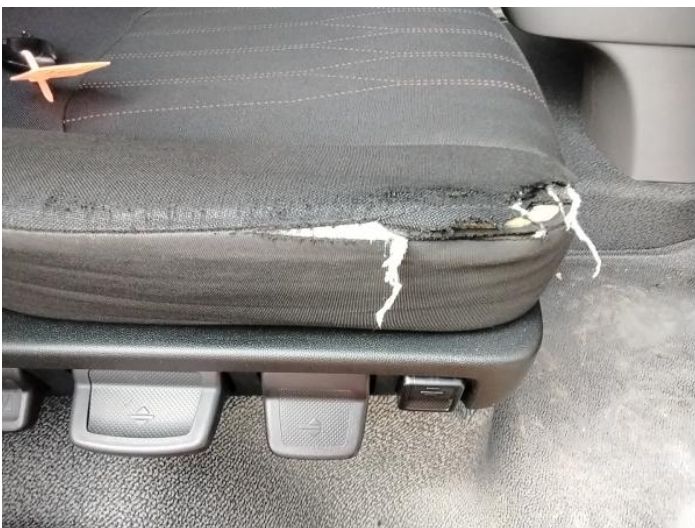
13: Seat Base Cover osf
Torn
Over 3mm
