# VEHICLE INSPECTION REPORT

**PE65VAJ**

## Daf LF 220

\*COLLECTED AS NON-RUNNER - CAB CORROSION, WARNING LIGHTS ON DASH\*

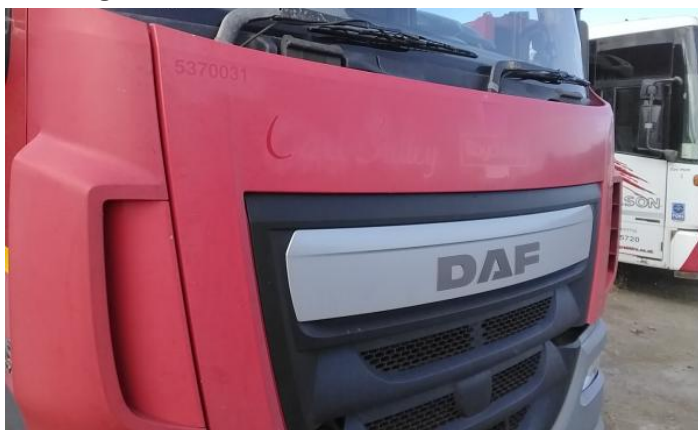
1: Bonnet  
Chipped  
Multiple Chips

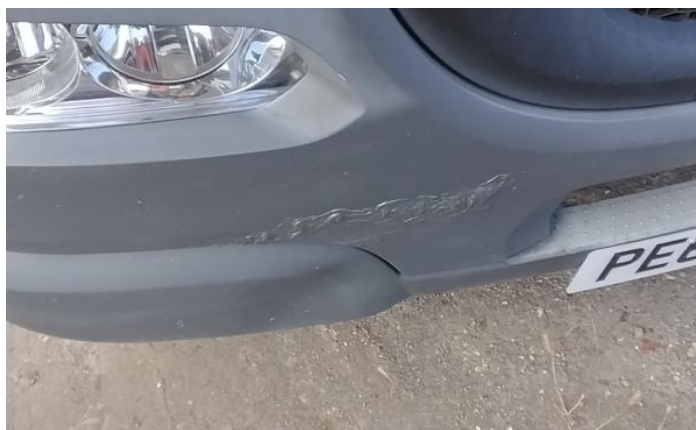
2: Panel Front  
Poor Previous Repair  
Rippled Up To 30%

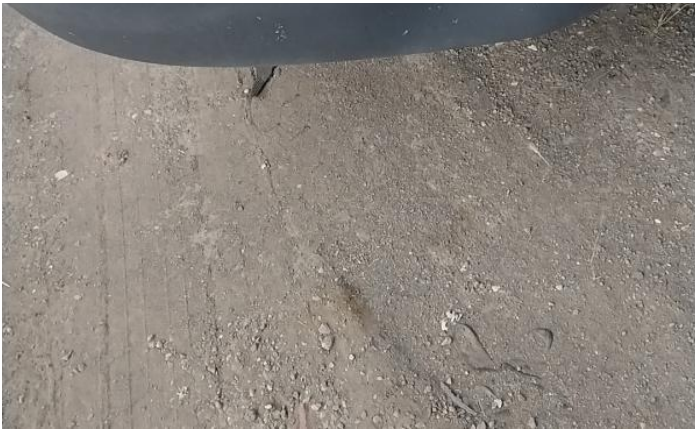
3: Bumper Front  
Dented  
Over 30mm

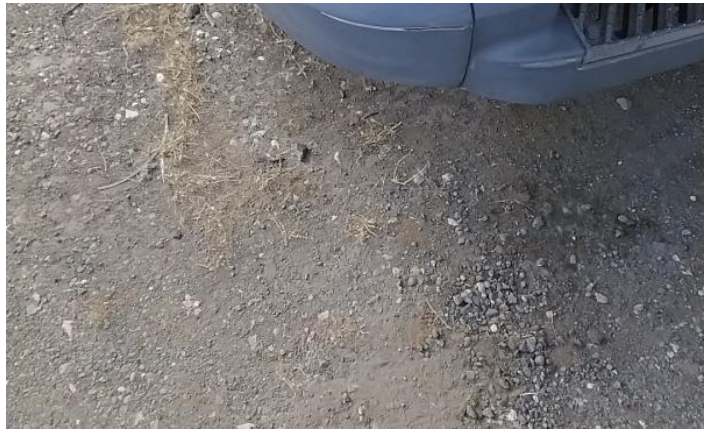
4: Bumper Front  
Scratched  
Over 100mm Thru Paint

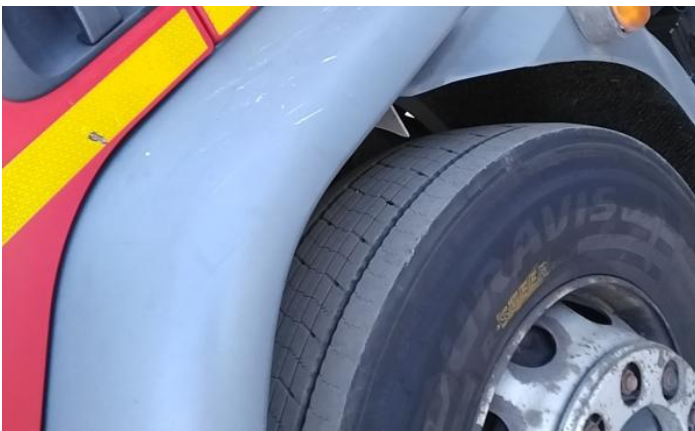
5: Wing nsf  
Scratched  
Over 25mm Thru Paint

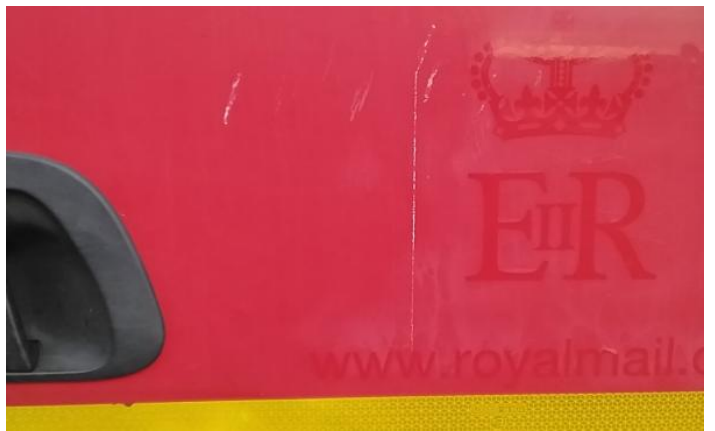
6: Door osf  
Scratched  
Over 25mm Thru Paint

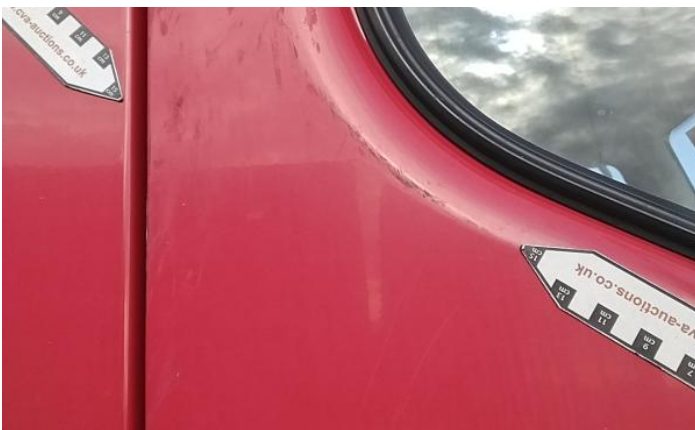
7: Door osf  
Scratched  
Over 25mm Thru Paint

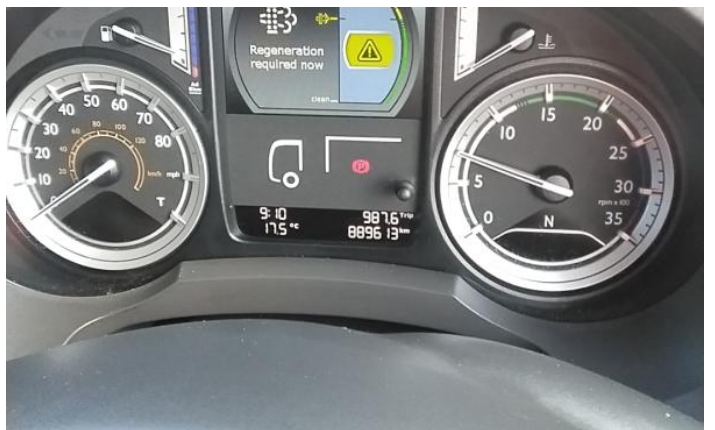
8: Dash Warning Lights  
Displayed  
No Action

| EML light illuminated | | Fault | DPF light illuminated | | Fault |

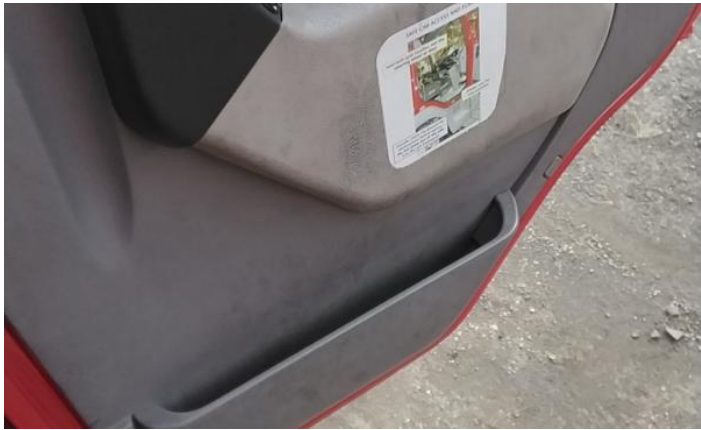
9: Door Pad osf  
Soiled  
Heavy

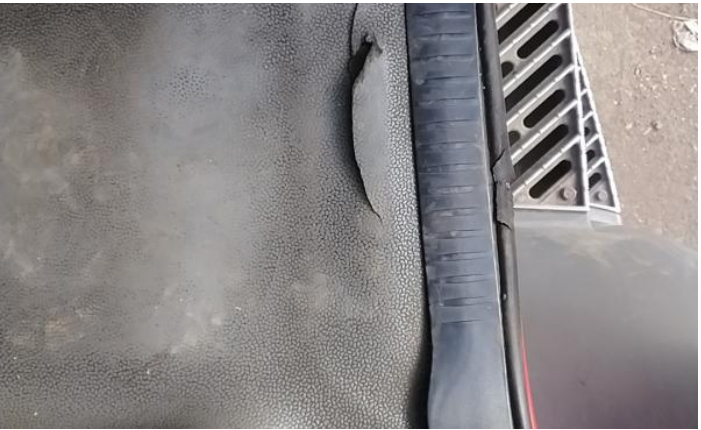
10: Carpets Front  
Torn  
Over 10mm

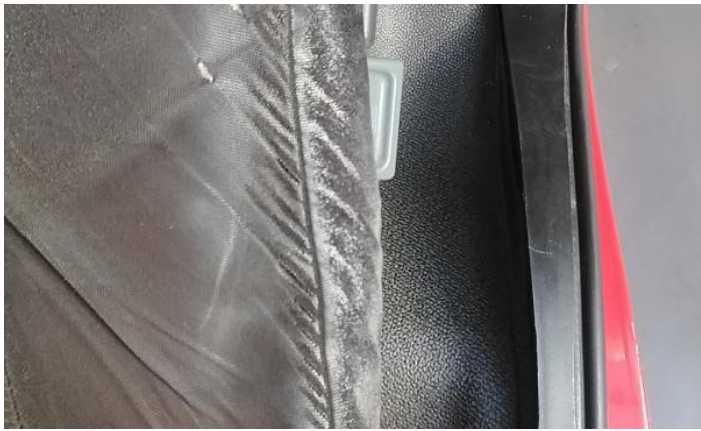
11: Seat Base Cover osf  
Holed  
Over 3mm
