# VEHICLE INSPECTION REPORT

**WU16PDO**

## Daf LF 180

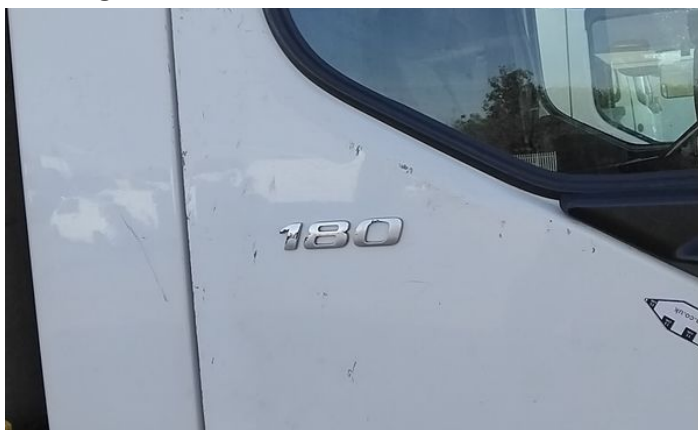
1: Door osf  
Dented  
With Paint Damage

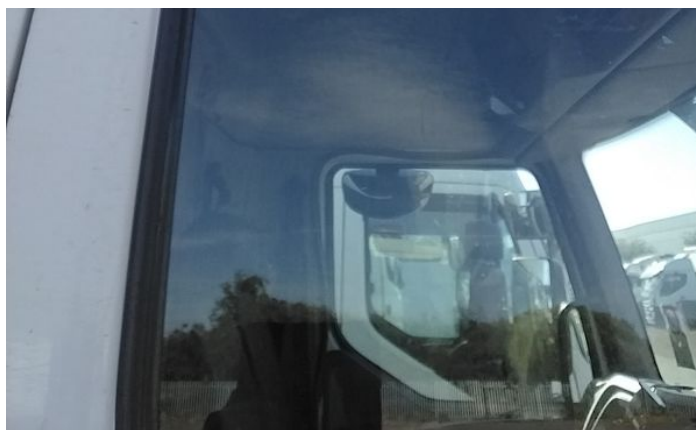
2: Door Moulding osf  
Missing  
Replace

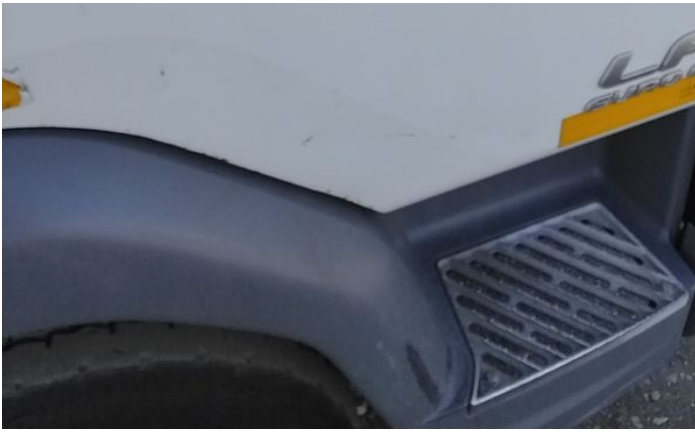
3: Door osf  
Scratched  
Over 25mm Thru Paint

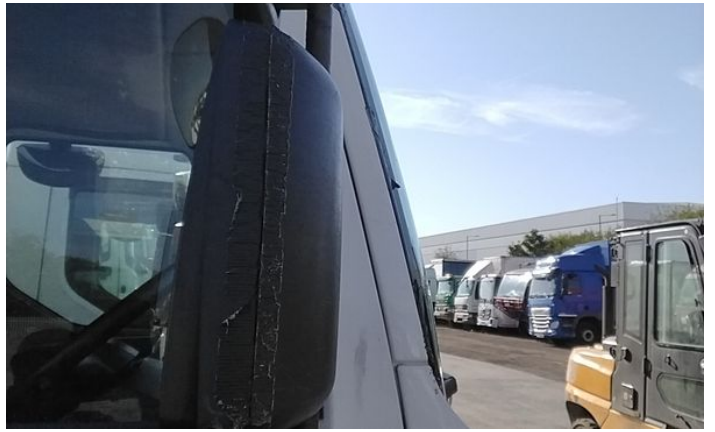
4: Door Mirror Assy osf  
Broken  
Replace

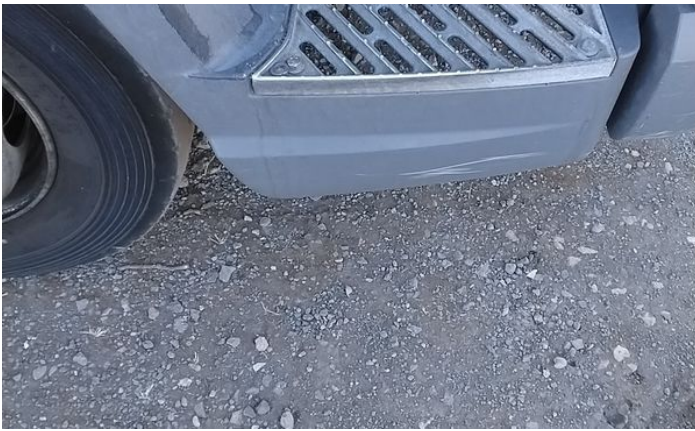
5: Wing osf  
Scratched  
Over 25mm Thru Paint

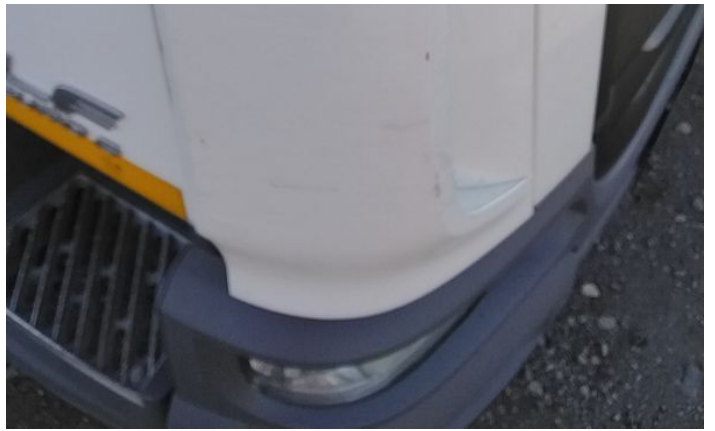
6: Panel Front  
Scratched  
Over 25mm Thru Paint

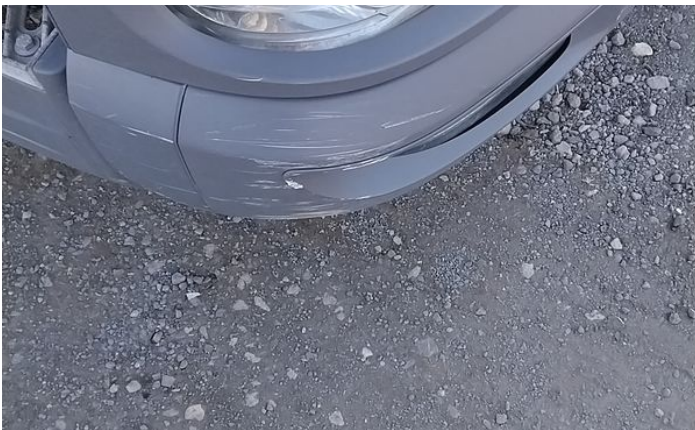
7: Bumper Front  
Dented  
With Paint Damage

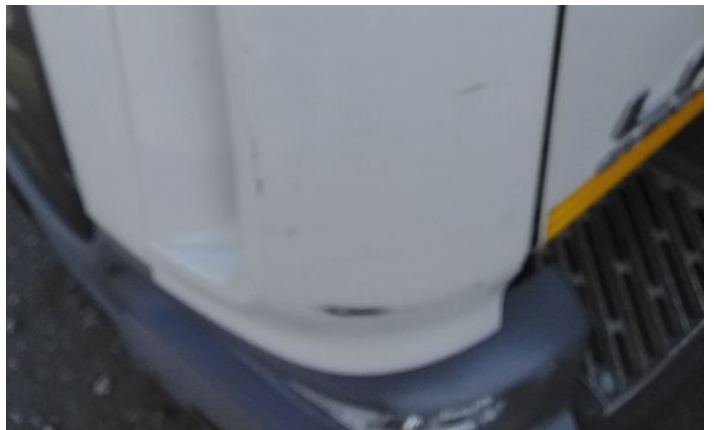
8: Panel Front  
Scratched  
Over 25mm Thru Paint

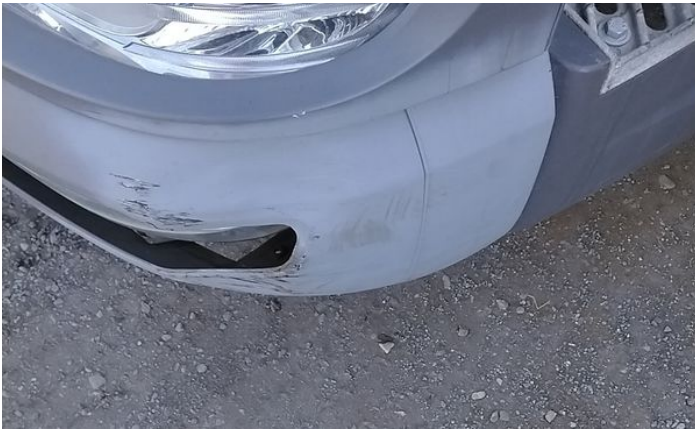
9: Bumper Front  
Dented  
With Paint Damage

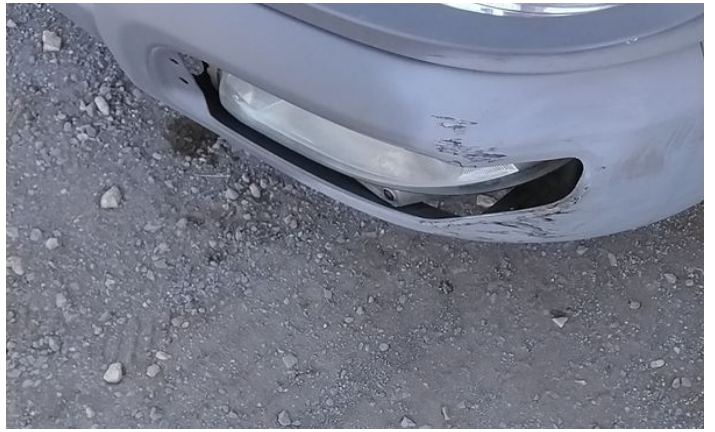
10: Bumper Front Moulding  
Missing  
Replace

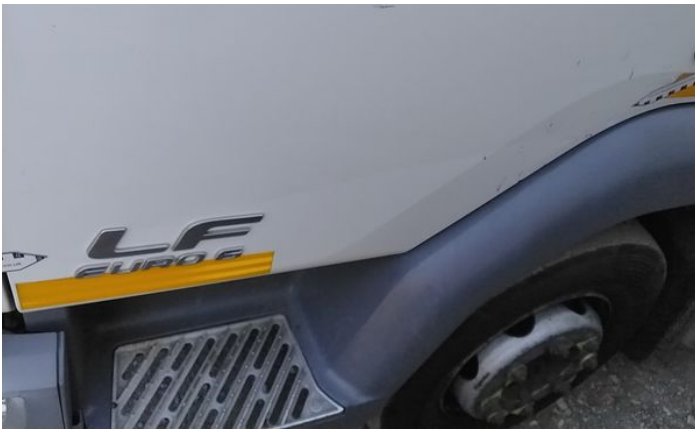
11: Door nsf  
Dented  
With Paint Damage

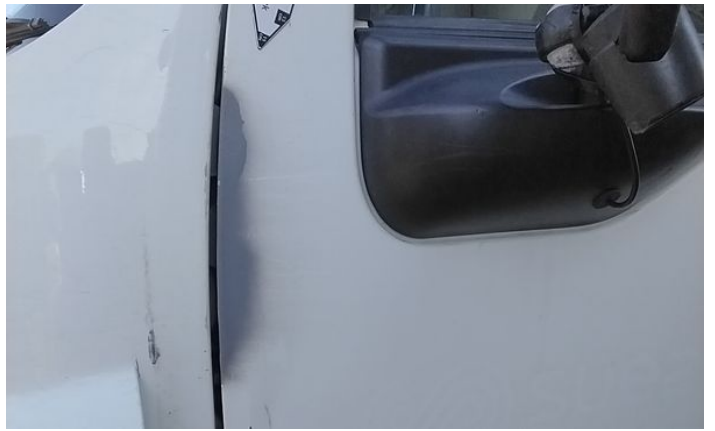
12: Door nsf  
Dented  
With Paint Damage

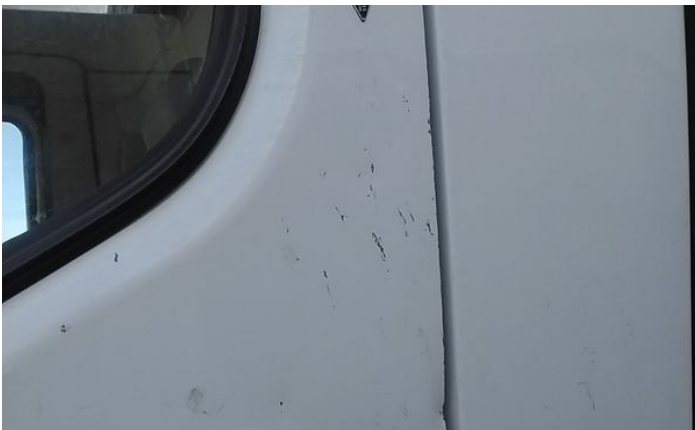
13: Door nsf  
Dented  
With Paint Damage

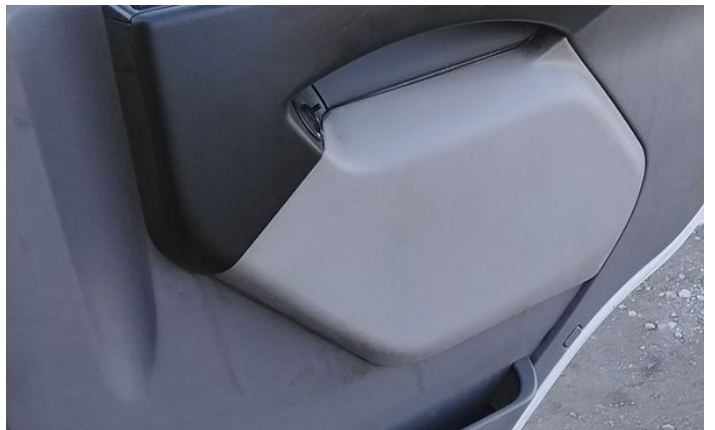
14: Door Pad osf  
Soiled  
Heavy

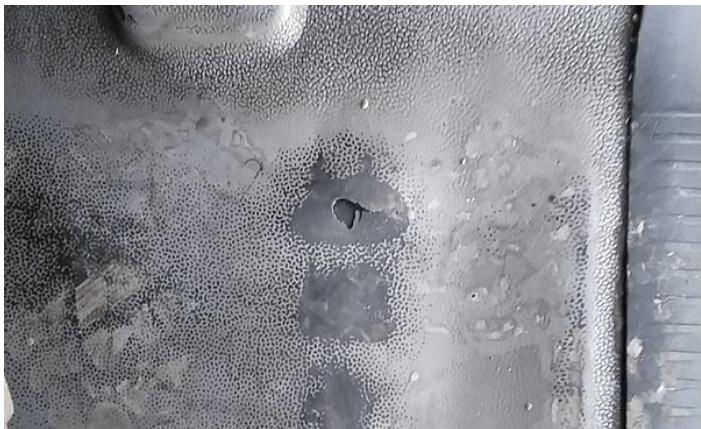
15: Carpets Front  
Holed  
Over 3mm

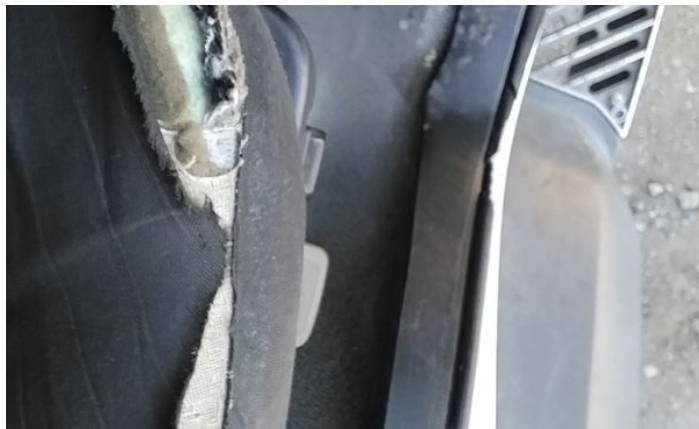
16: Seat Base Cover osf  
Holed  
Over 3mm

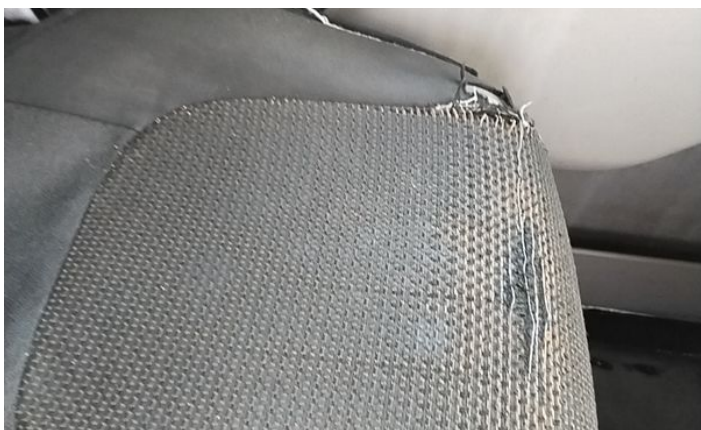
17: Seat Base Cover nsf  
Holed  
Over 3mm
