# VEHICLE INSPECTION REPORT

**BX09FZR**

## Daf LF 45.180

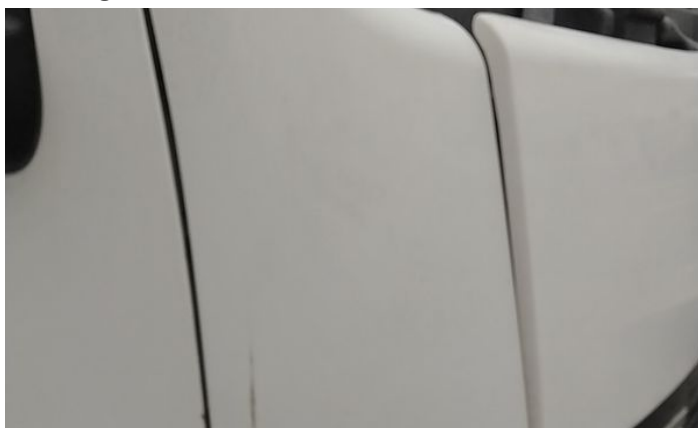
1: Panel Front  
Cracked  
Replace

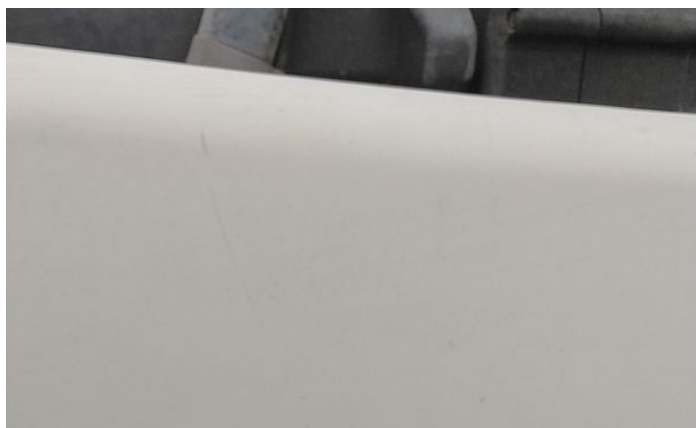
2: Bonnet  
Scratched  
Over 25mm Thru Paint

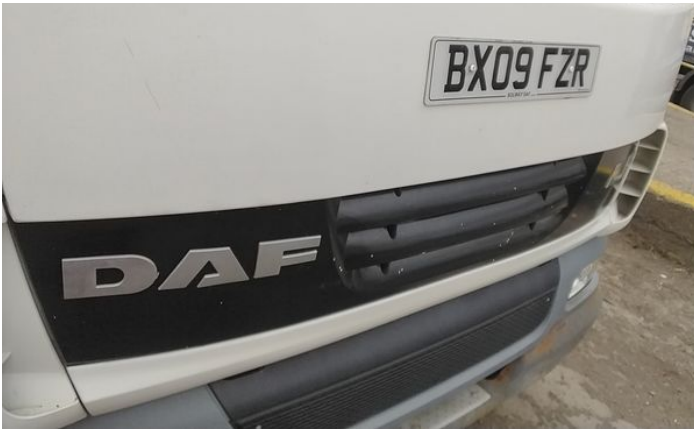
3: Bonnet  
Chipped  
Multiple Chips

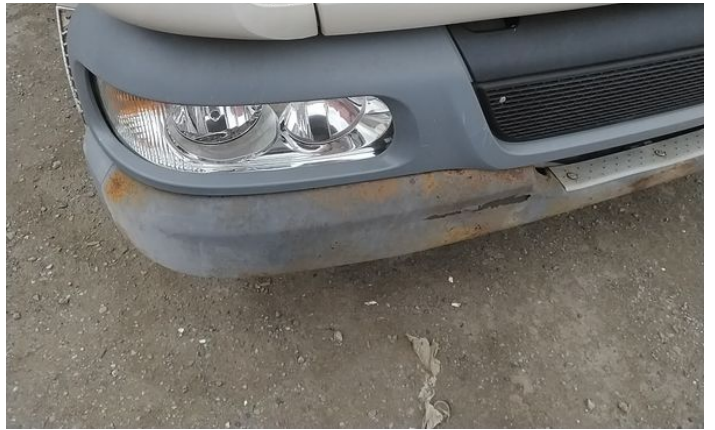
4: Bumper Front  
Dented  
With Paint Damage

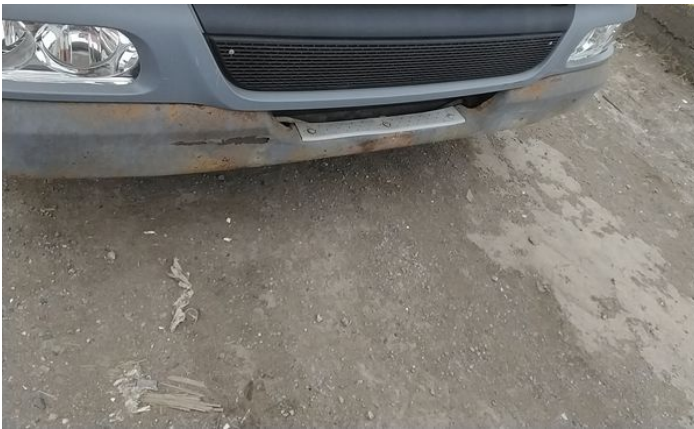
5: Bumper Front  
Rusted  
Over 5mm

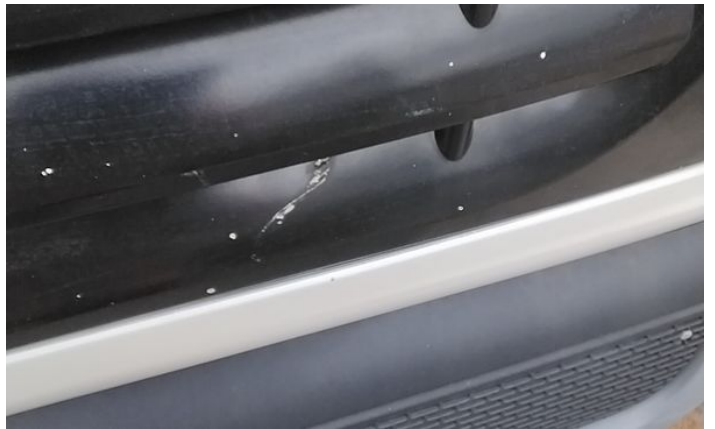
6: Bumper Front Grill  
Broken  
Replace

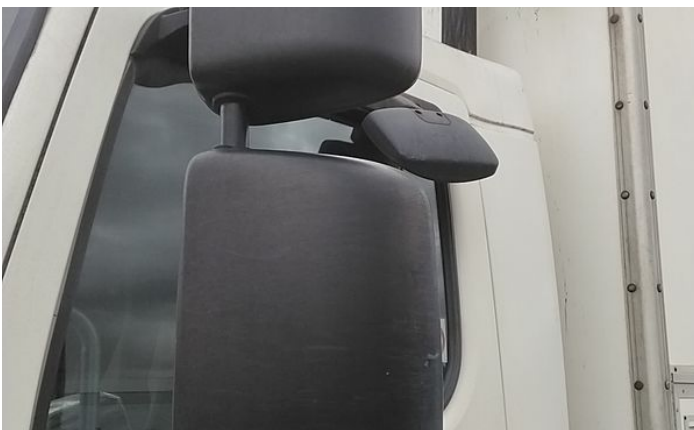
7: Door Mirror Assy nsf  
Scuffed (Unpainted)  
Over 100mm

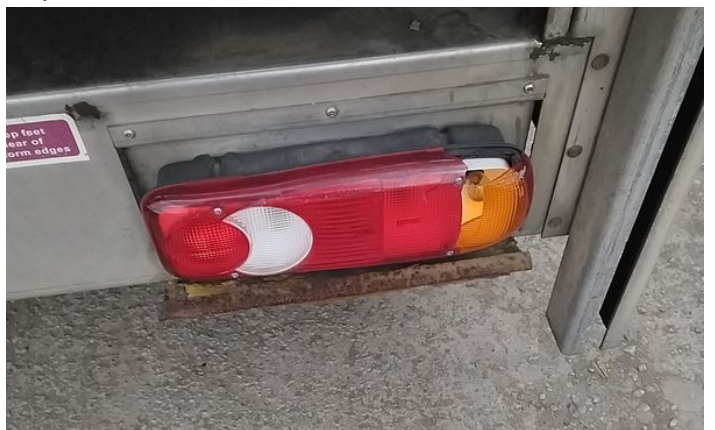
8: Lamp osr  
Broken  
Replace

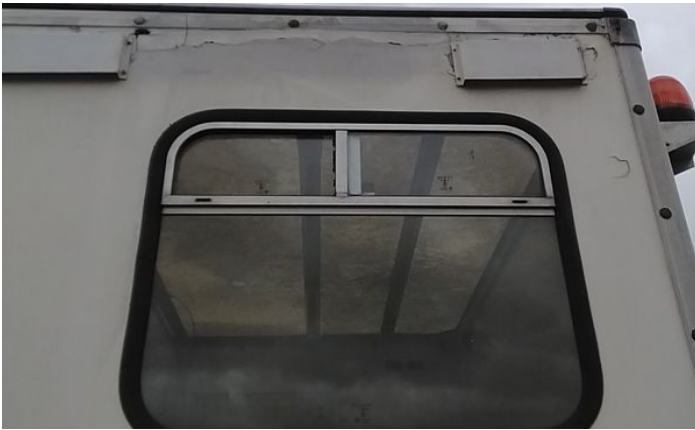
9: Qtr Panel osr  
Cracked  
Replace

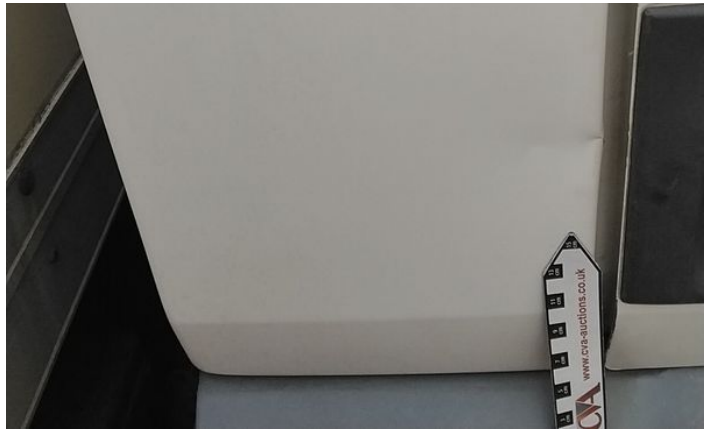
10: B Post os  
Dented  
Over 30mm

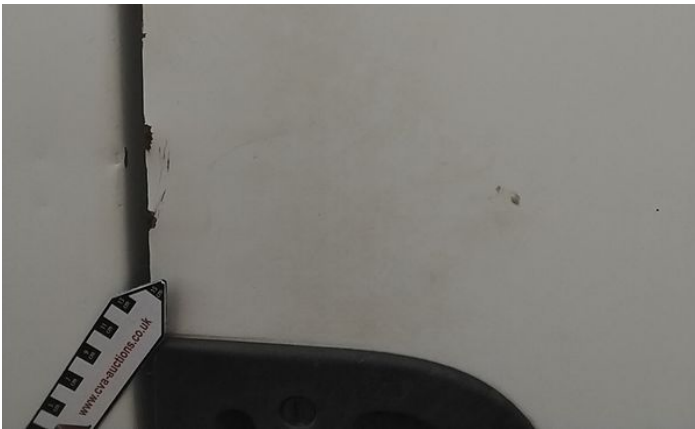
11: Door osf  
Dented  
With Paint Damage

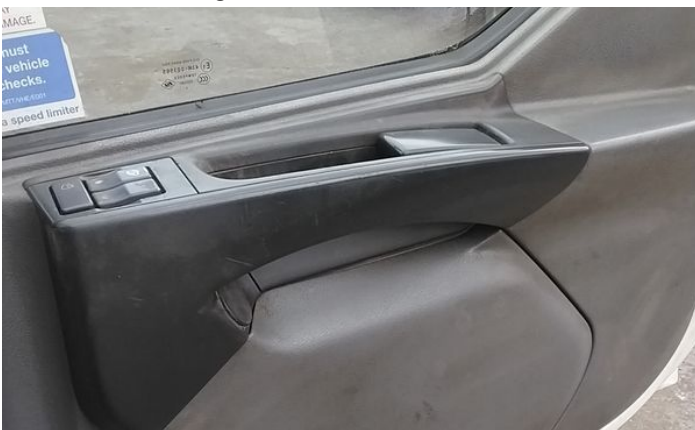
13: Door Pad osf  
Soiled  
Heavy

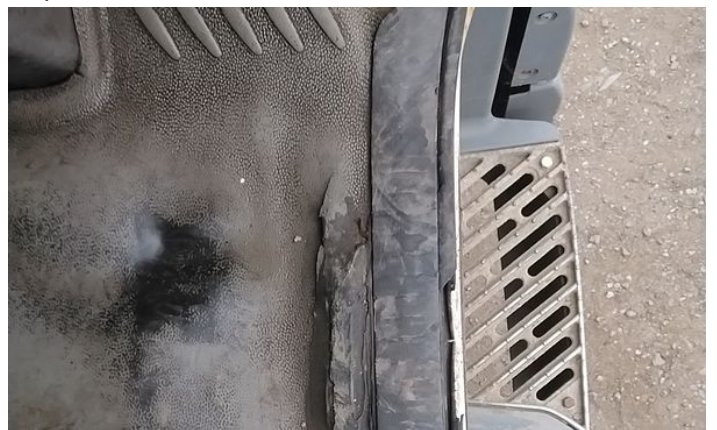
14: Carpets Front  
Torn  
Over 10mm

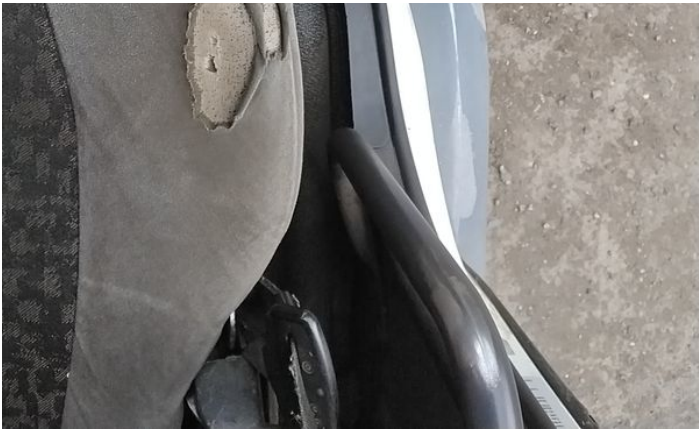
15: Seat Base Cover osf  
Torn  
Over 3mm

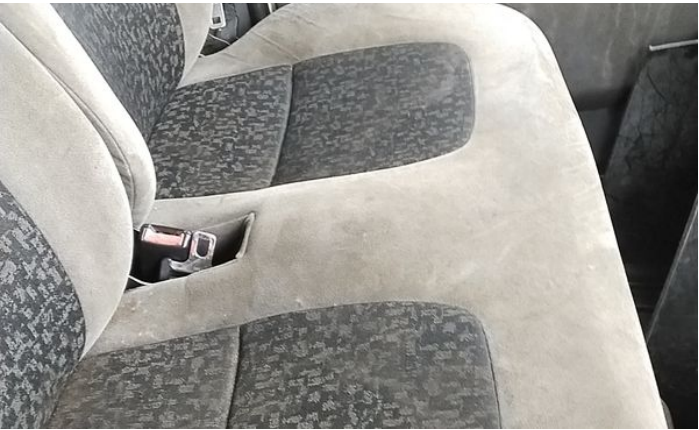
16: Seat Base Cover nsf  
Soiled  
Heavy
