# VEHICLE INSPECTION REPORT

**BC15ZDA**

## Iveco Daily 70-170

### Inspection

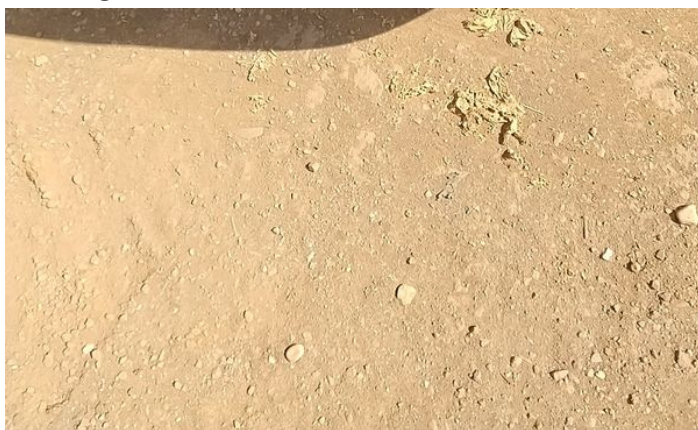
1: Bumper Front  
Scratched  
Over 100mm Thru Paint

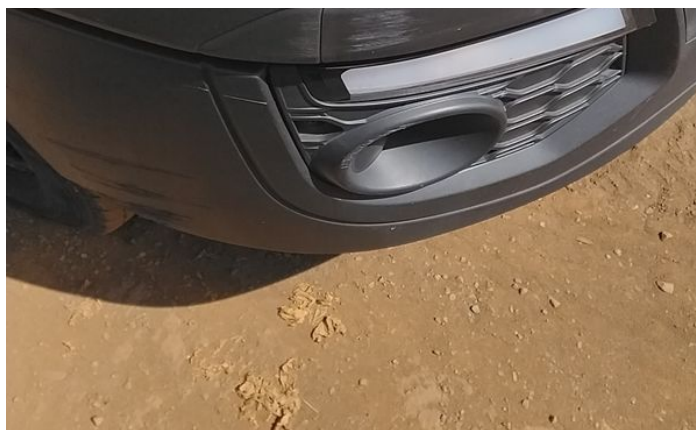
2: Bumper Front Moulding  
Scuffed (Unpainted)  
Over 100mm

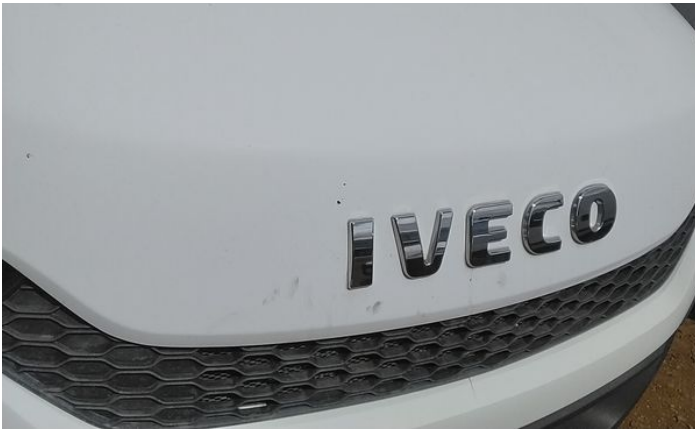
3: Bonnet  
Chipped  
Multiple Chips

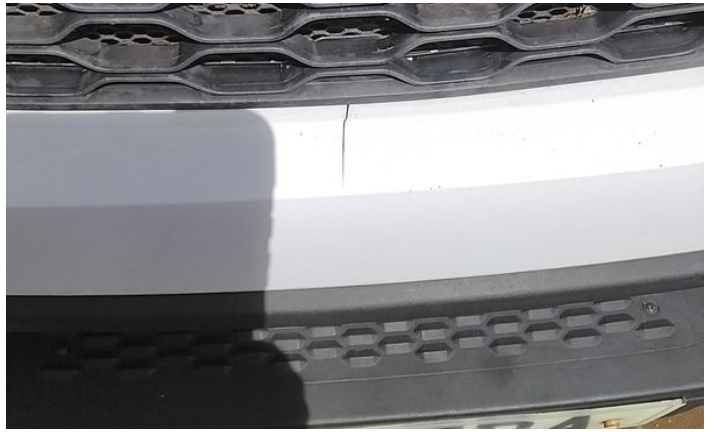
4: Panel Front  
Cracked  
Replace

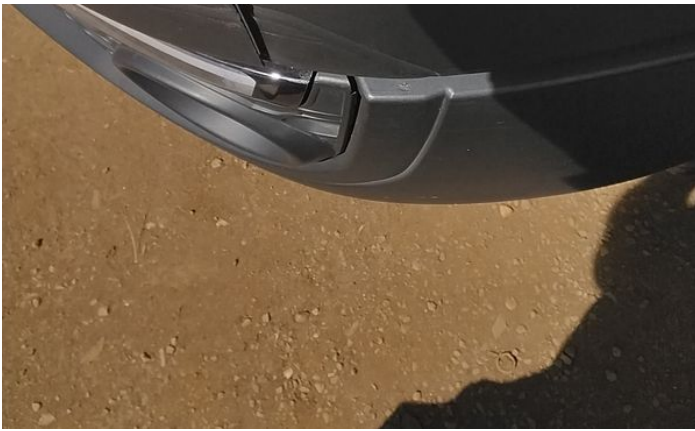
5: Wing nsf  
Dented  
With Paint Damage

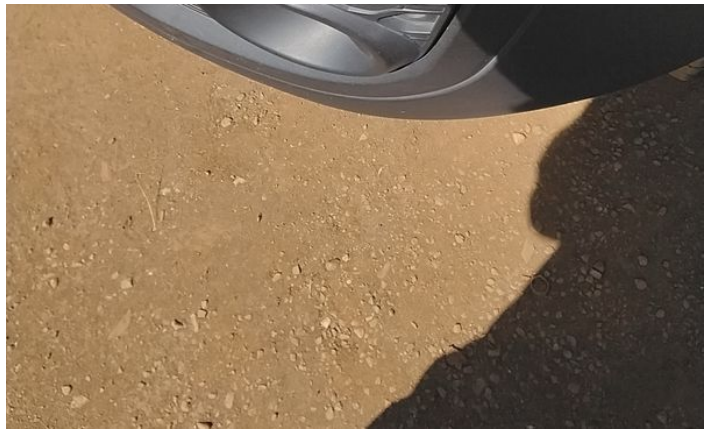
6: Bumper Front Moulding  
Scuffed (Unpainted)  
Over 100mm

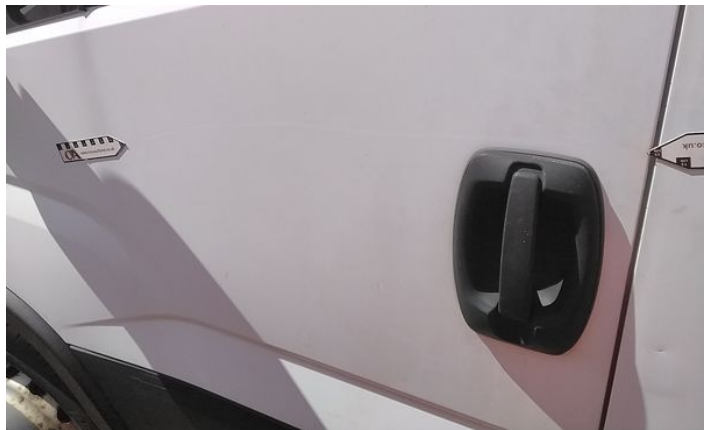
8: Door nsf  
Scratched  
Over 25mm Thru Paint

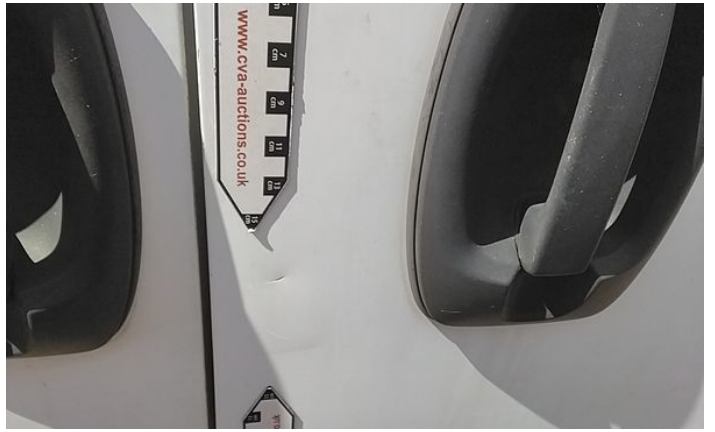
10: Qtr Panel nsr  
Dented  
With Paint Damage

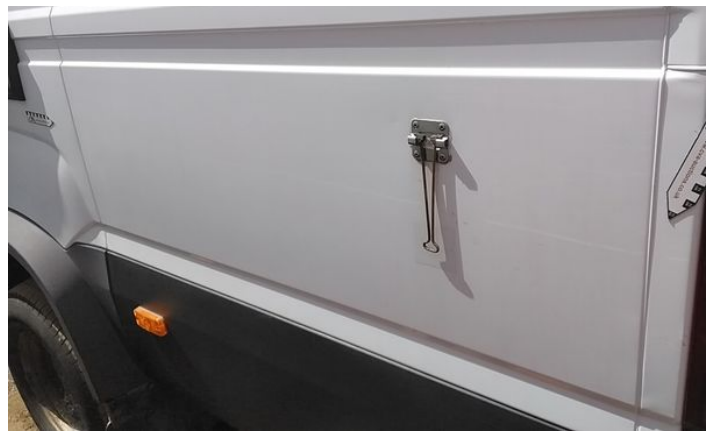
12: Qtr Panel nsr  
Scratched  
Over 25mm Thru Paint

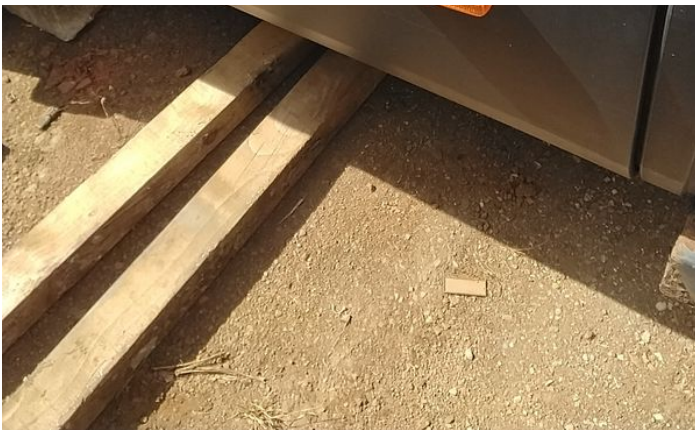
13: Qtr Panel Moulding ns  
Scuffed (Unpainted)  
Over 100mm

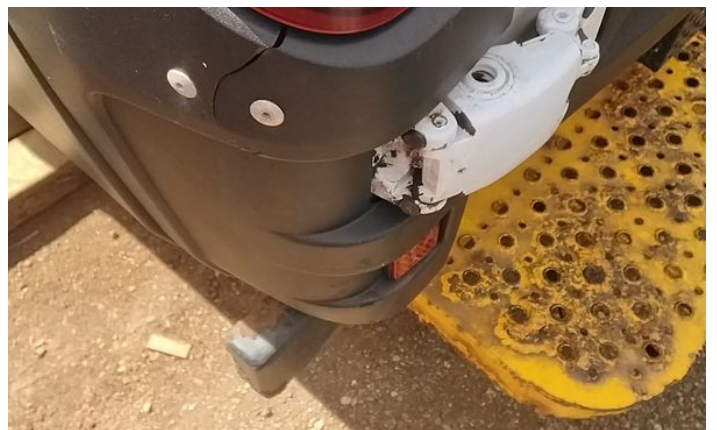
14: Bumper Rear Moulding  
Broken  
Replace

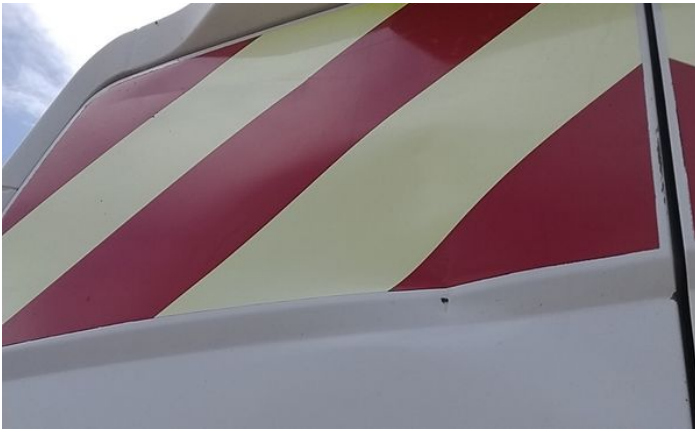
15: Door nsr  
Dented  
With Paint Damage

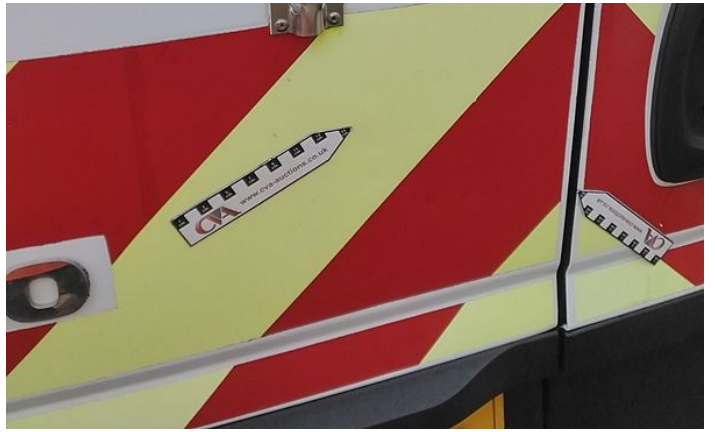
16: Door nsr  
Dented  
Over 30mm

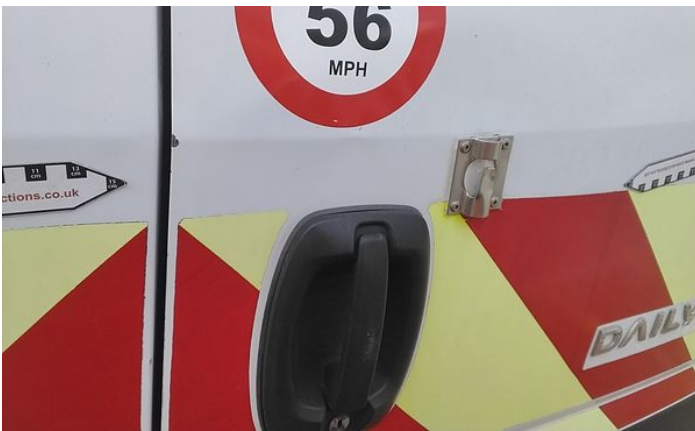
17: Door osf  
Dented  
Over 30mm

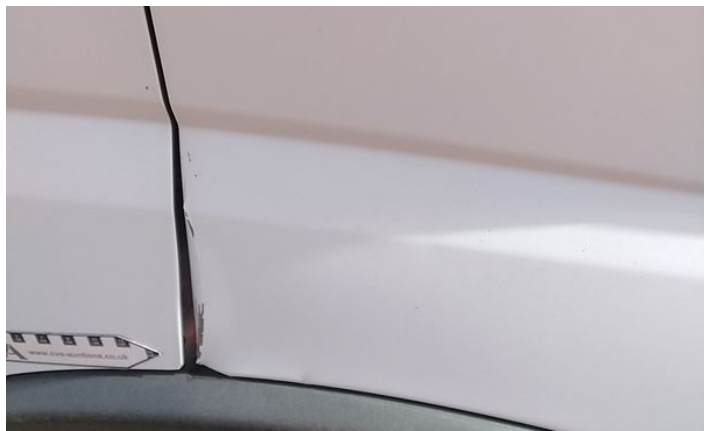
18: Wing osf  
Dented  
With Paint Damage

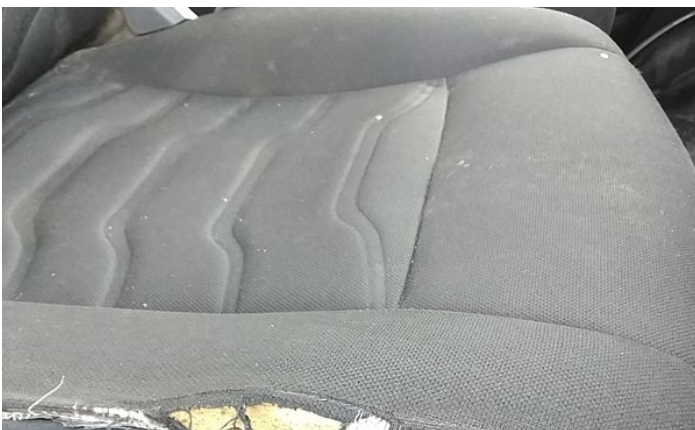
19: Seat Base Cover osf  
Torn  
Over 3mm

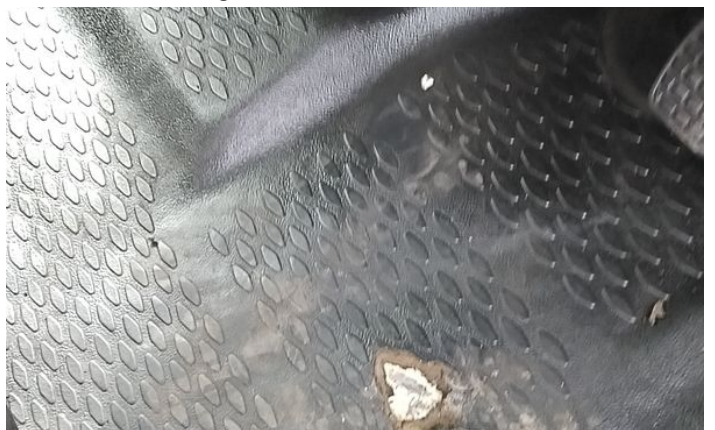
20: Carpets Front  
Holed  
Over 3mm

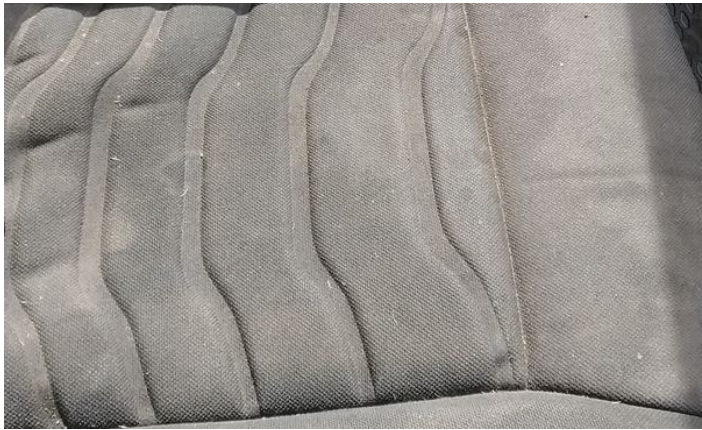
21: Seat Base Cover nsf  
Soiled  
Heavy
