# VEHICLE INSPECTION REPORT

**BC15ZDD**

## Iveco Daily 70-170

**Non Runner**  
Inspection

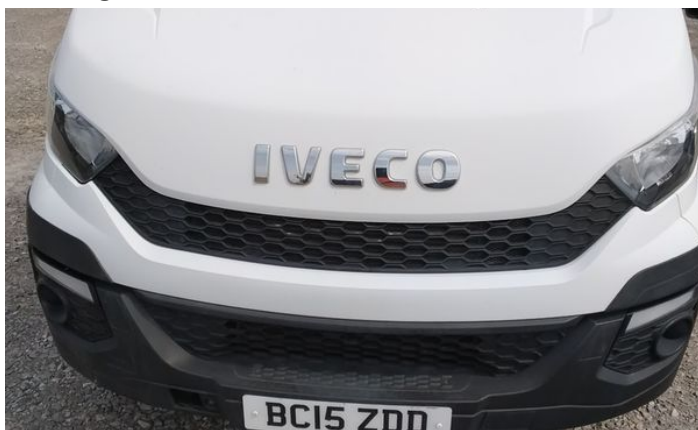
1: Bonnet  
Chipped  
Multiple Chips

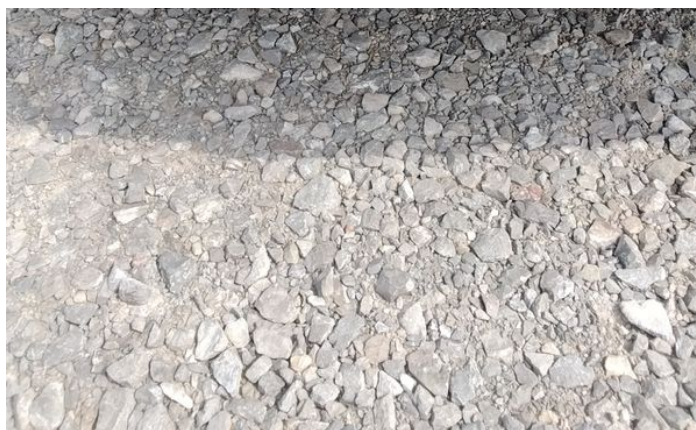
2: Front TowEye Cvr  
Missing  
Replace

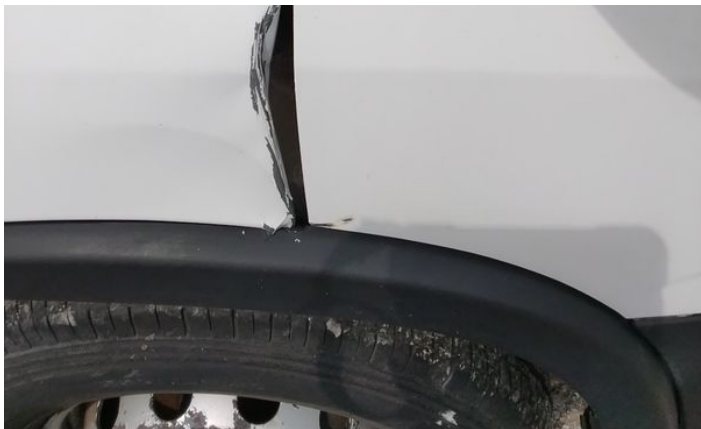
3: Wing nsf  
Dented  
Hail - Severe

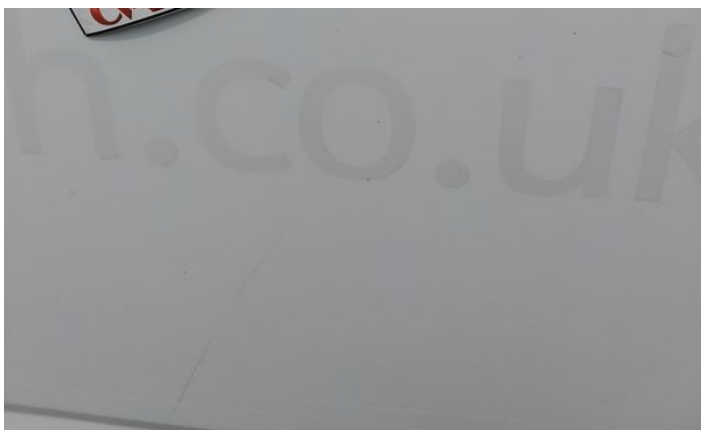
5: Qtr Panel nsr  
Scratched  
Over 25mm Thru Paint

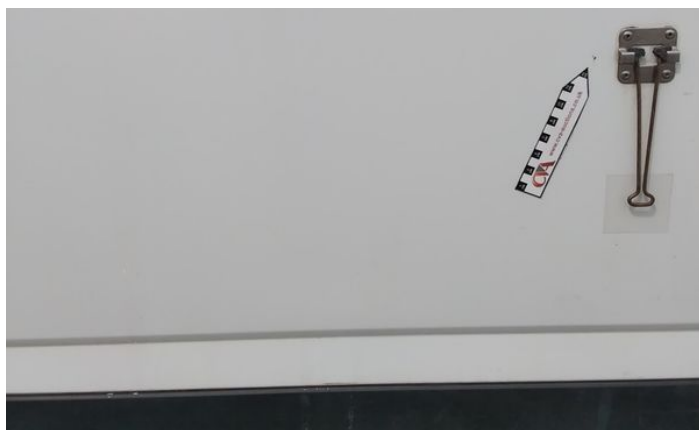
6: Qtr Panel nsr  
Scratched  
Over 25mm Thru Paint

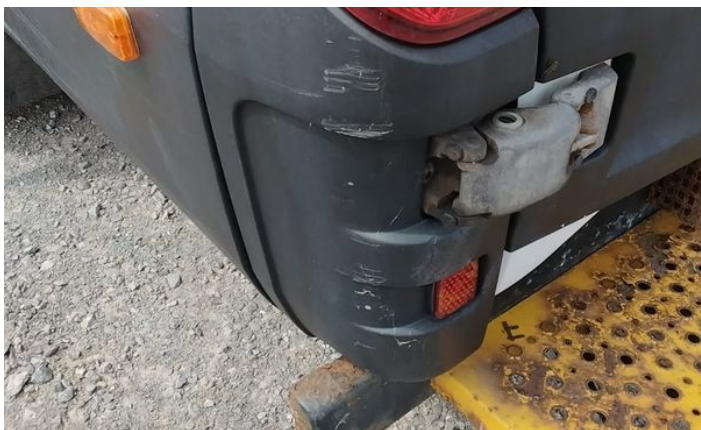
7: Bumper Rear  
Scratched  
Over 100mm Thru Paint

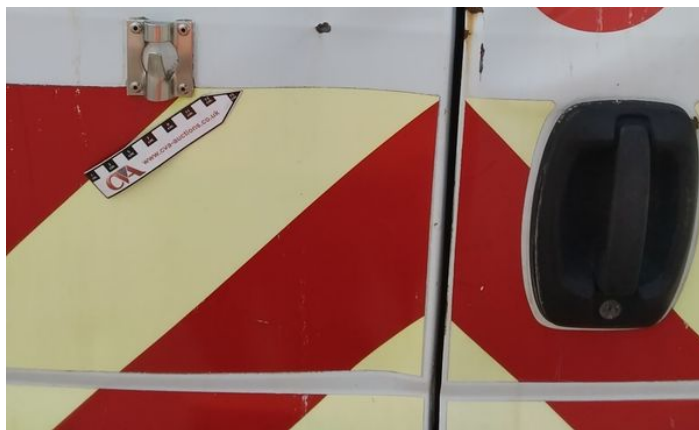
8: Door nsr  
Dented  
With Paint Damage

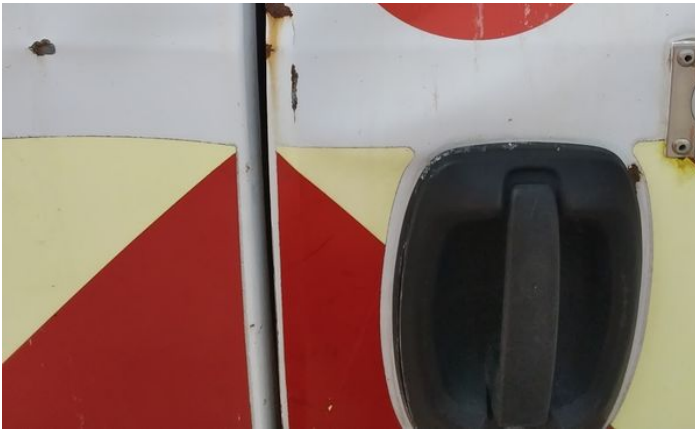
9: Door osr  
Dented  
With Paint Damage

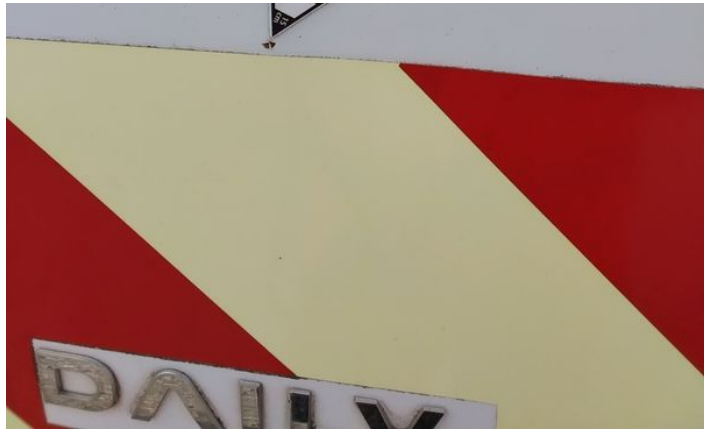
10: Door osr  
Rusted  
UpTo 5mm

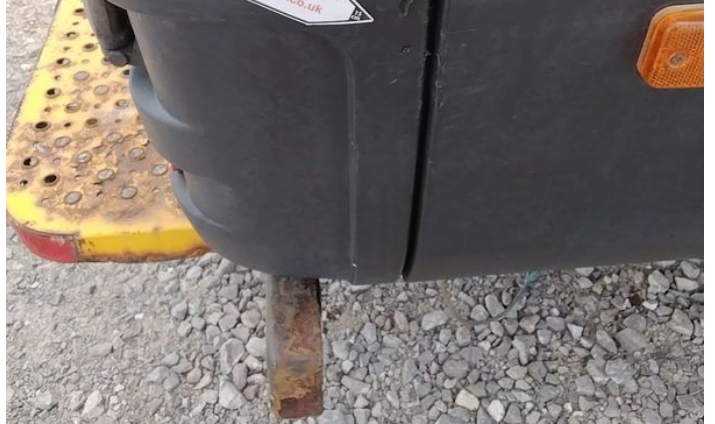
12: Bumper Rear  
Scratched  
25 to 100mm Thru Paint

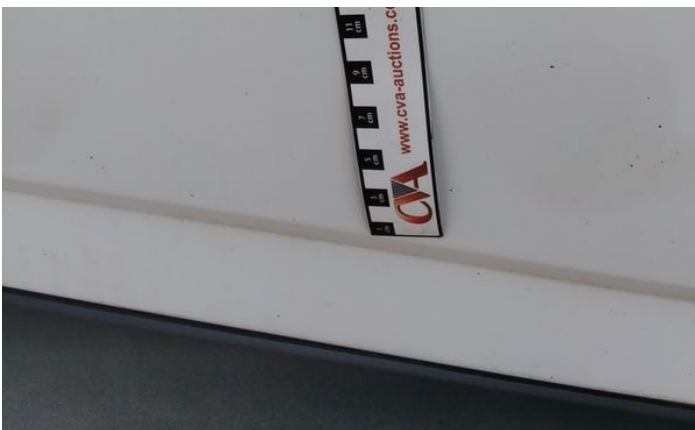
13: Qtr Panel osr  
Rusted  
Over 5mm

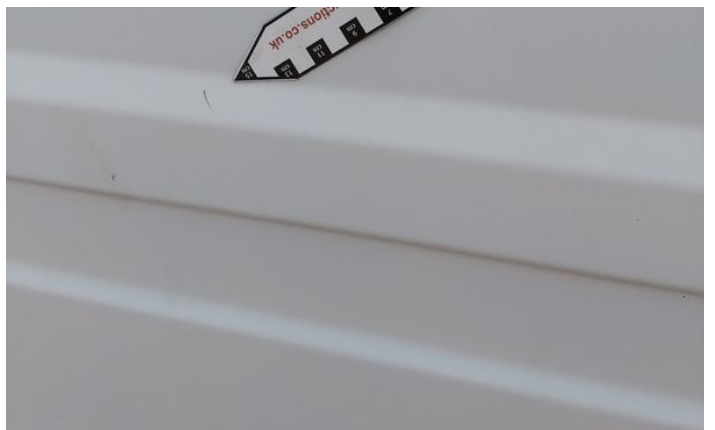
14: Qtr Panel osr  
Scratched  
Over 25mm Thru Paint

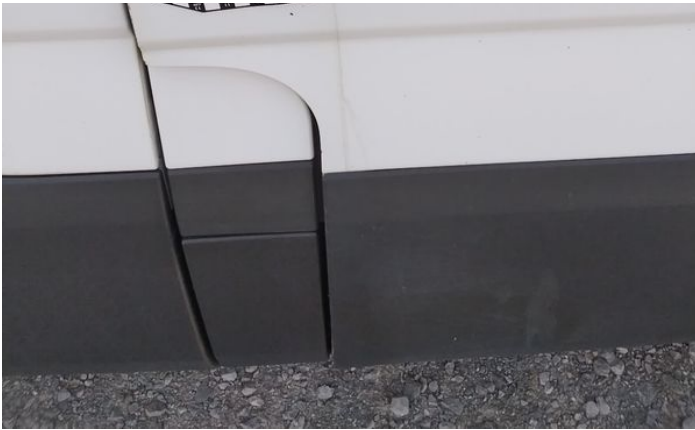
15: Door osr  
Chipped  
Multiple Chips

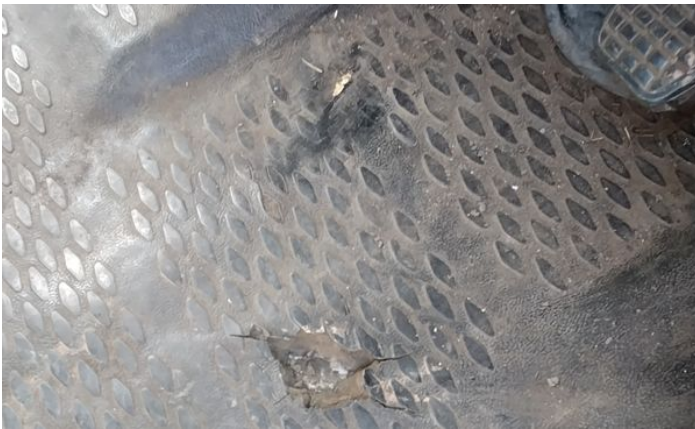
17: Carpets Front  
Holed  
Over 3mm

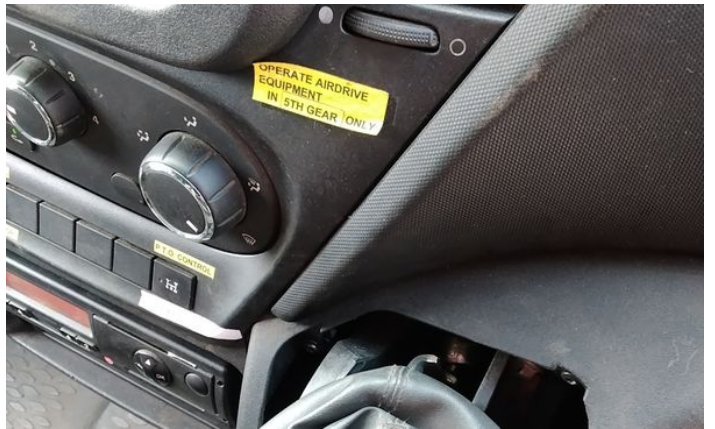
18: Fascia Trim  
Damaged  
Replace
