# VEHICLE INSPECTION REPORT

**BX09HCY**

## Daf LF 45.180

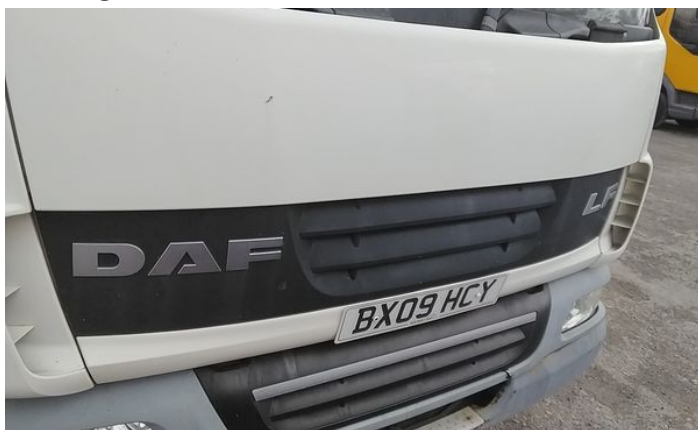
1: Bonnet  
Chipped  
Multiple Chips

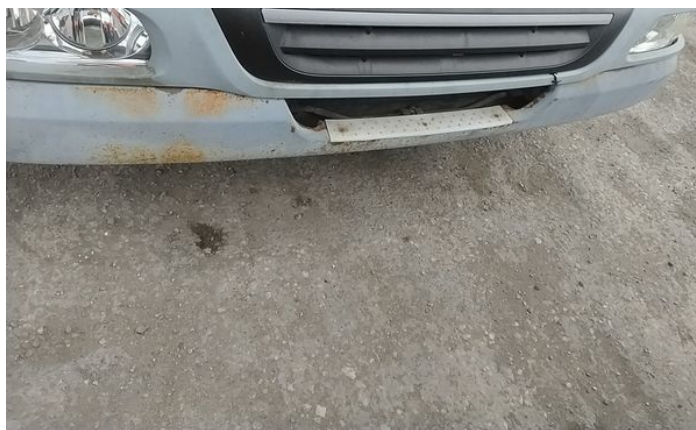
2: Bumper Front  
Rusted  
Over 5mm

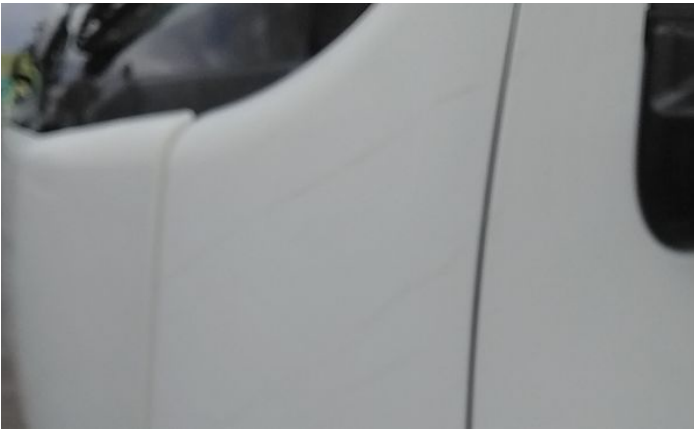
3: Panel Front  
Scratched  
Over 25mm Thru Paint

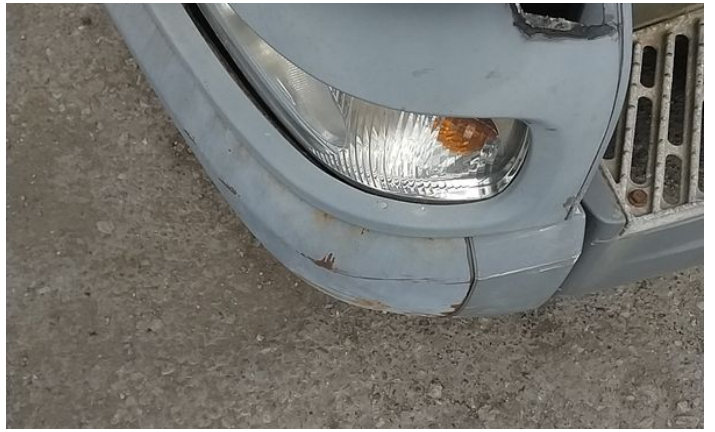
4: Bumper Front Moulding  
Broken  
Replace

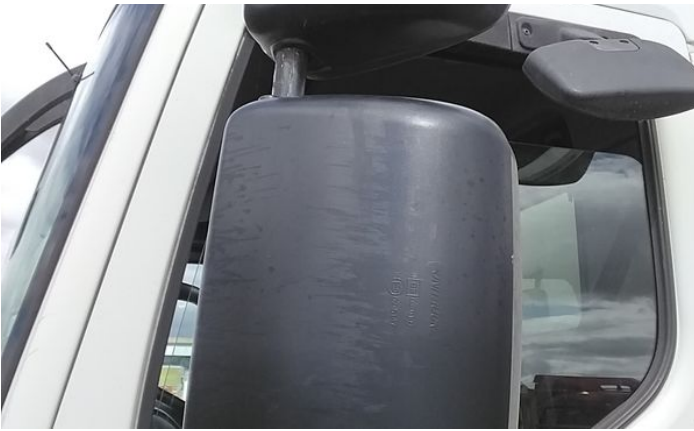
5: Door Mirror Assy nsf  
Scuffed (Unpainted)  
Over 100mm

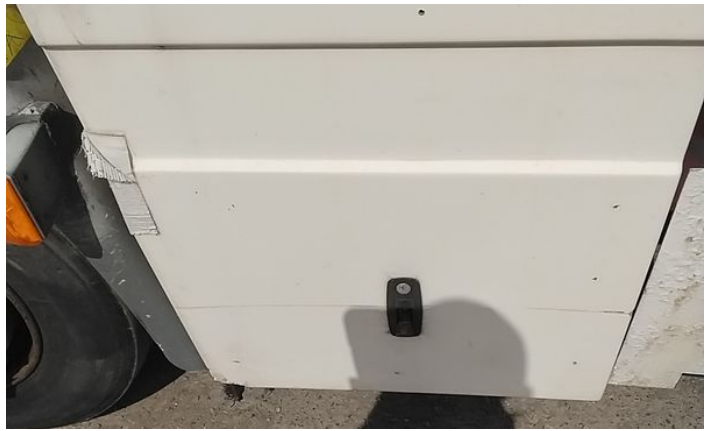
6: Qtr Panel Moulding ns  
Scratched (Painted)  
Over 25mm Thru Paint

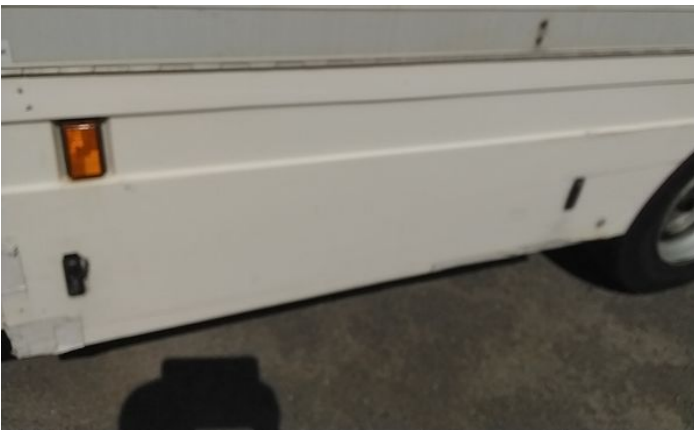
7: Qtr Panel Moulding ns  
Broken  
Replace

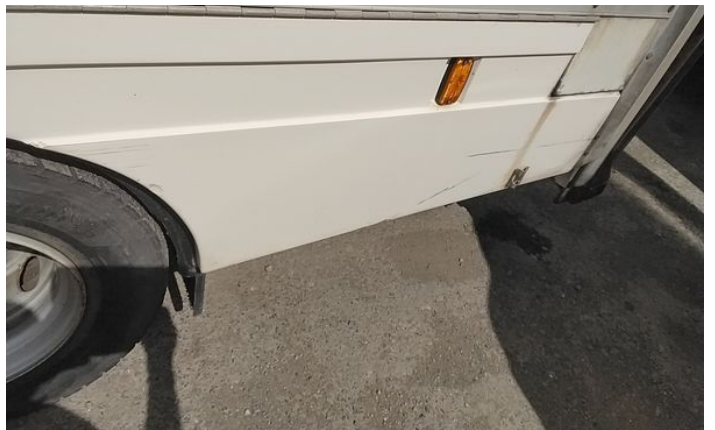
8: Qtr Panel Moulding ns  
Scratched (Painted)  
Over 25mm Thru Paint

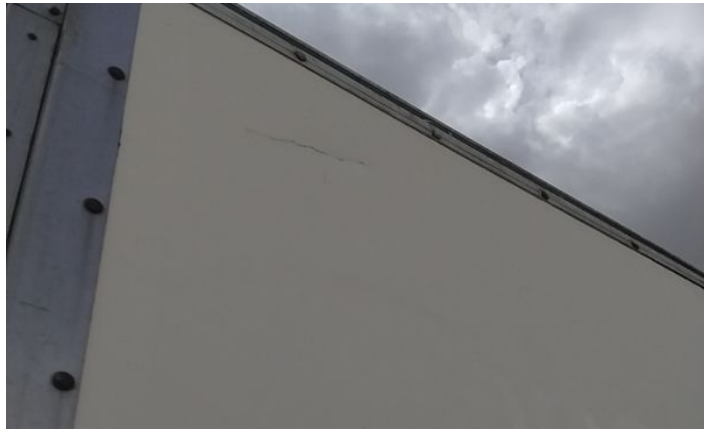
10: Qtr Panel osr  
Cracked  
Replace

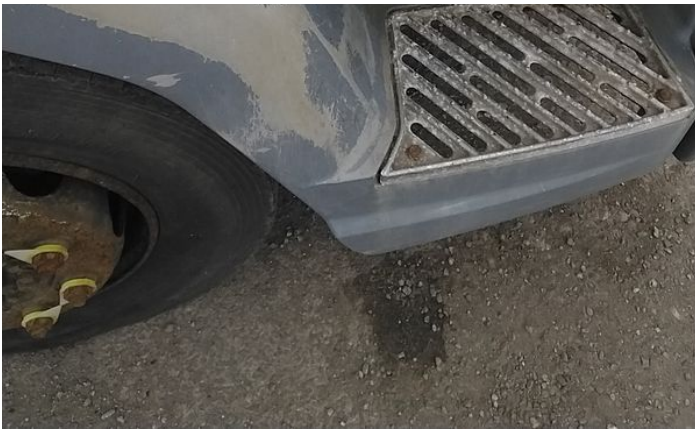
11: Door osf  
Dented  
With Paint Damage

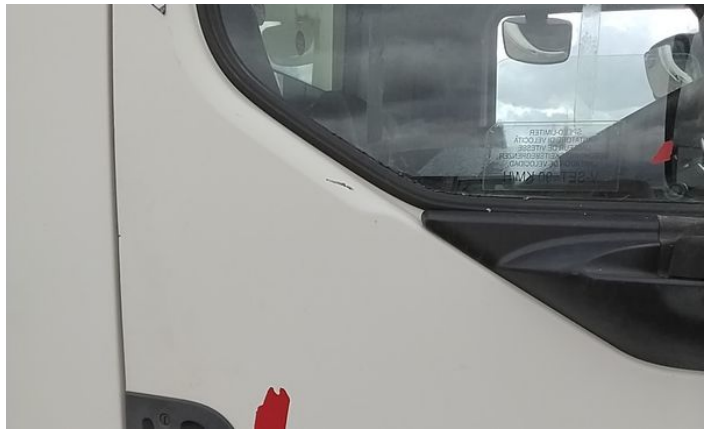
12: Door osf  
Scratched  
Over 25mm Thru Paint

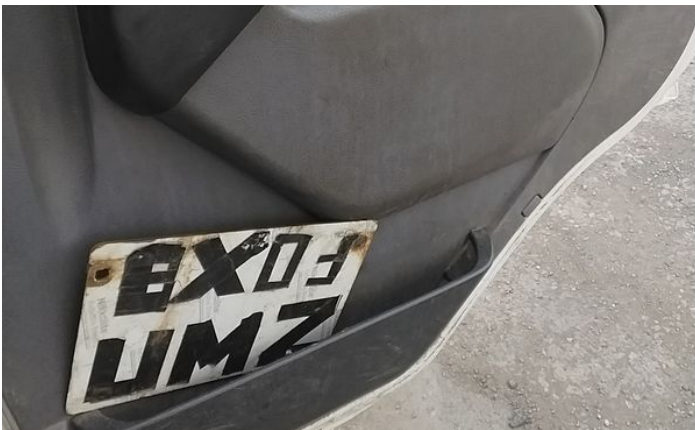
13: Door Pad osf  
Soiled  
Heavy

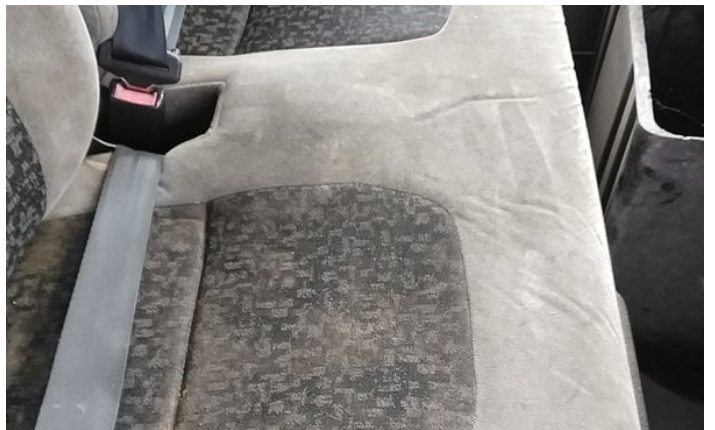
14: Seat Base Cover nsf  
Soiled  
Heavy
