VEHICLE INSPECTION REPORT

DW19UGL

Daf LF 180

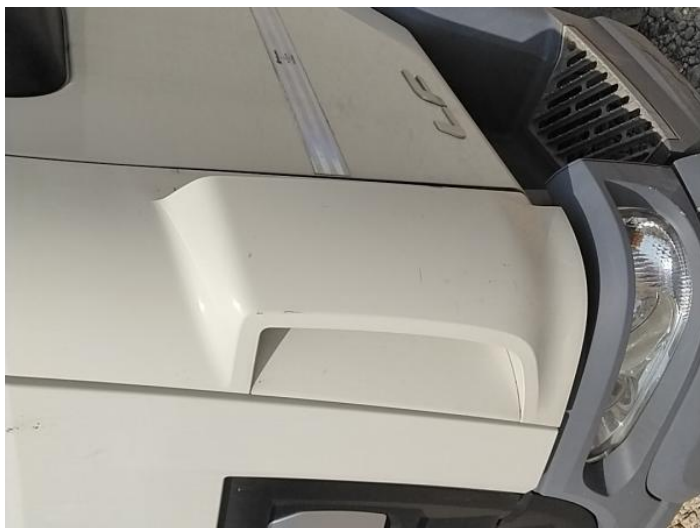
1: Moulding nsf Wing
Scratched (Painted)
Over 25mm Thru Paint

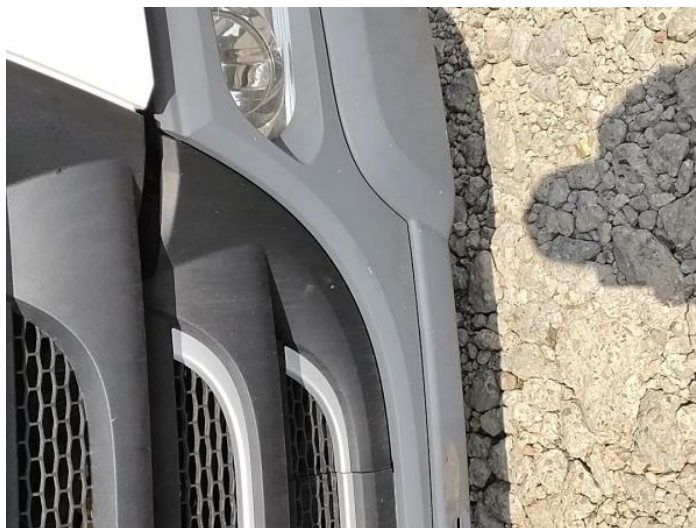
2: Bumper Front
Cracked
Over 25mm

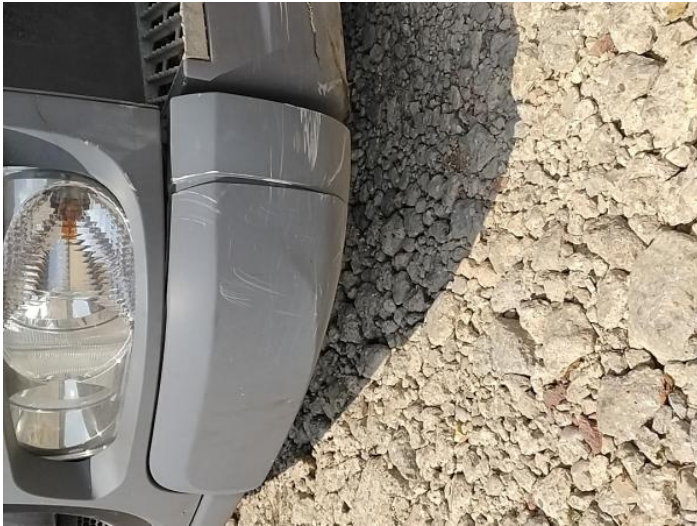
4: Bumper Front
Scratched
Over 100mm Thru Paint

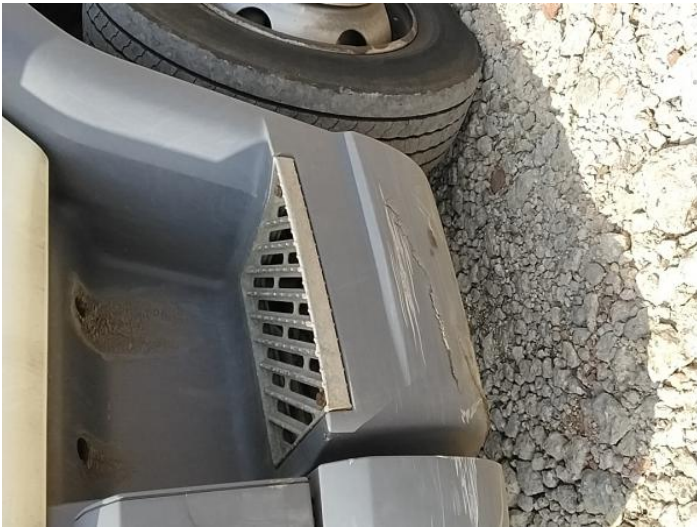
5: General Exterior
Soiled
Light

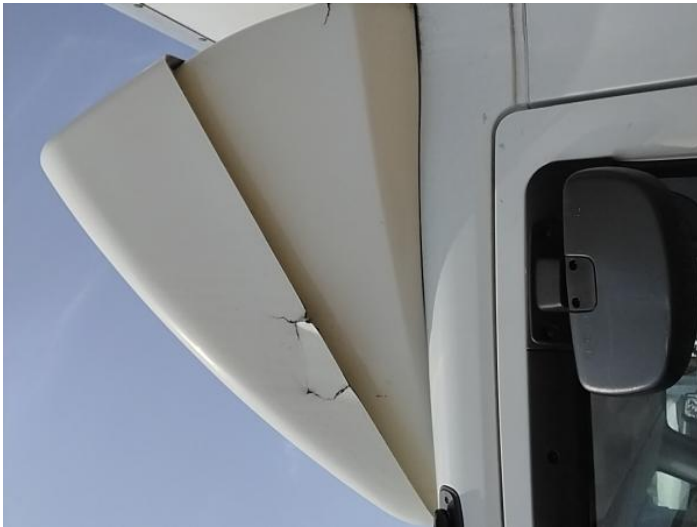
6: General Exterior
Soiled
Light

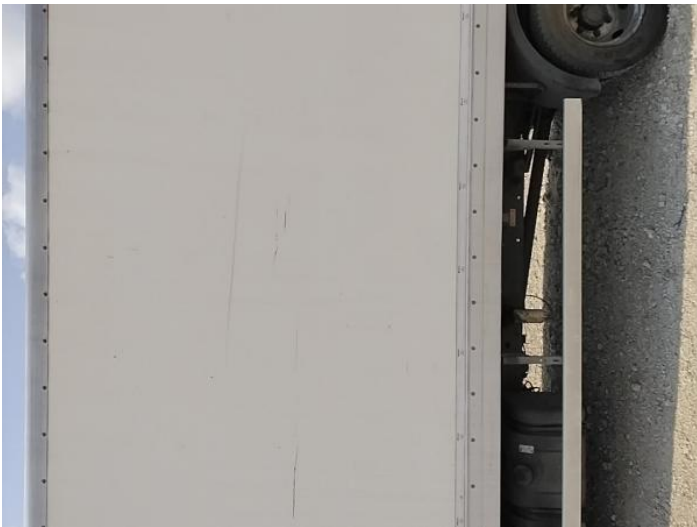
7: General Exterior
Soiled
Light

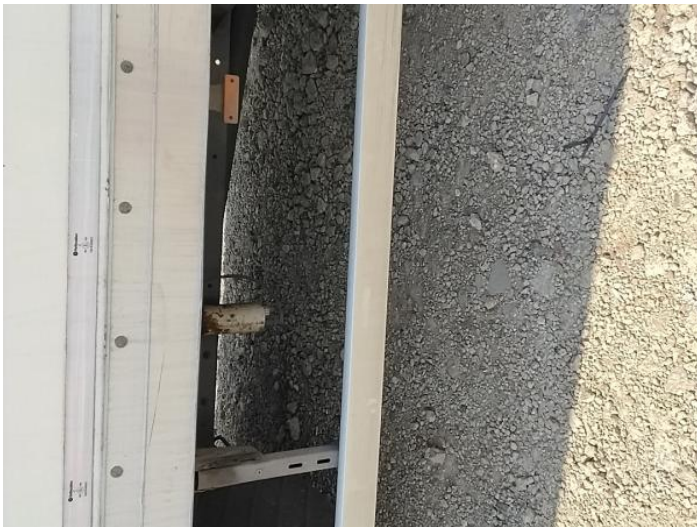
8: General Exterior
Soiled
Light

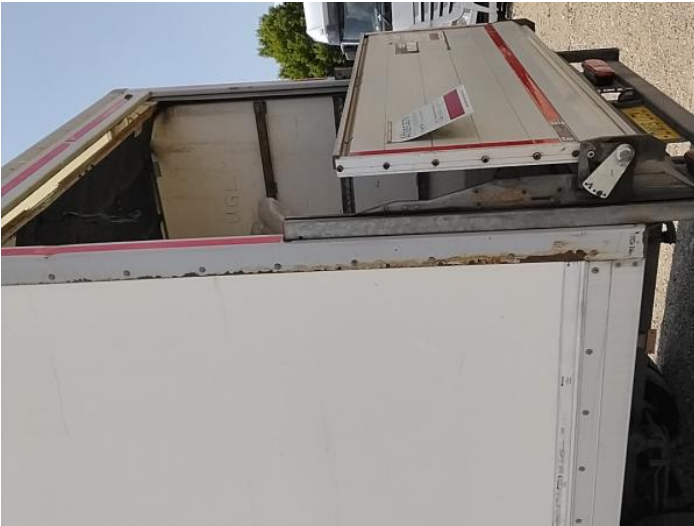
9: General Exterior
Soiled
Light

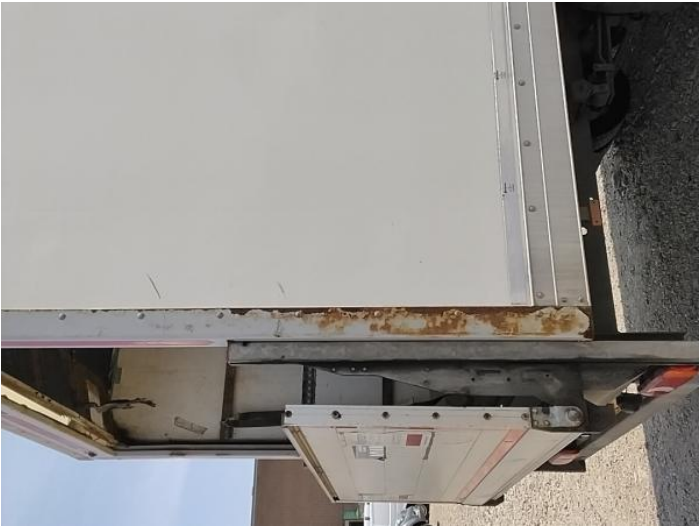
10: General Exterior
Soiled
Light

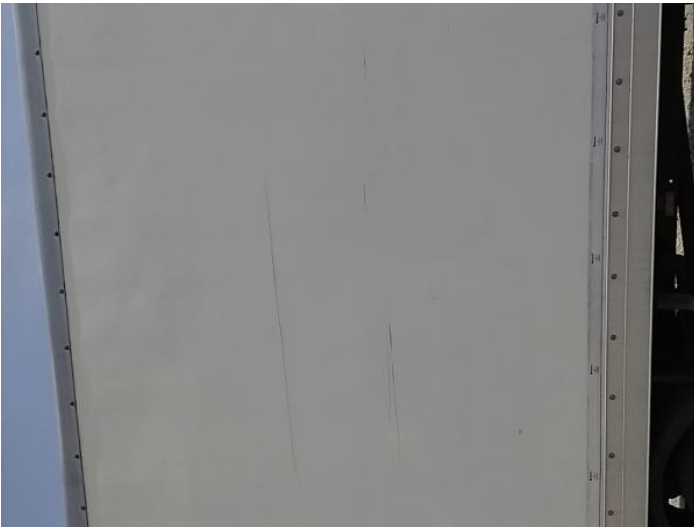
11: General Exterior
Soiled
Light

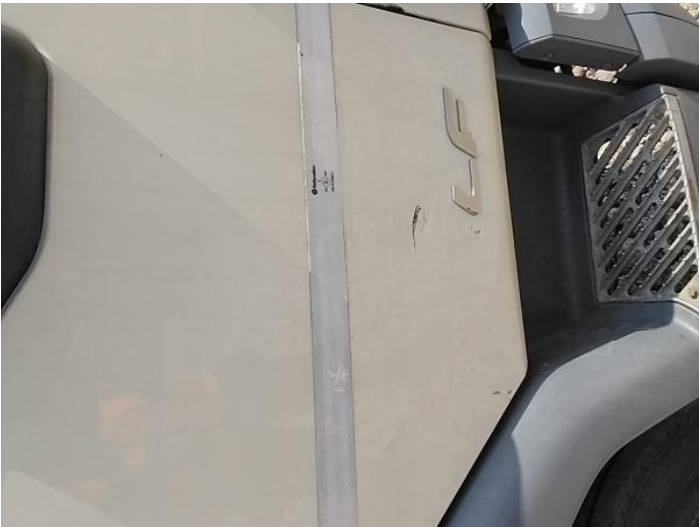
12: Door osf
Dented
With Paint Damage

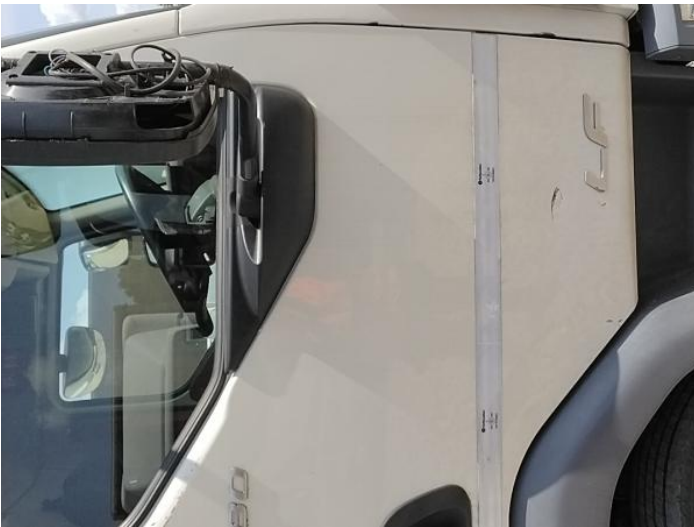
13: Door osf
Scratched
Over 25mm Thru Paint

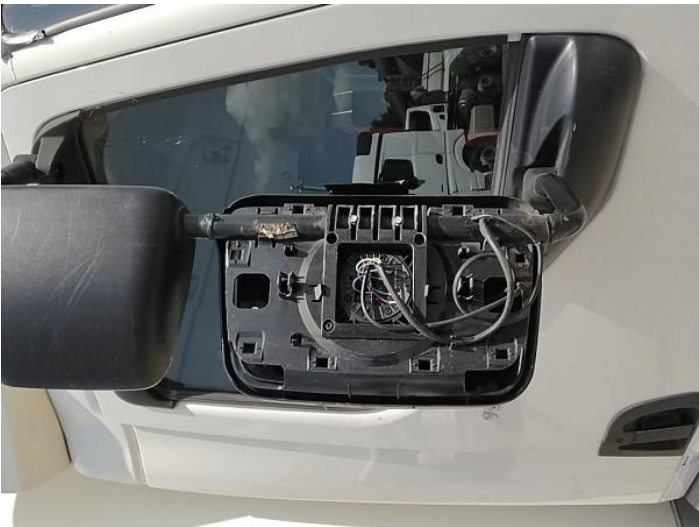
14: Door Mirror Assy osf
Missing
Replace

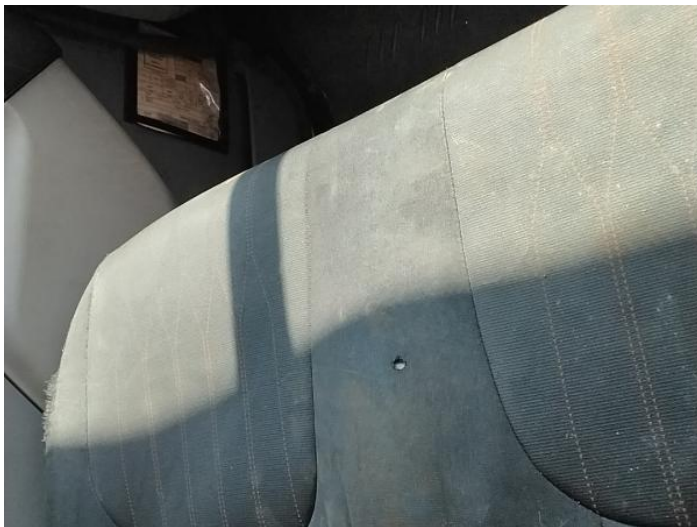
15: Seat Base Cover nsf
Burn
Over 3mm

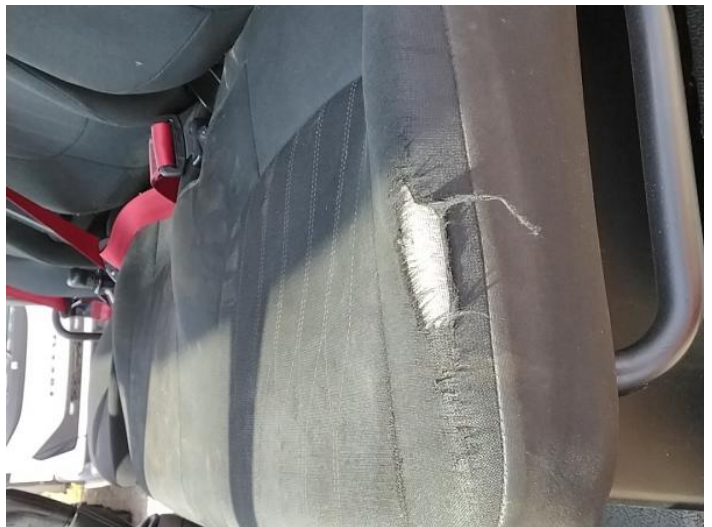
16: Seat Base Cover nsf
Torn
Over 3mm
