# VEHICLE INSPECTION REPORT

**YY18OKD**

## Daf CF 260

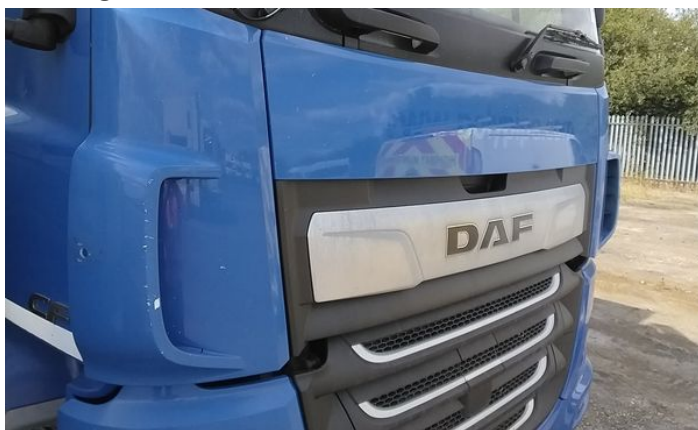
1: Bonnet  
Chipped  
Multiple Chips

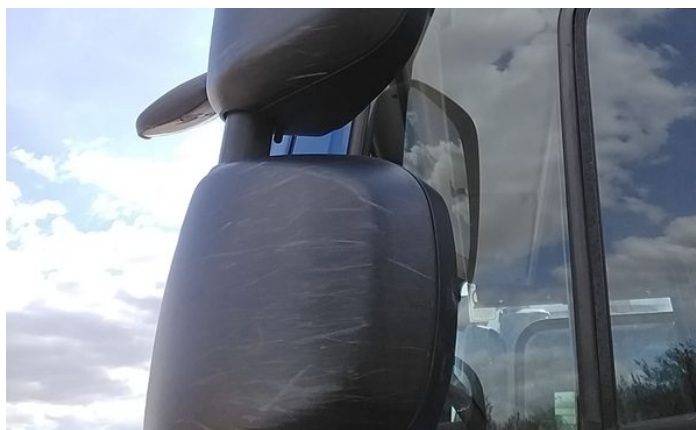
2: Door Mirror Assy nsf  
Broken  
Replace

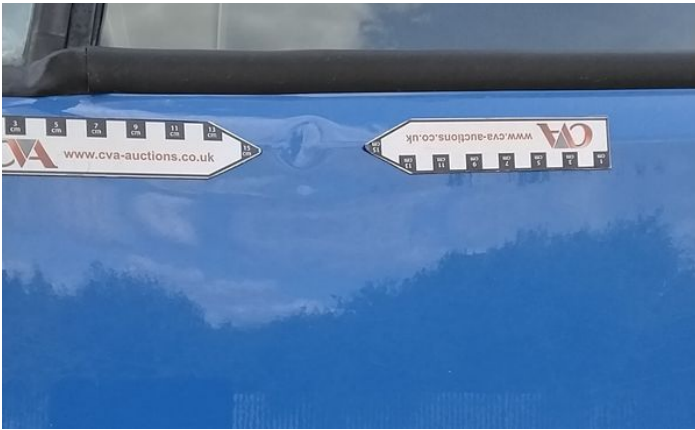
3: Door nsf  
Dented  
With Paint Damage

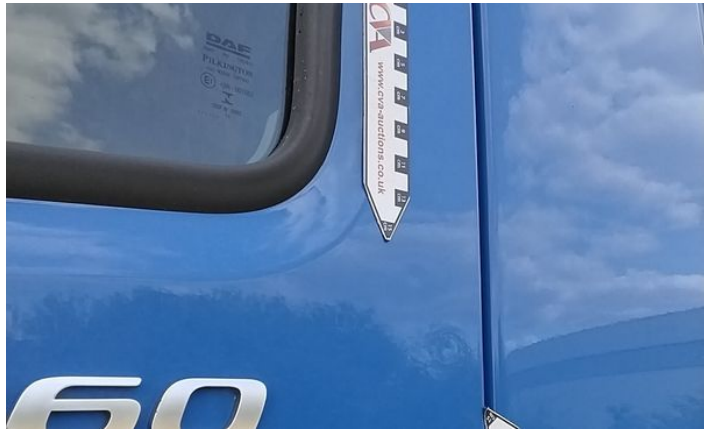
4: Door nsf  
Dented  
Over 30mm

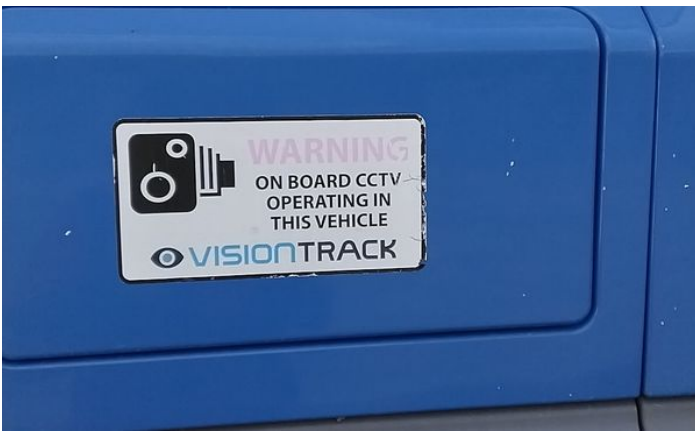
5: Qtr Panel nsr  
Chipped  
Multiple Chips

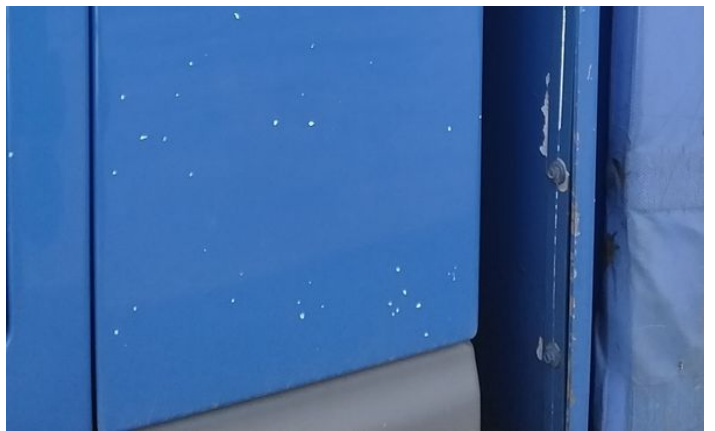
6: Qtr Panel Moulding ns  
Scratched (Painted)  
Over 25mm Thru Paint

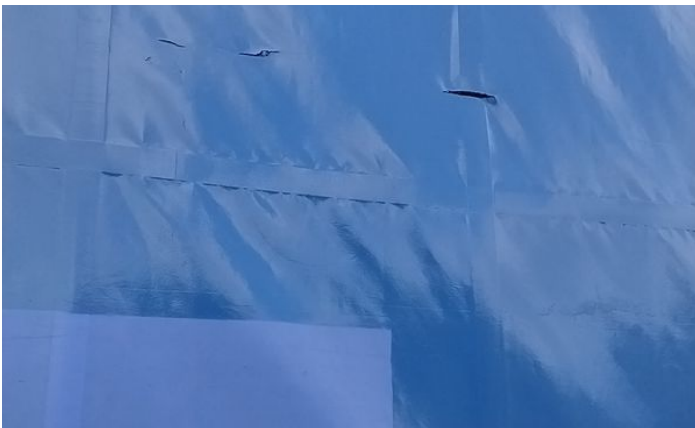
7: Qtr Panel nsr  
Hole  
Over 10mm

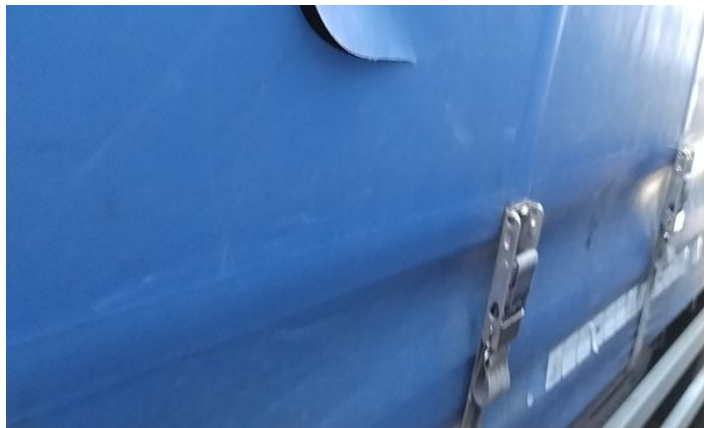
8: Qtr Panel osr  
Hole  
Over 10mm

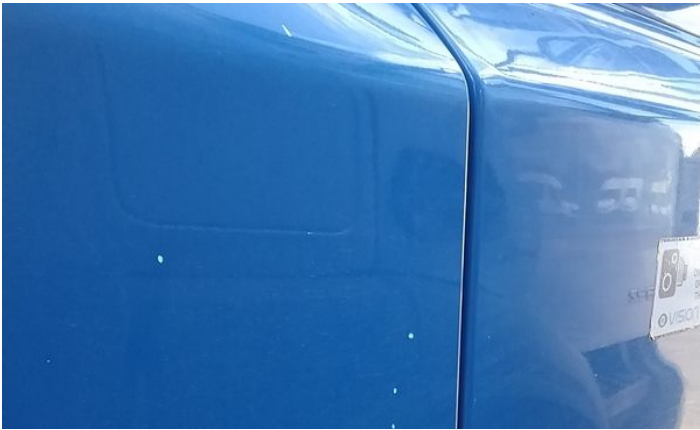
9: Qtr Panel Moulding os  
Scratched (Painted)  
Over 25mm Thru Paint

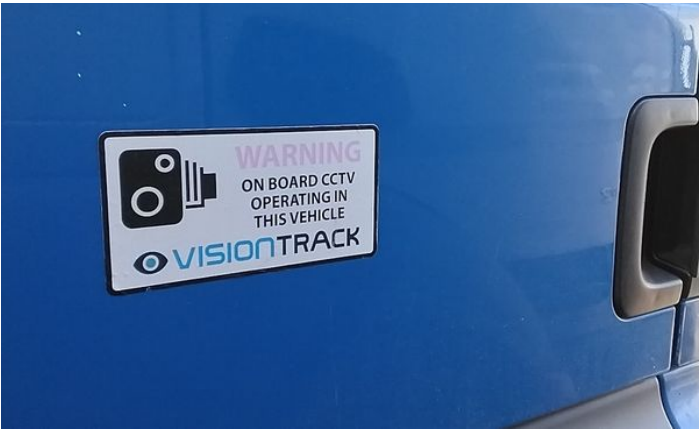
10: Qtr Panel osr  
Chipped  
Multiple Chips

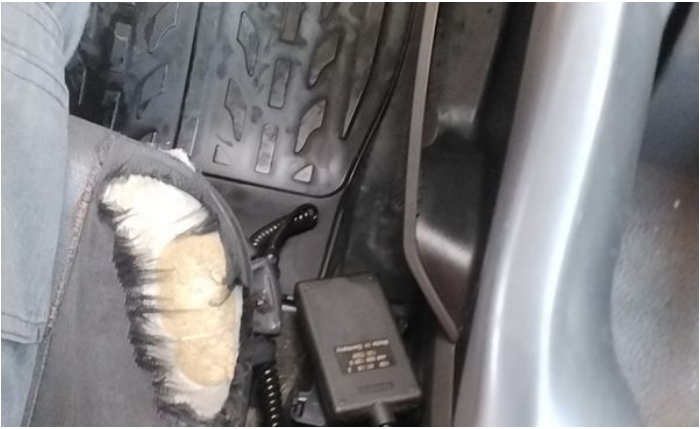
12: Seat Base Cover osf  
Holed  
Over 3mm
