# VEHICLE INSPECTION REPORT

**PF14TZB**

## Daf LF 150

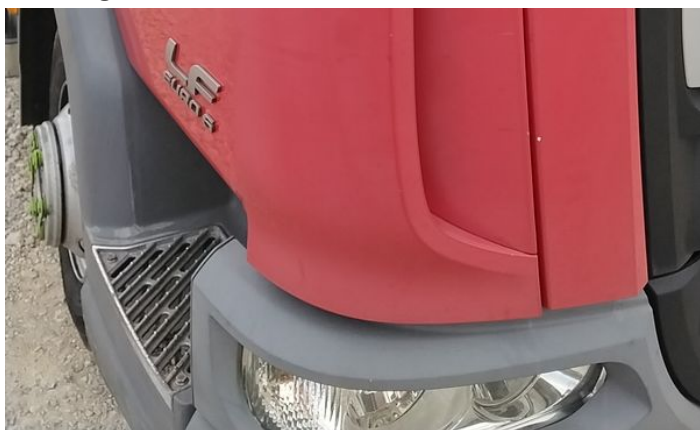
1: Wing osf  
Scratched  
UpTo 25mm Thru Paint

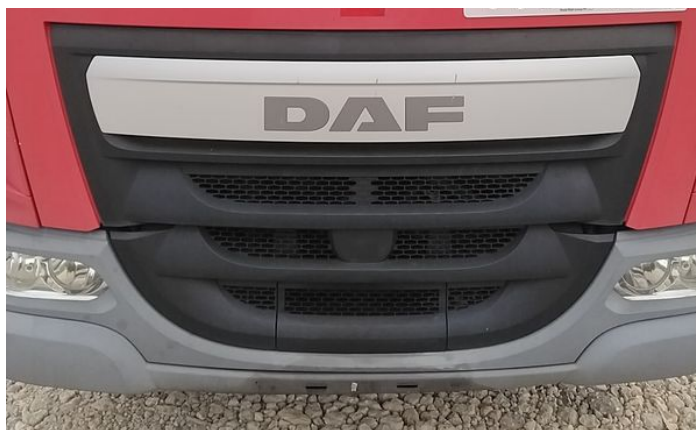
2: Bonnet  
Scratched  
Over 25mm Thru Paint

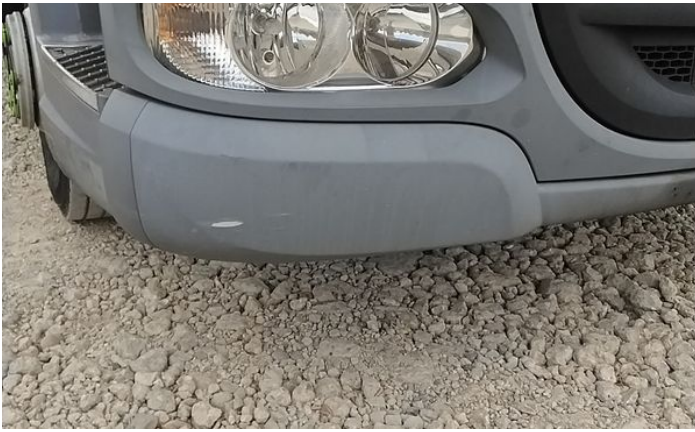
3: Bumper Front  
Scratched  
UpTo 25mm Thru Paint

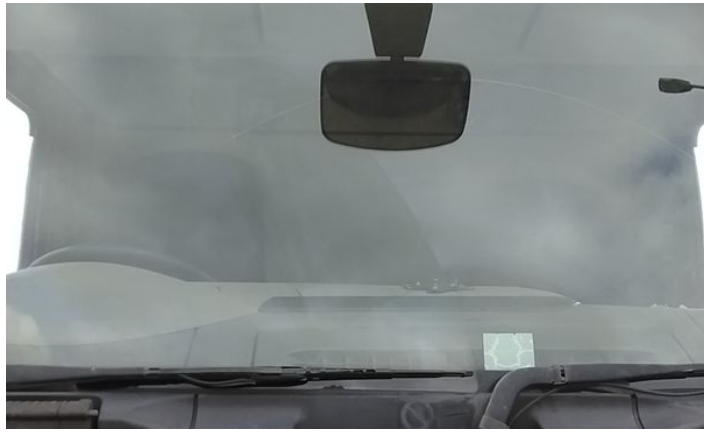
4: Screen Front  
Chipped  
Over 10mm

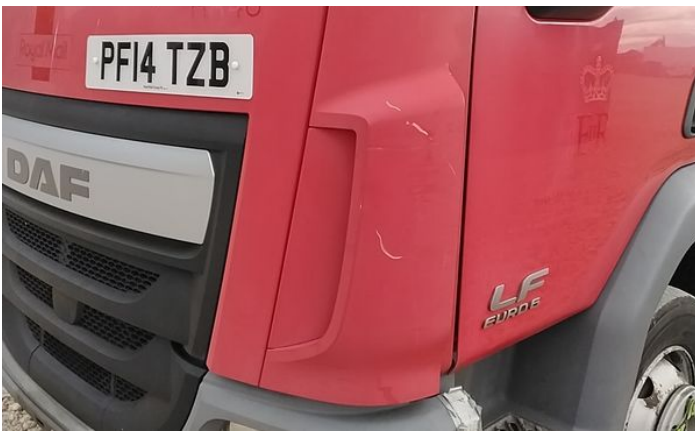
5: Wing nsf  
Scratched  
Over 25mm Thru Paint

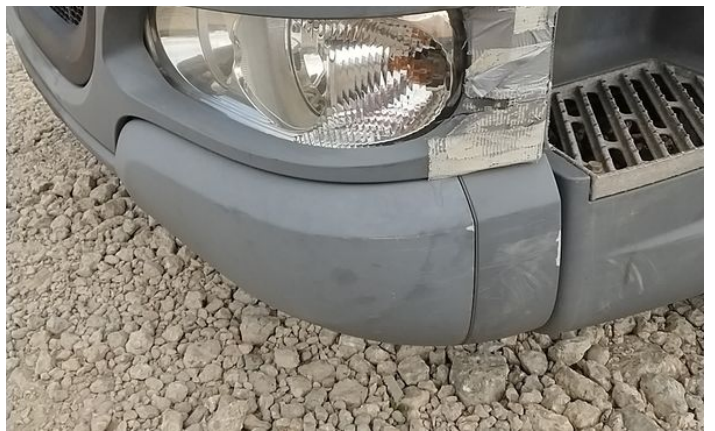
6: Fog Lamp Surround ns  
Broken  
Replace

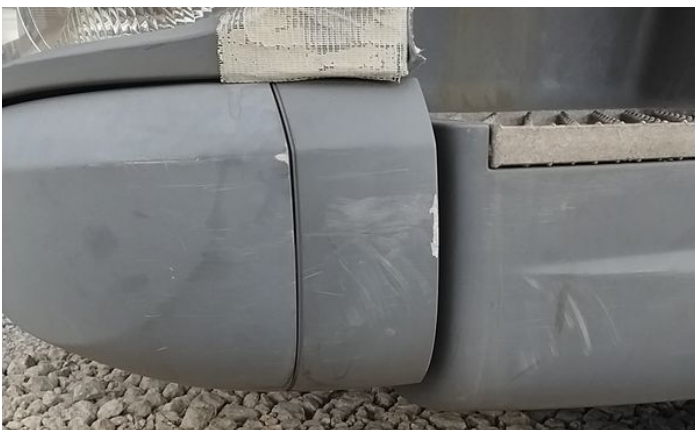
7: Bumper Front  
Scratched  
25 to 100mm Thru Paint

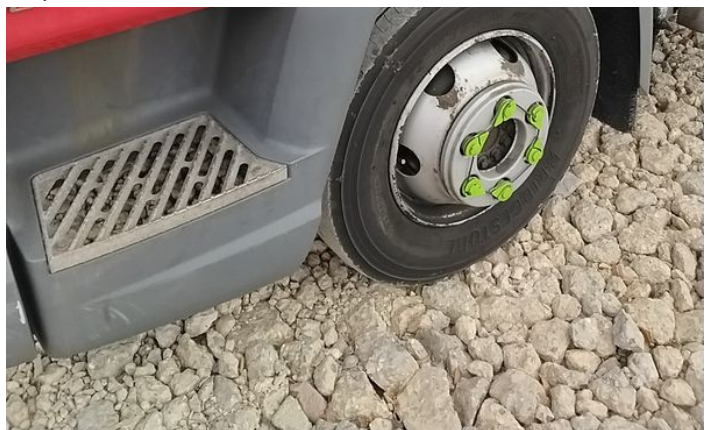
8: Wing Front Arch Extension ns  
Scuffed (Unpainted)  
Over 100mm

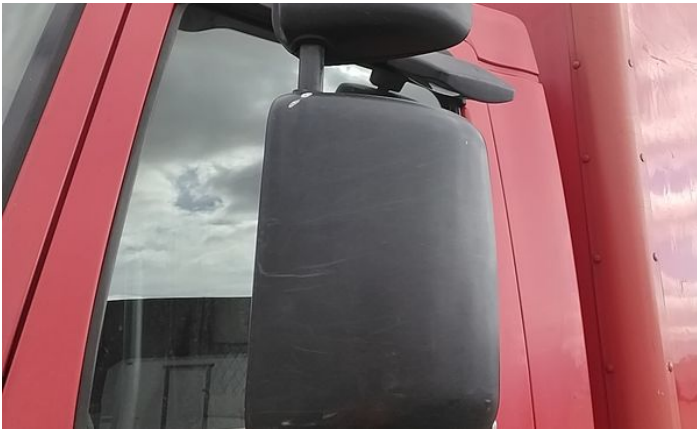
9: Door Mirror Assy nsf  
Scuffed (Unpainted)  
Over 100mm

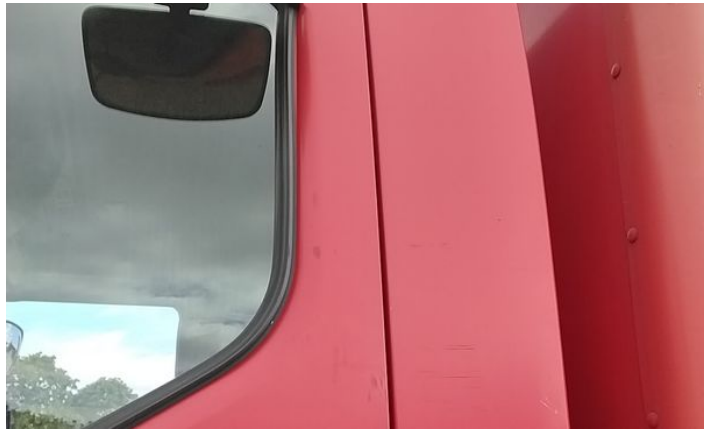
10: Door nsf  
Scratched  
Over 25mm Not Thru Paint

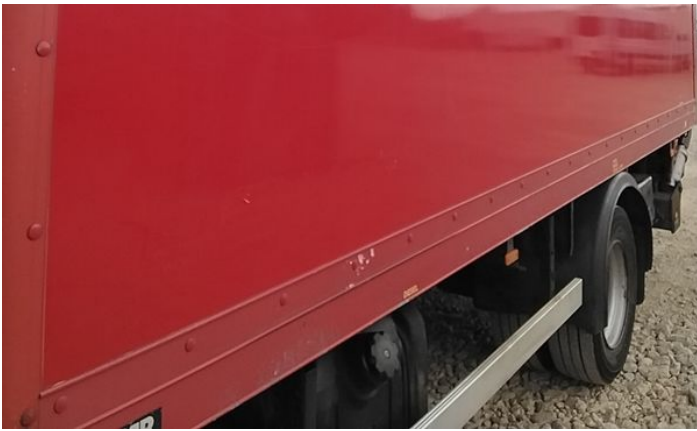
11: Qtr Panel nsr  
Scratched  
Over 25mm Not Thru Paint

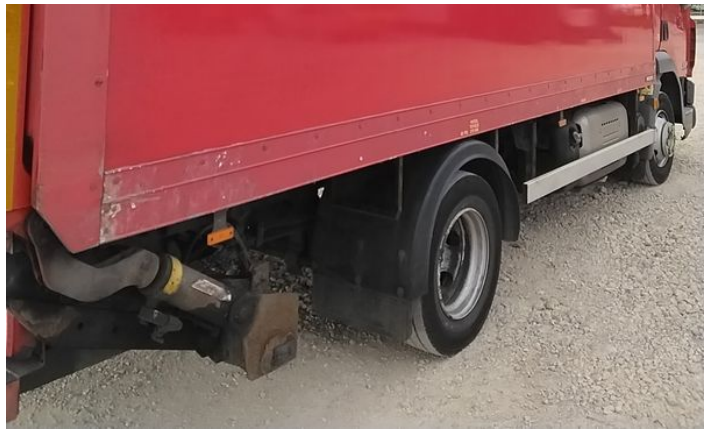
12: Qtr Panel osr  
Scratched  
Over 25mm Not Thru Paint

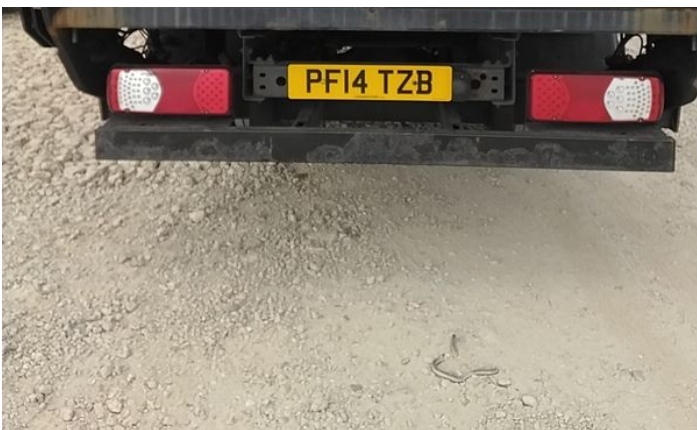
13: Bumper Rear  
Rusted  
Over 5mm

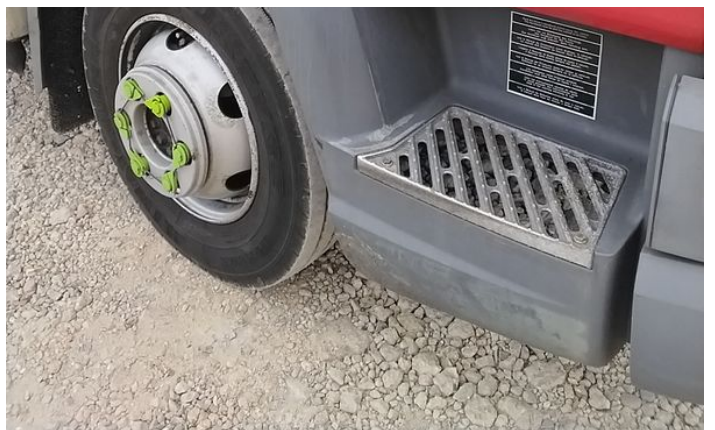
14: Wing Front Arch Extension os  
Scuffed (Unpainted)  
Over 100mm

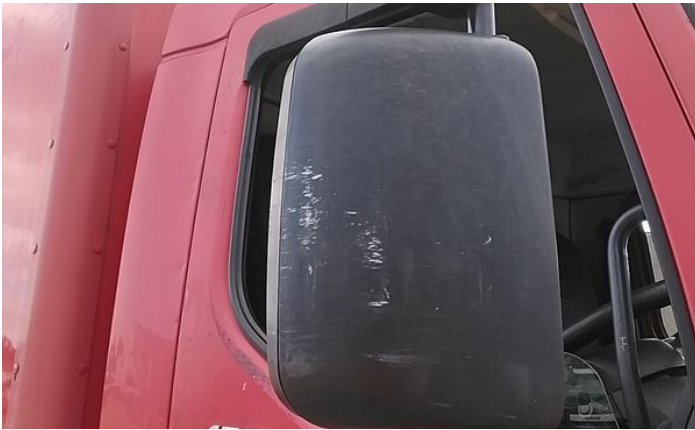
15: Door Mirror Assy osf  
Scuffed (Unpainted)  
Over 100mm

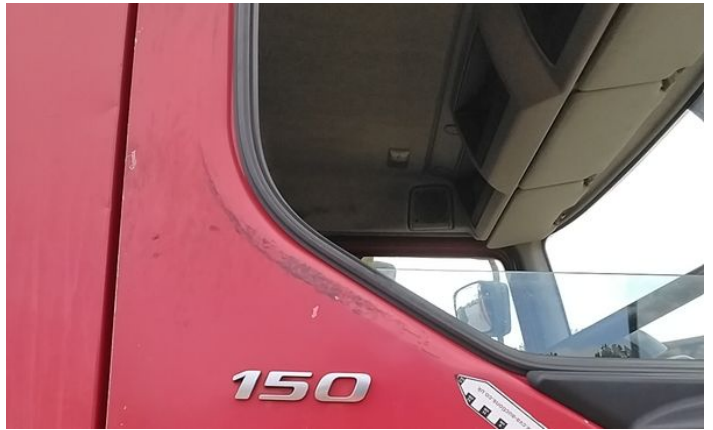
16: Door osf  
Scratched  
Over 25mm Not Thru Paint

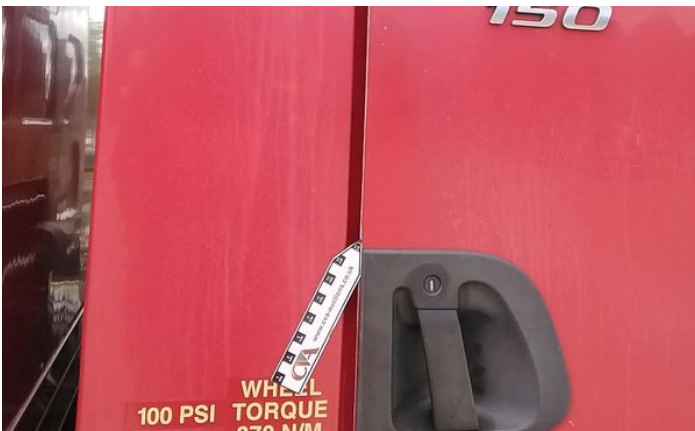
17: Door osf  
Chipped  
Edge Chip

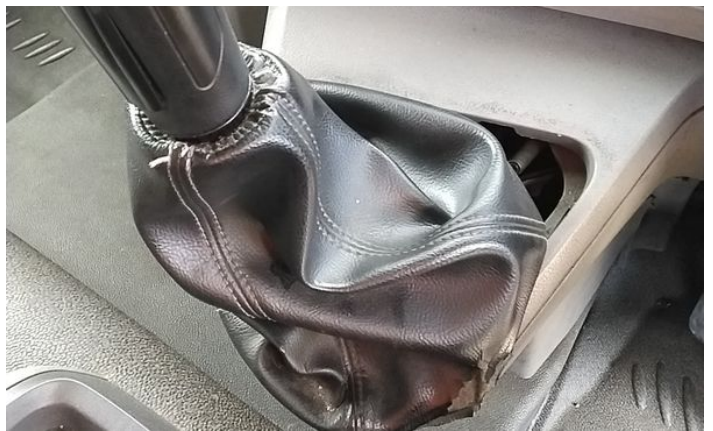
18: Centre Console Front  
Broken  
Replace
