# VEHICLE INSPECTION REPORT

**VN67KZS**

## Dennis Elite 6

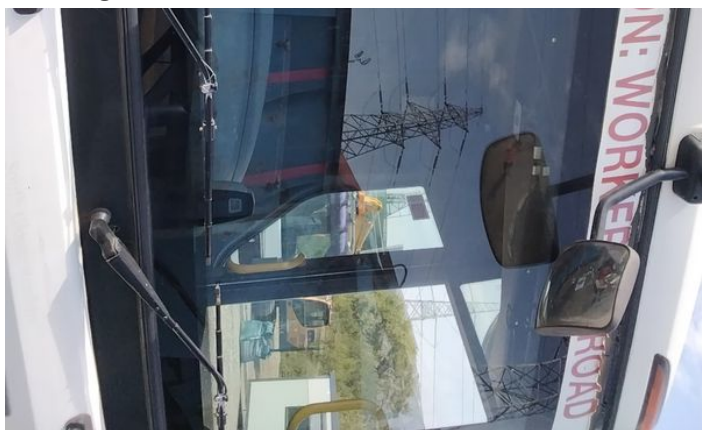
1: Screen Front  
Chipped  
Over 10mm

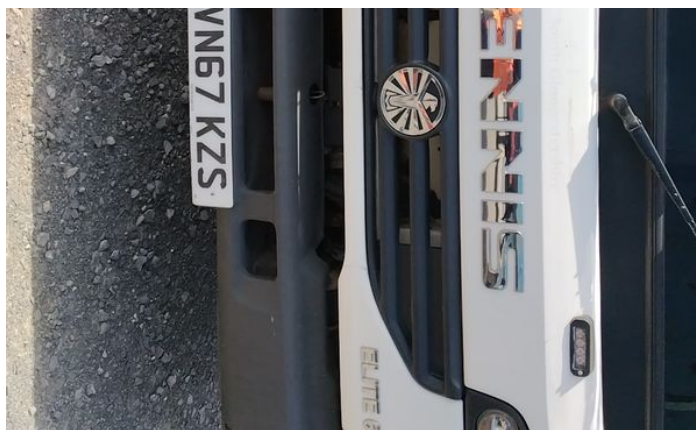
2: Bonnet  
Chipped  
Multiple Chips

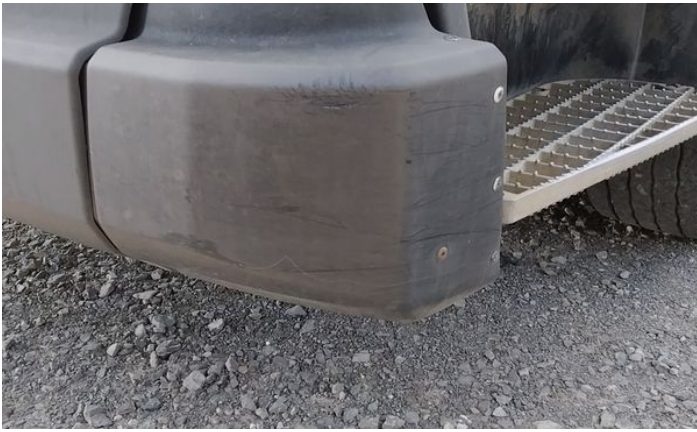
3: Bumper Front  
Scratched  
Over 100mm Thru Paint

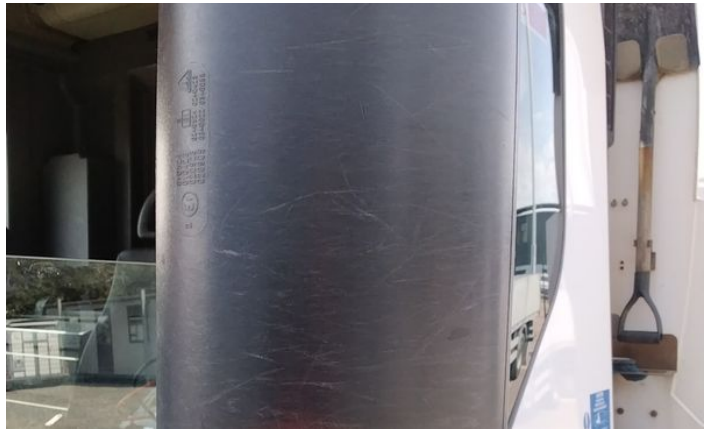
4: Door Mirror Assy nsf  
Broken  
Replace

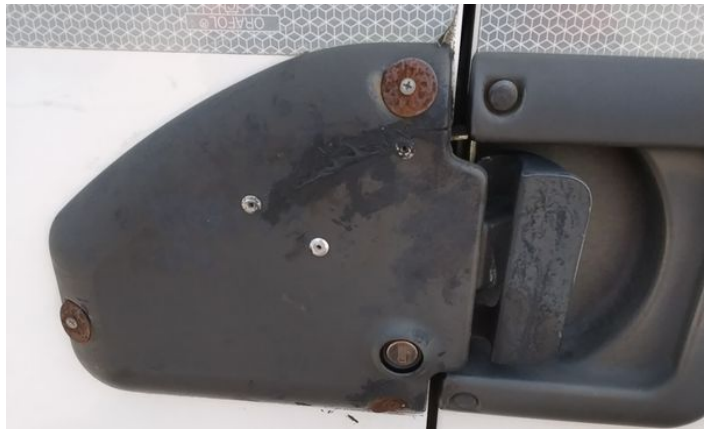
6: Door Moulding nsf  
Broken  
Replace

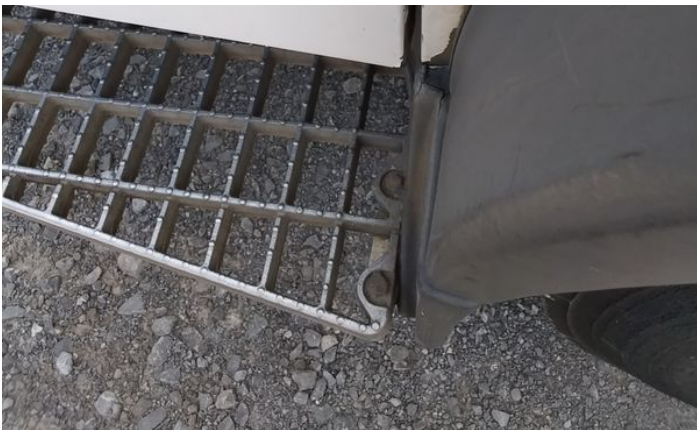
7: Door nsf  
Chipped  
Multiple Chips

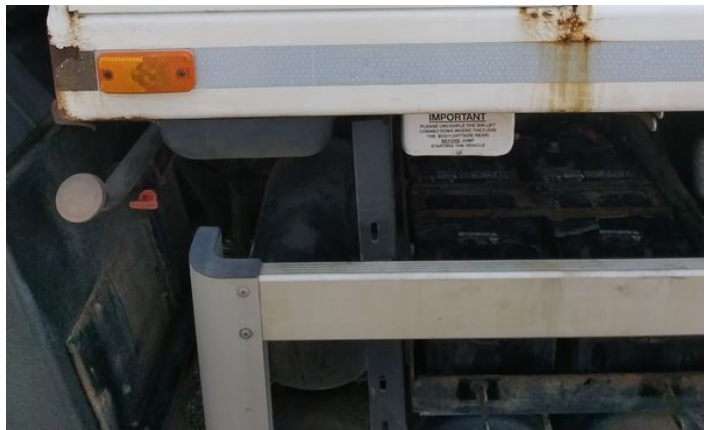
8: Qtr Panel nsr  
Rusted  
Over 5mm

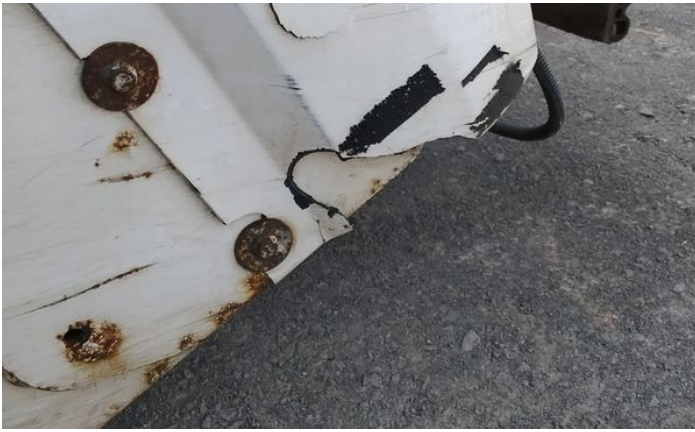
9: Qtr Panel Moulding ns  
Broken  
Replace

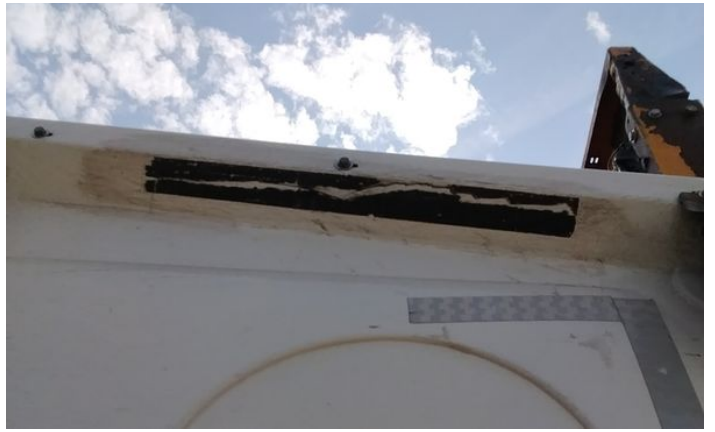
10: Qtr Panel Moulding ns  
Broken  
Replace

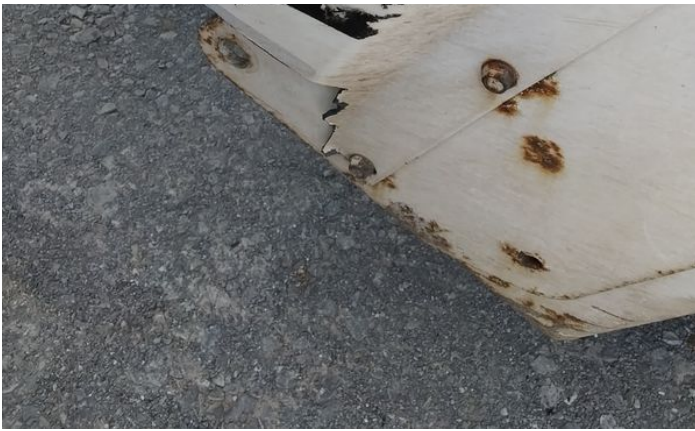
11: Qtr Panel Moulding os  
Broken  
Replace

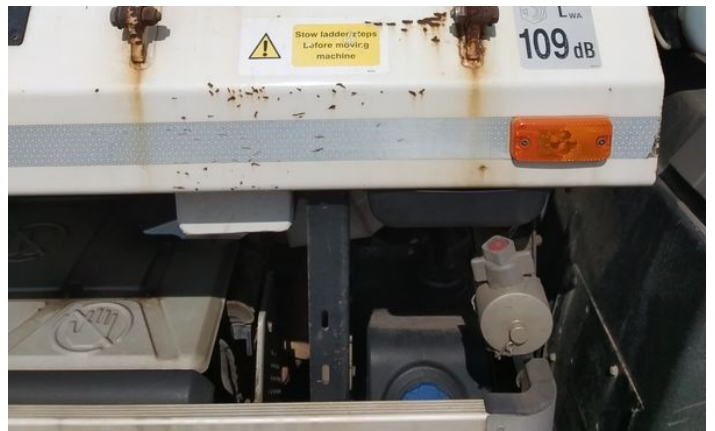
12: Qtr Panel osr  
Scratched  
Rusted

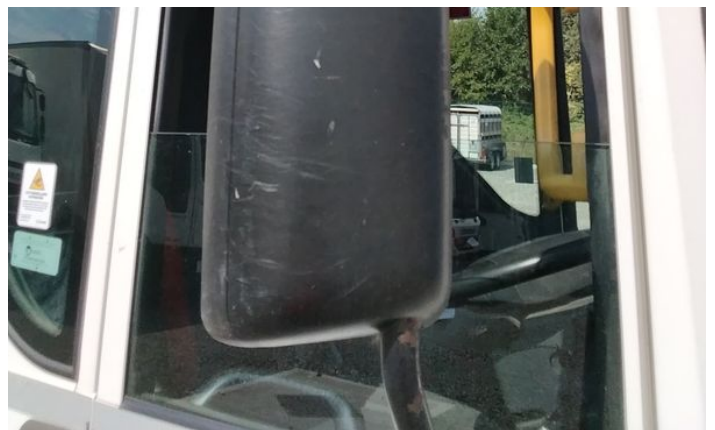
14: Door Mirror Assy osf  
Scuffed (Unpainted)  
Over 100mm

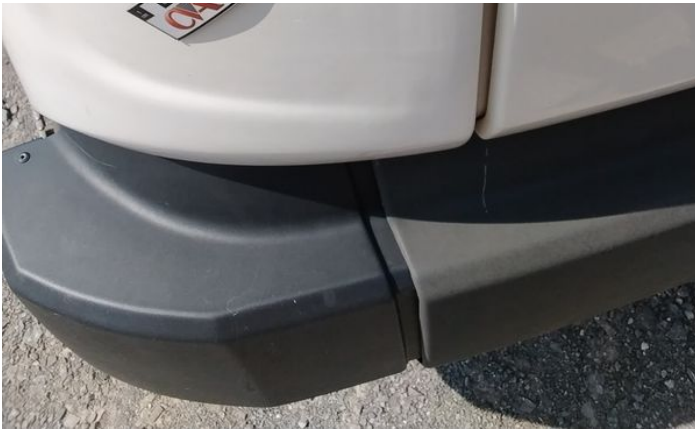
15: Moulding osf Wing  
Scratched (Painted)  
UpTo 25mm Thru Paint

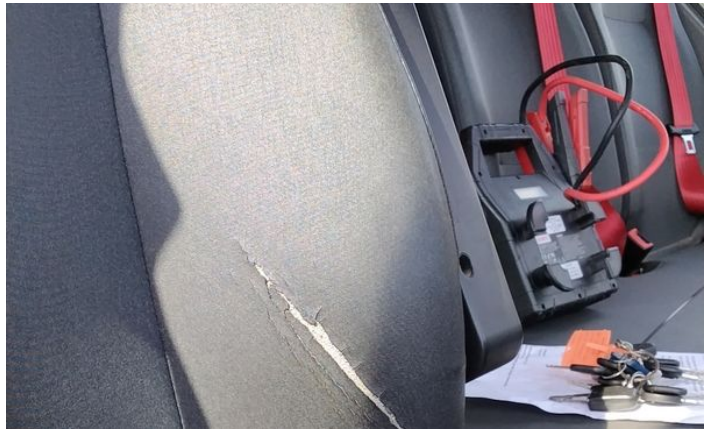
16: Seat Back Cover osf  
Holed  
Over 3mm

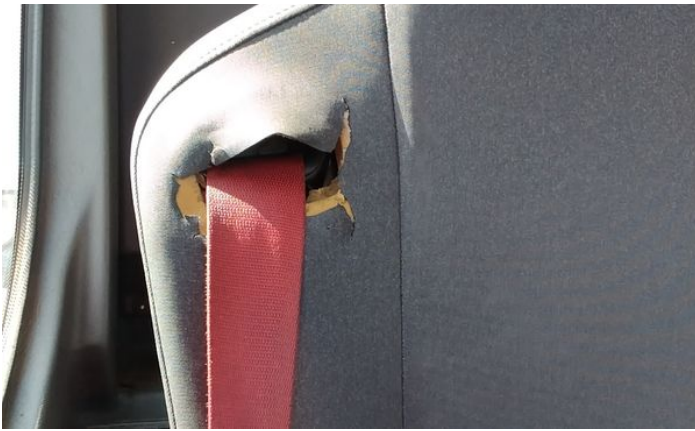
17: Seat Back Cover nsf  
Holed  
Over 3mm

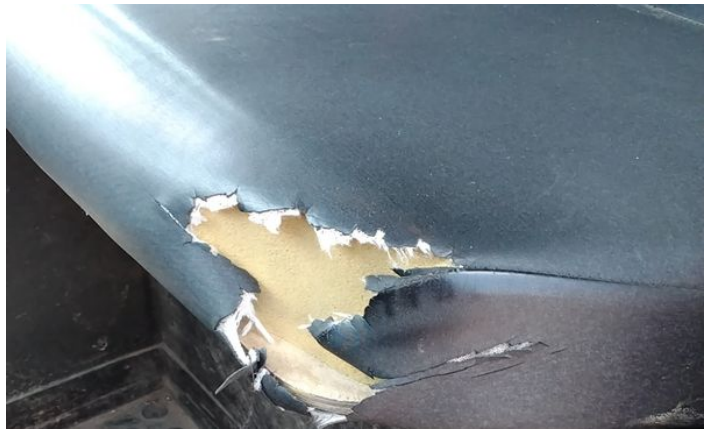
18: Seat Base Cover nsf  
Holed  
Over 3mm

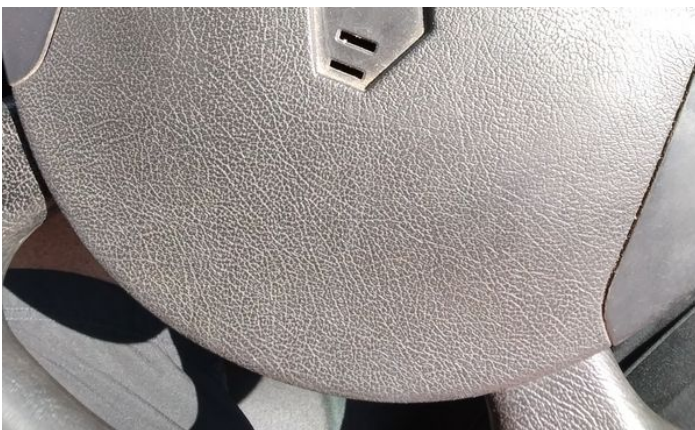
19: Steering Wheel  
Damaged  
Replace

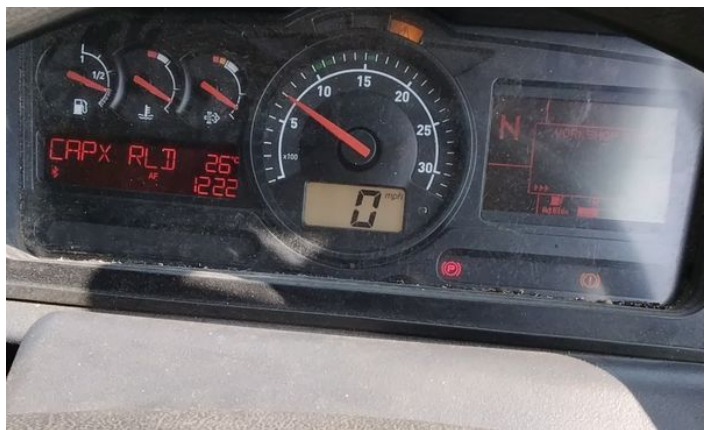
20: Dash Warning Lights  
Displayed  
No Action
