# VEHICLE INSPECTION REPORT

**VN67KZT**

## Dennis Elite 6

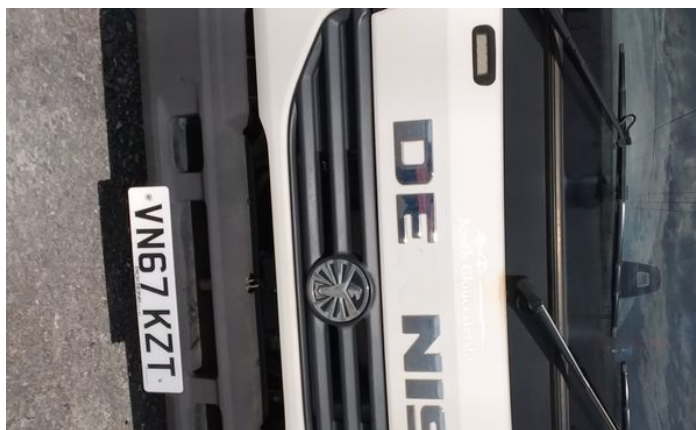
2: Bonnet  
Chipped  
Multiple Chips

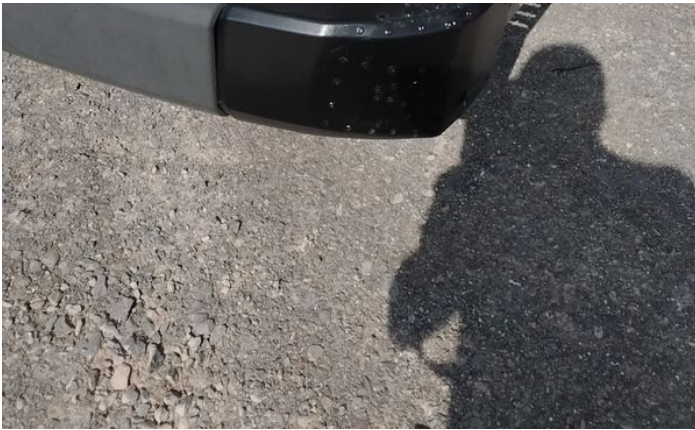
3: Bumper Front  
Poor Previous Repair  
Poor Colour

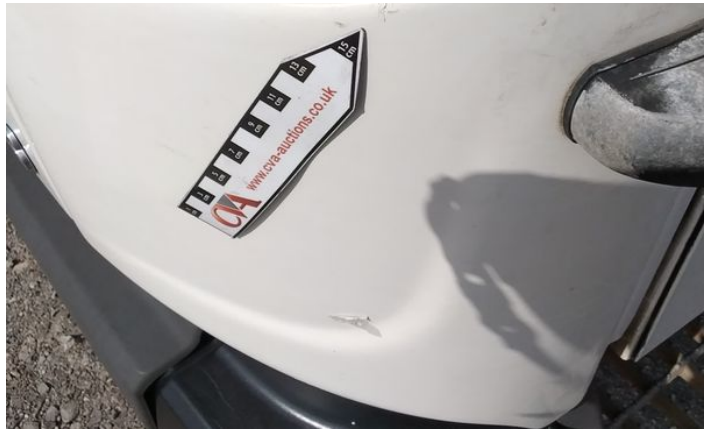
4: Wing nsf  
Cracked  
Replace

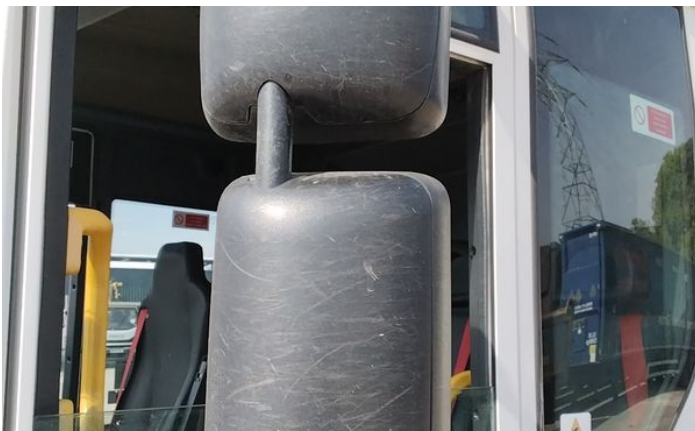
5: Door Mirror Assy nsf  
Scuffed (Unpainted)  
Over 100mm

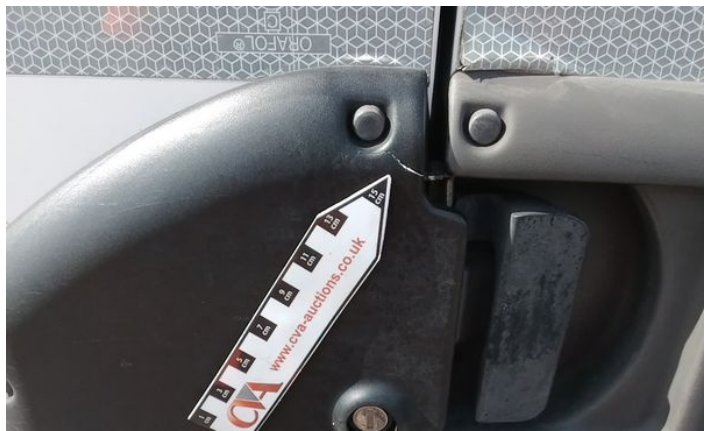
6: Door Moulding nsf  
Broken  
Replace

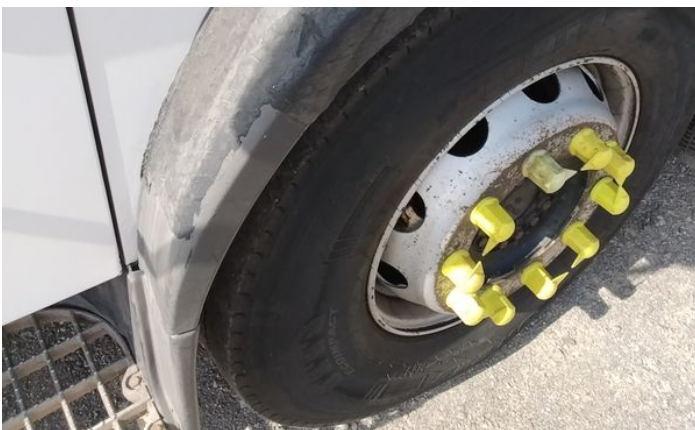
7: Wing Front Arch Extension ns  
Broken  
Replace

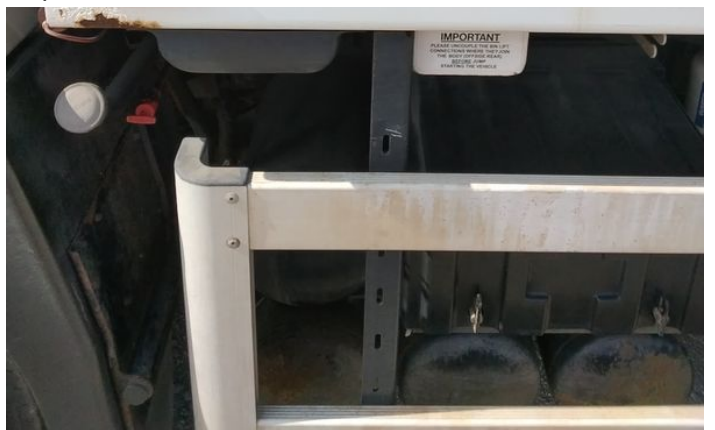
8: Qtr Panel nsr  
Rusted  
Over 5mm

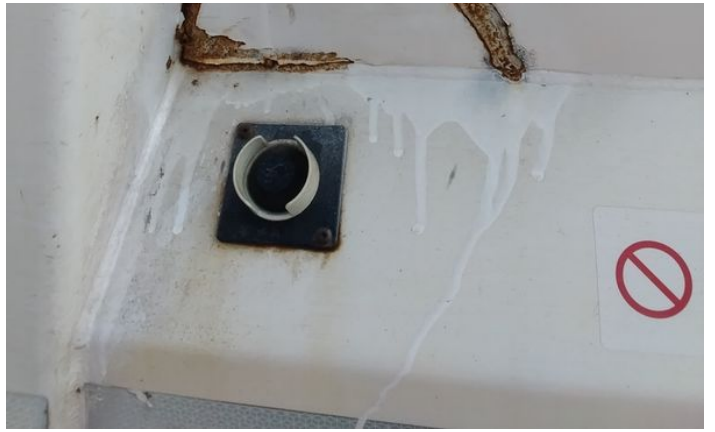
10: Qtr Panel osr  
Dented  
Hail - Severe

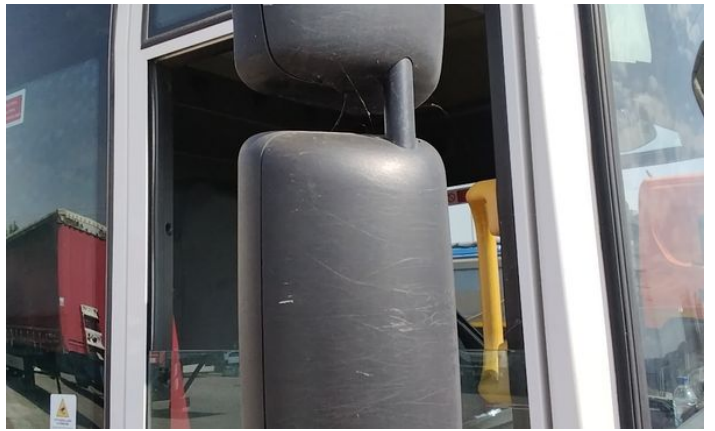
12: Door Mirror Assy osf  
Scuffed (Unpainted)  
Over 100mm

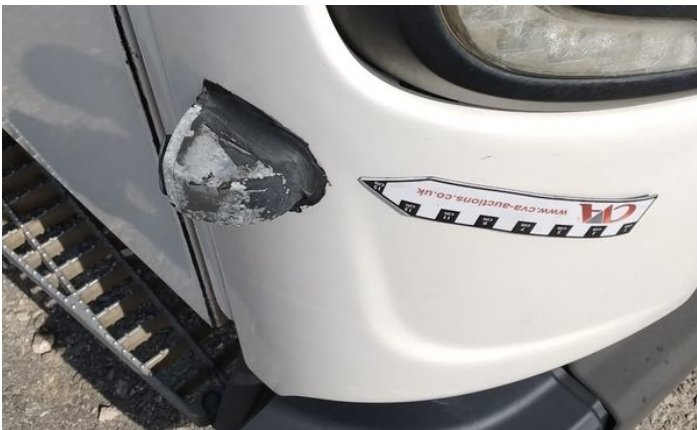
13: Moulding osf Wing  
Broken  
Replace

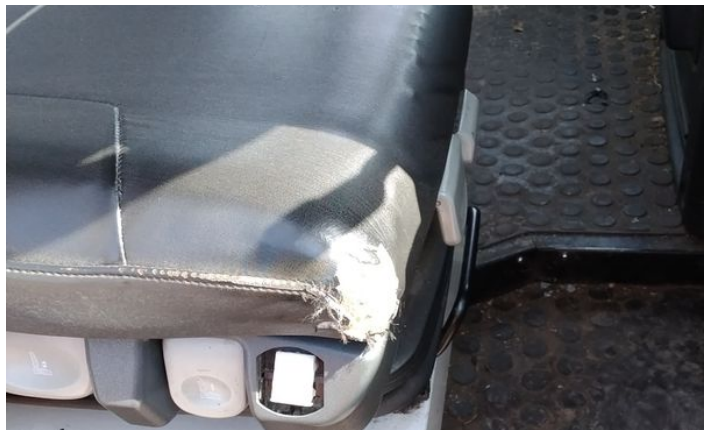
14: Seat Base Cover osf  
Holed  
Over 3mm

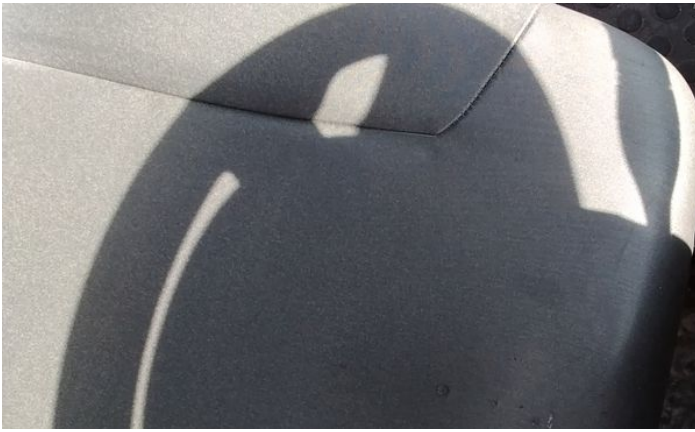
15: Seat Base Cover osf  
Burn  
Over 3mm

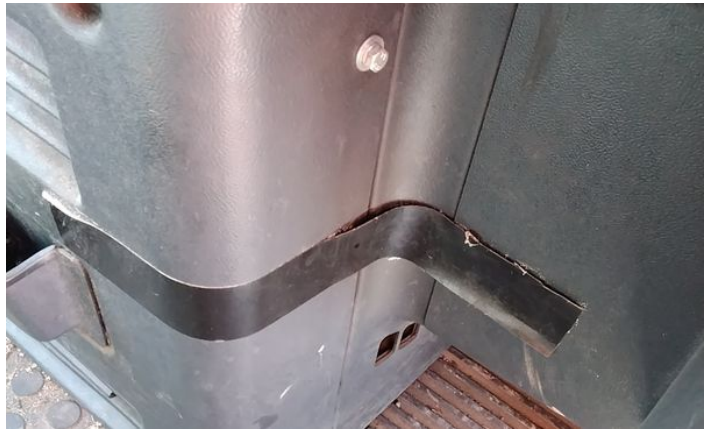
16: Centre Console Front  
Broken  
Replace

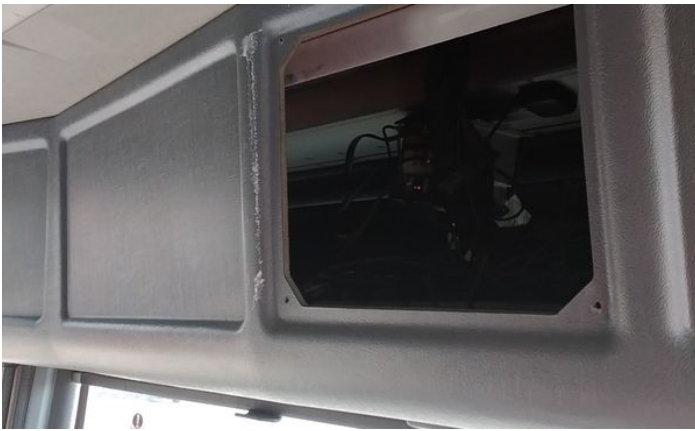
17: Fascia Panel  
Missing  
Replace

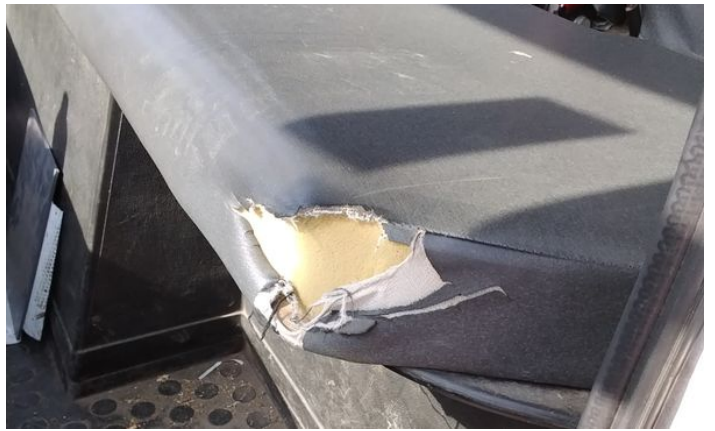
18: Seat Base Cover osf  
Holed  
Over 3mm

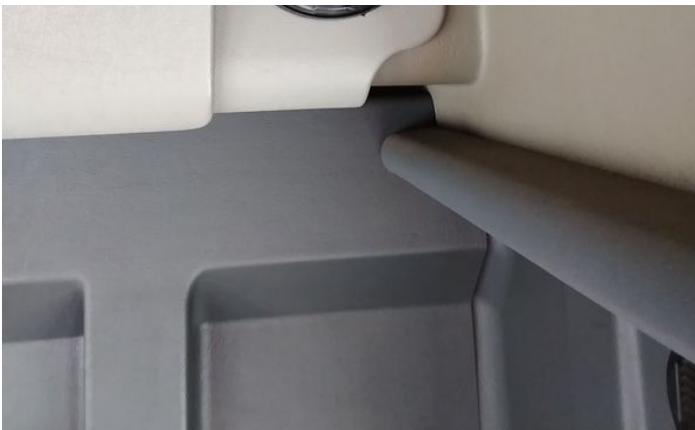
19: Fascia Trim  
Missing  
Replace

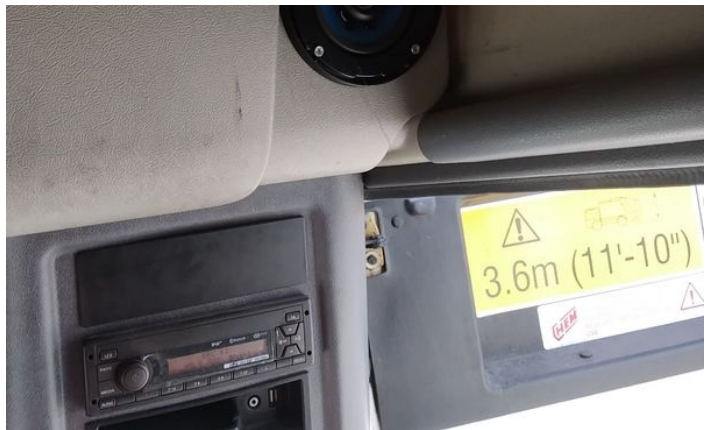
20: Fascia Trim  
Missing  
Replace

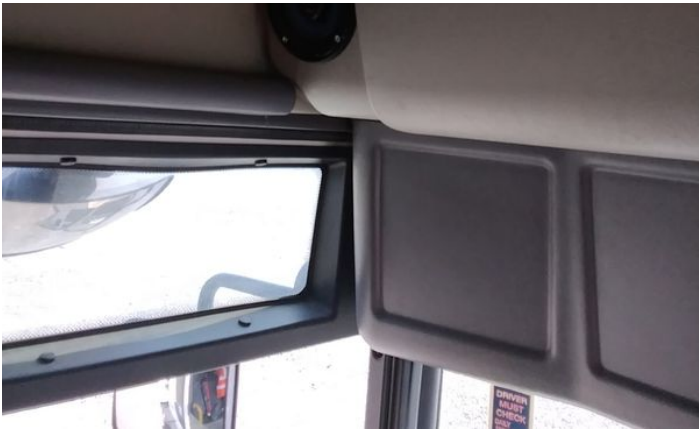
21: Fascia Trim  
Missing  
Replace

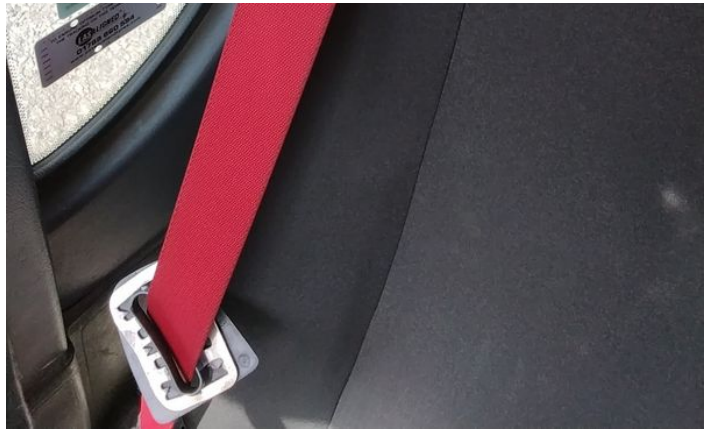
22: Seat Back Cover osf  
Torn  
Over 3mm

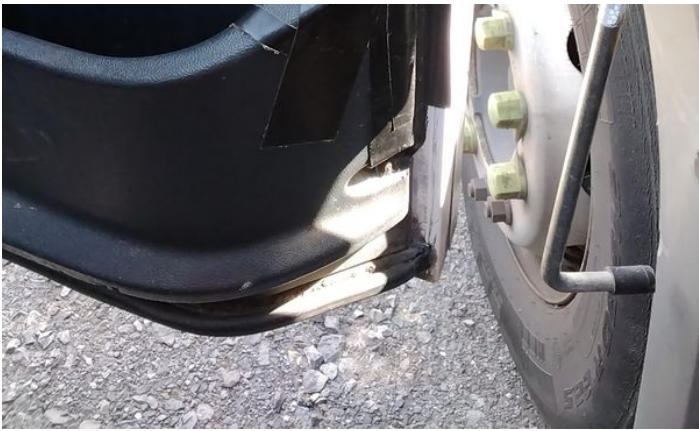
23: Door Pad osf  
Broken  
Replace
