## VEHICLE INSPECTION REPORT

**WS19AEV**

### Fiat Ducato 35 2.3 II MULTIJET 130PS

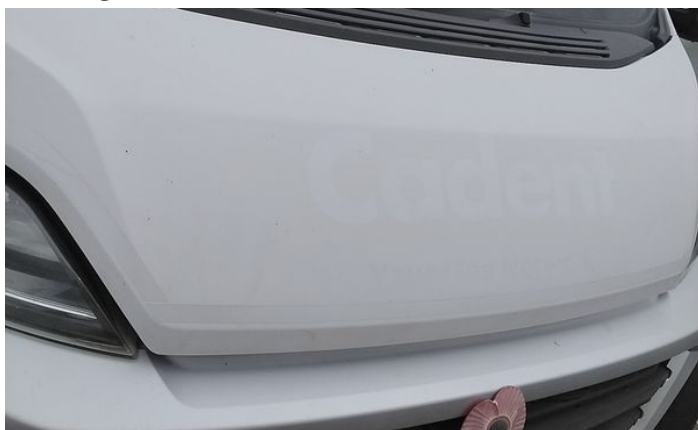
1: Bonnet  
Chipped  
Multiple Chips

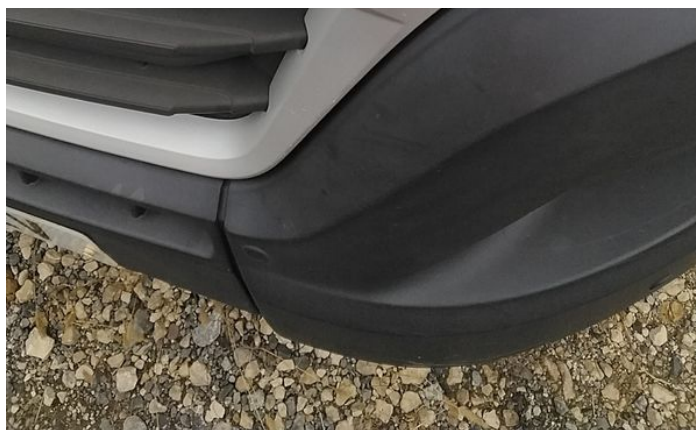
2: Panel Front  
Scratched  
Over 25mm Thru Paint

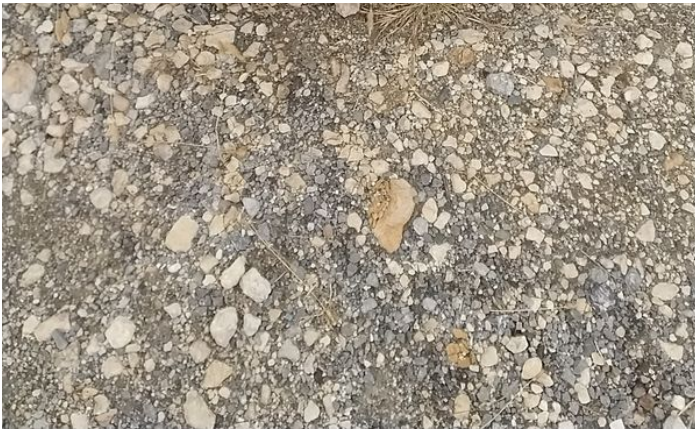
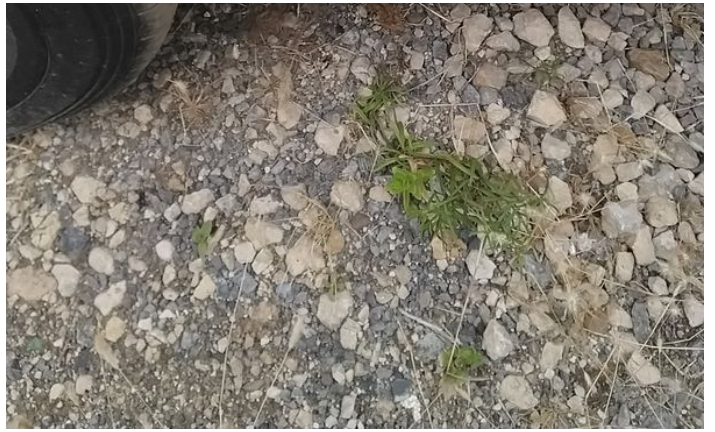
3: Bumper Front  
Scratched  
Over 100mm Thru Paint

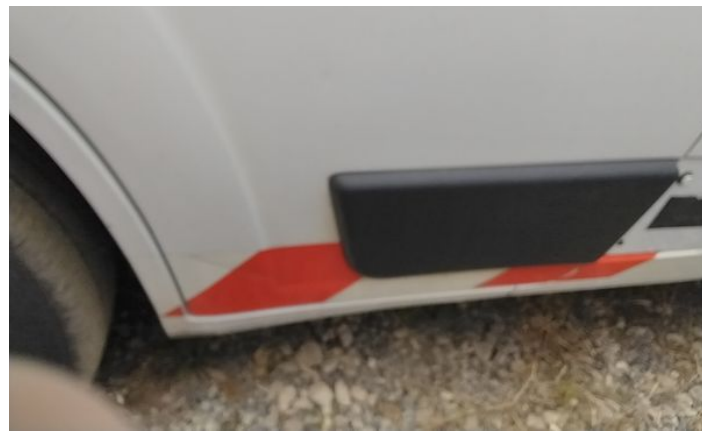
4: Door nsf  
Dented  
With Paint Damage

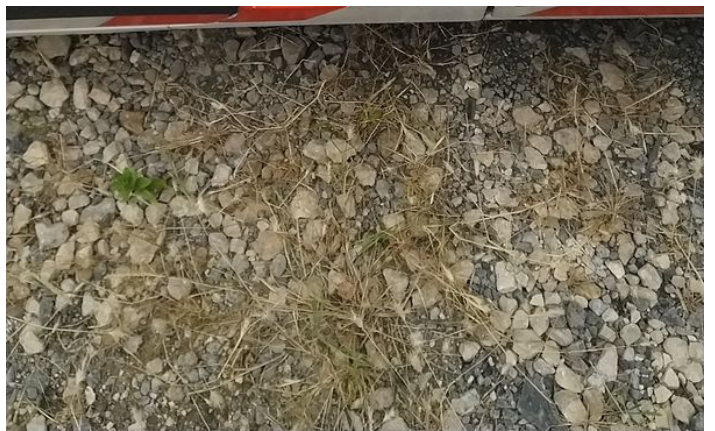
5: Door nsf  
Chipped  
Multiple Chips

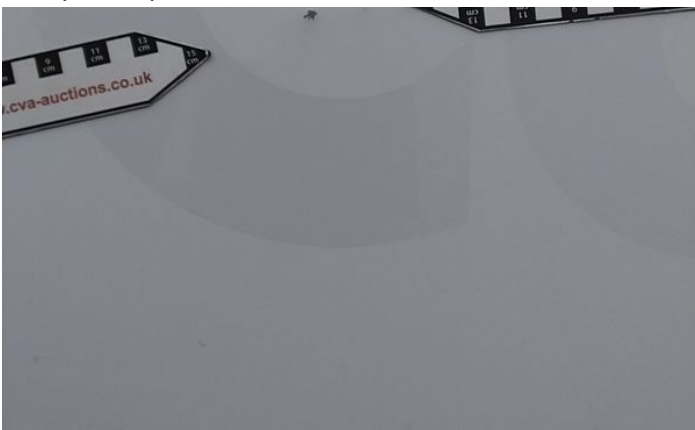
6: Door Moulding nsf  
Missing  
Replace

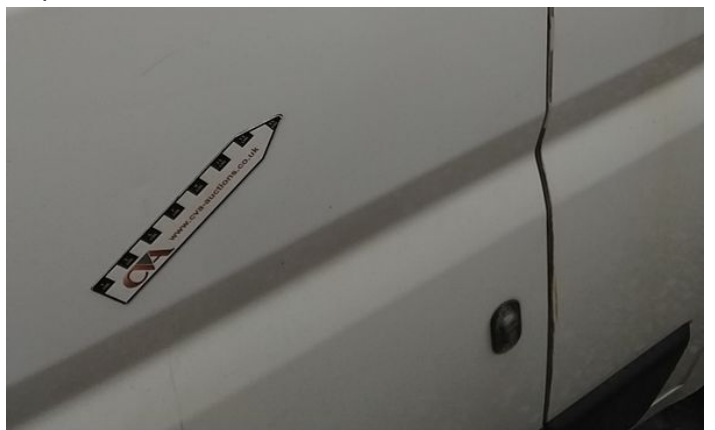
7: Qtr Panel nsr  
Dented  
With Paint Damage

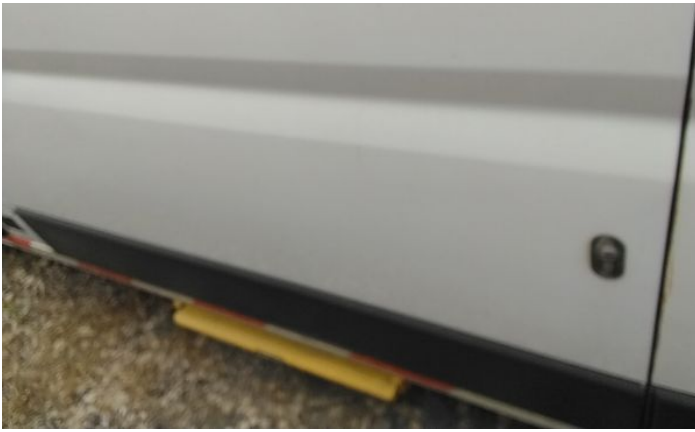
9: Qtr Panel nsr  
Chipped  
Multiple Chips

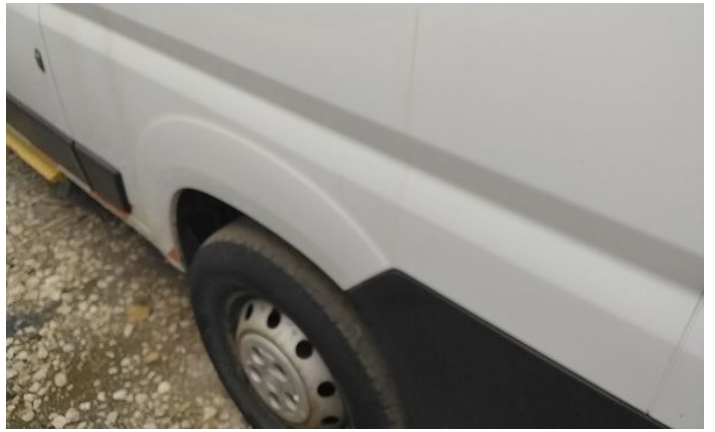
10: Qtr Panel nsr  
Chipped  
Multiple Chips

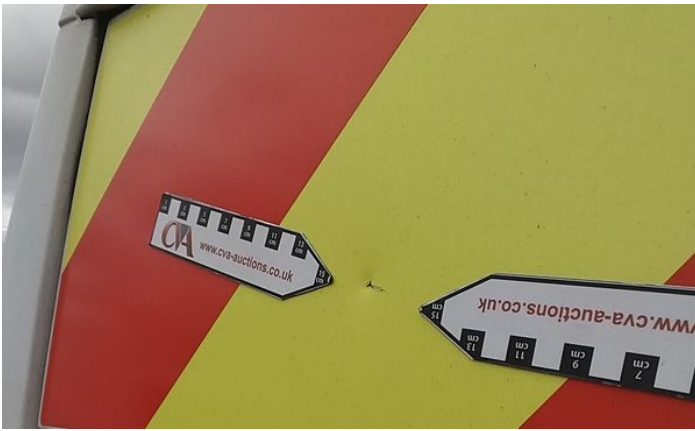
11: Door nsr  
Dented  
With Paint Damage

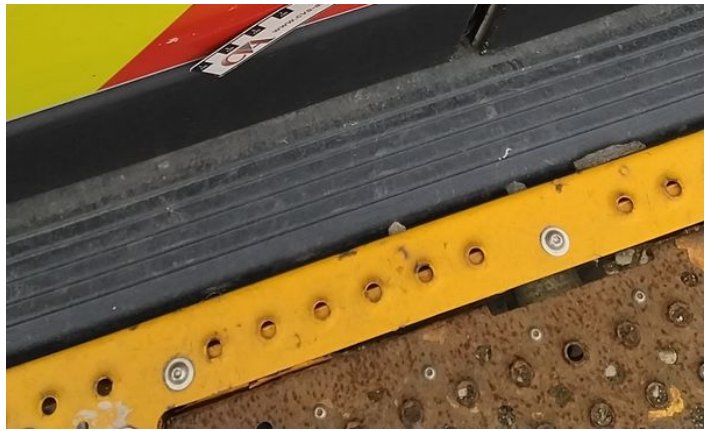
12: Door nsr  
Dented  
With Paint Damage

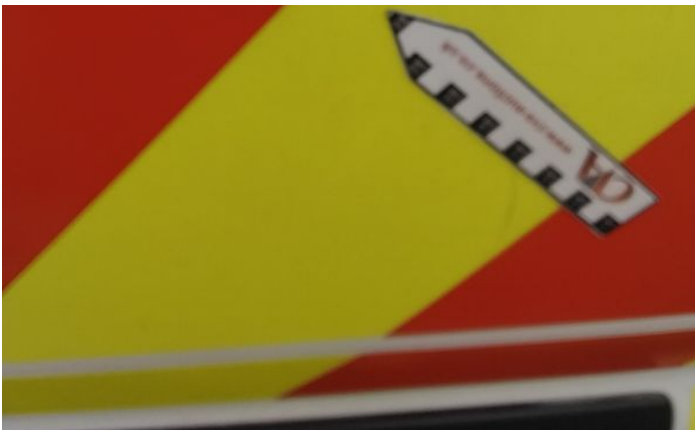
13: Door nsr  
Dented  
With Paint Damage

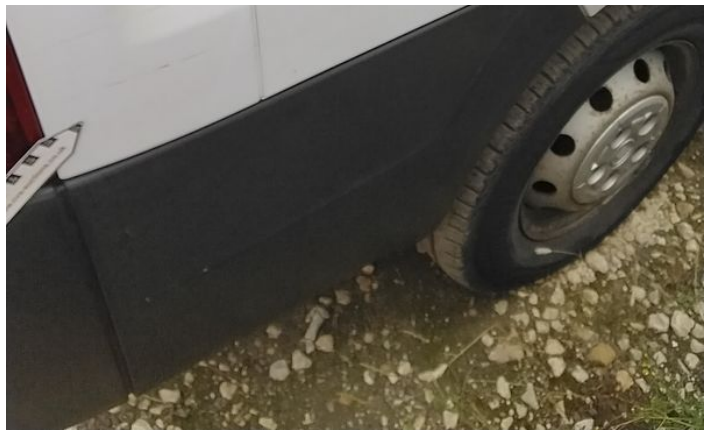
14: Qtr Panel osr  
Scratched  
Over 25mm Thru Paint

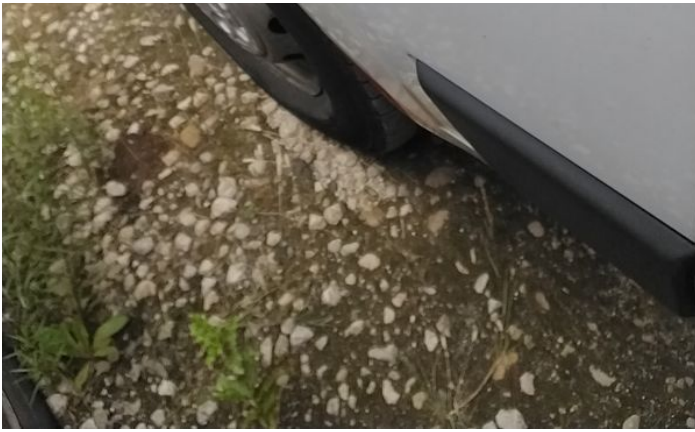
15: Qtr Panel osr  
Chipped  
Multiple Chips

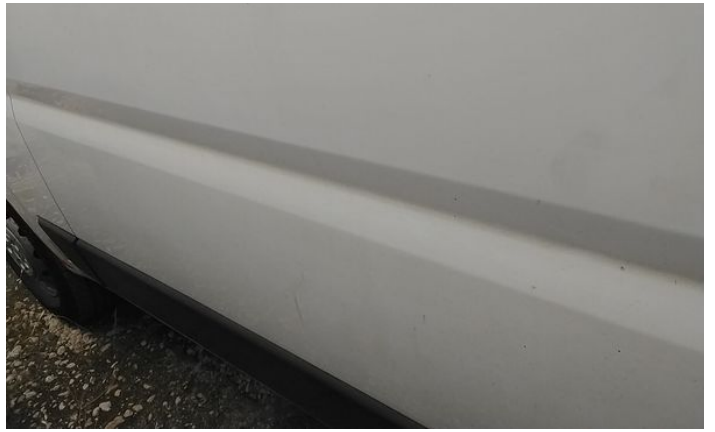
16: Qtr Panel osr  
Chipped  
Multiple Chips

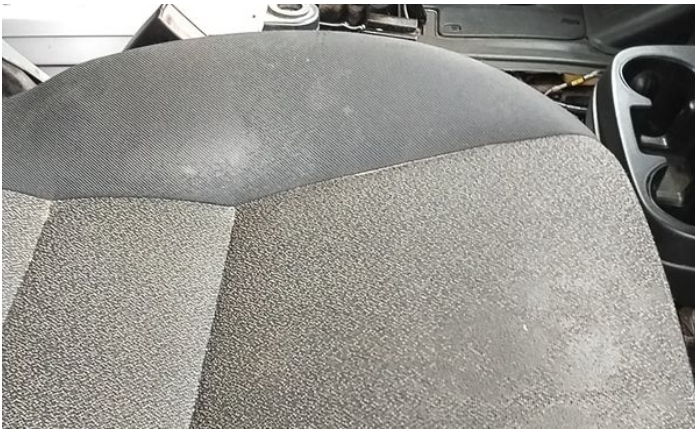
17: Seat Base Cover osf  
Soiled  
Heavy

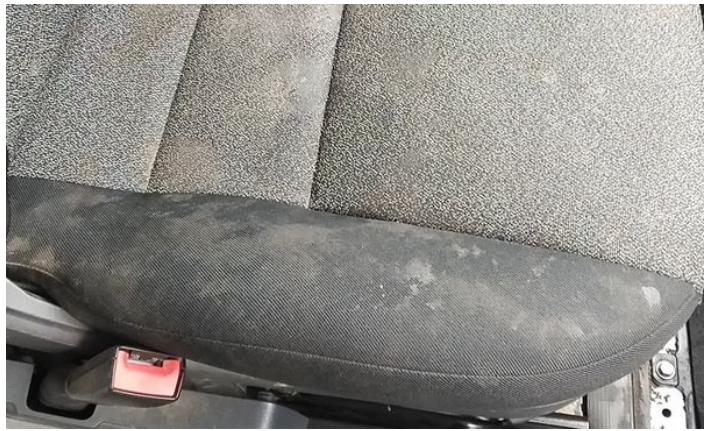
18: Seat Base Cover nsf  
Soiled  
Heavy

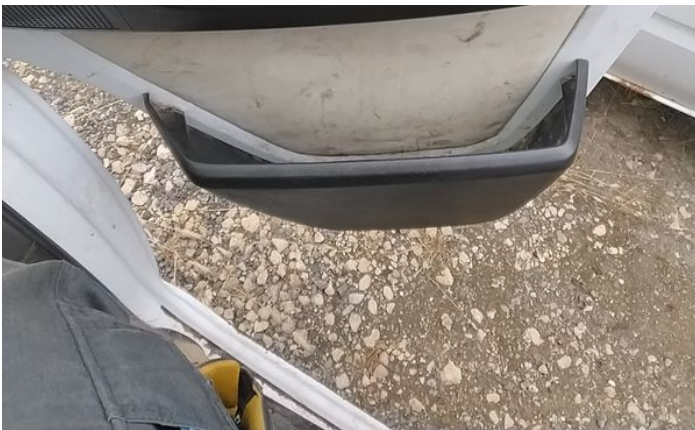
19: Door Pad osf  
Soiled  
Heavy

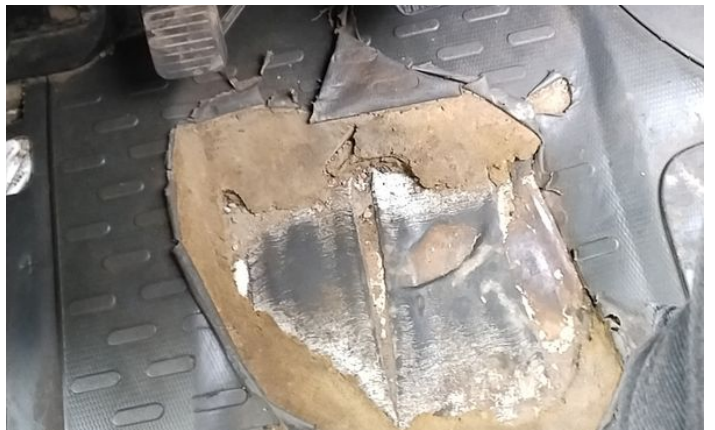
20: Carpets Front  
Holed  
Over 3mm
