# VEHICLE INSPECTION REPORT

**KU12WGV**

## Fuso Canter 7C18

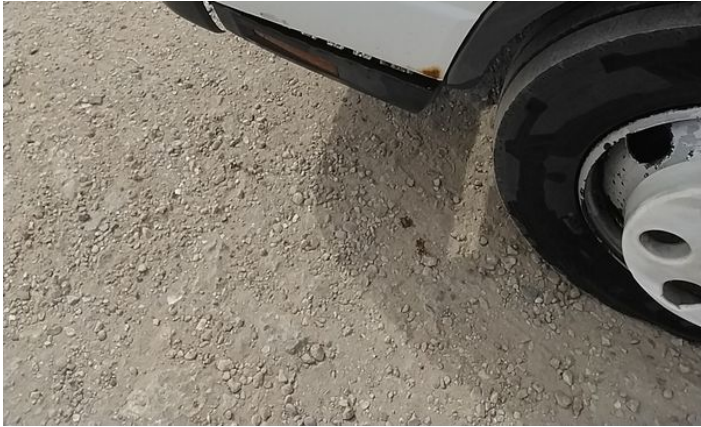
2: Door nsf  
Rusted  
UpTo 5mm
