# VEHICLE INSPECTION REPORT

**FJ64RZV**

## Mercedes-Benz Atego 1324

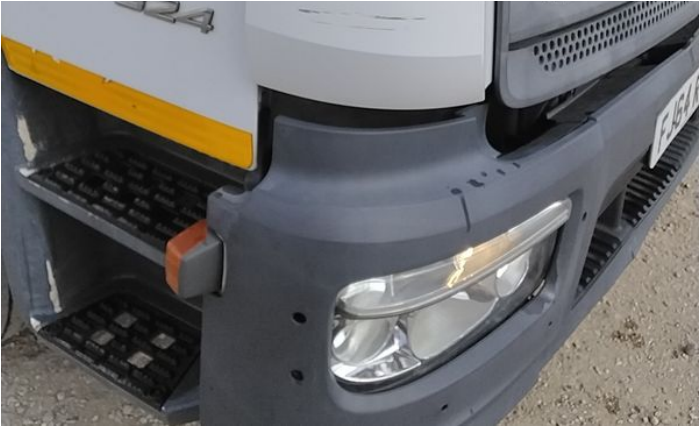
1: Wing osf  
Scratched  
UpTo 25mm Thru Paint

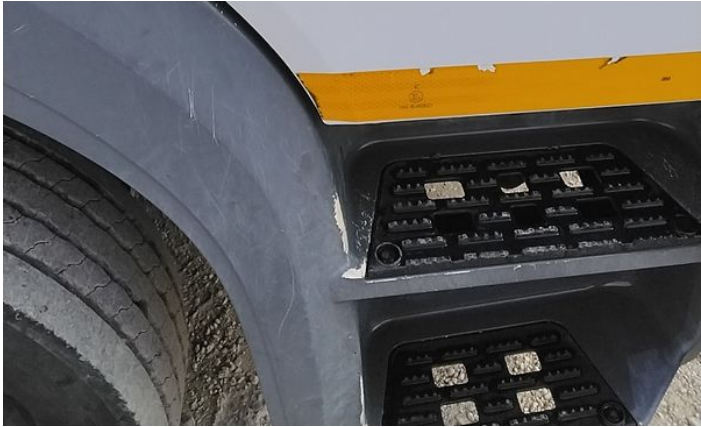
2: Door osf  
Rusted  
UpTo 5mm
