# VEHICLE INSPECTION REPORT

**LX65BCK**

## Mercedes-Benz Sprinter 513 CDI

### Inspection

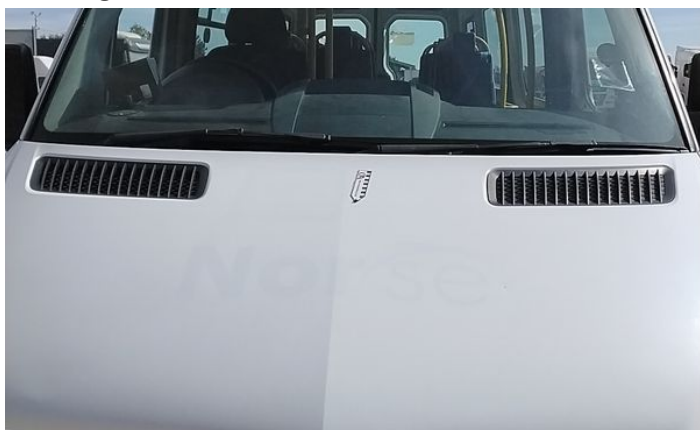
1: Bonnet  
Chipped  
Multiple Chips

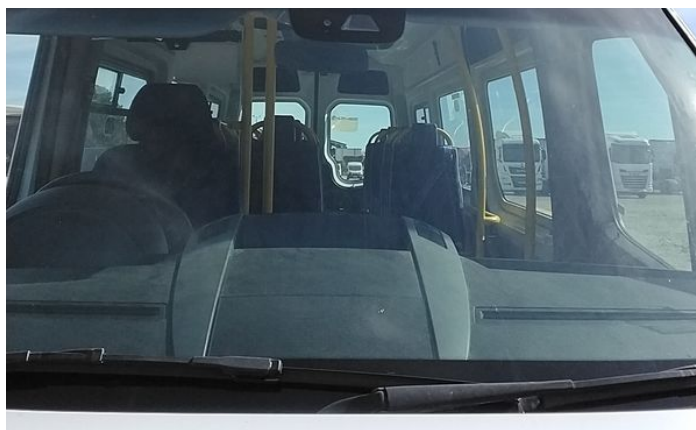
2: Screen Front  
Chipped  
Over 10mm

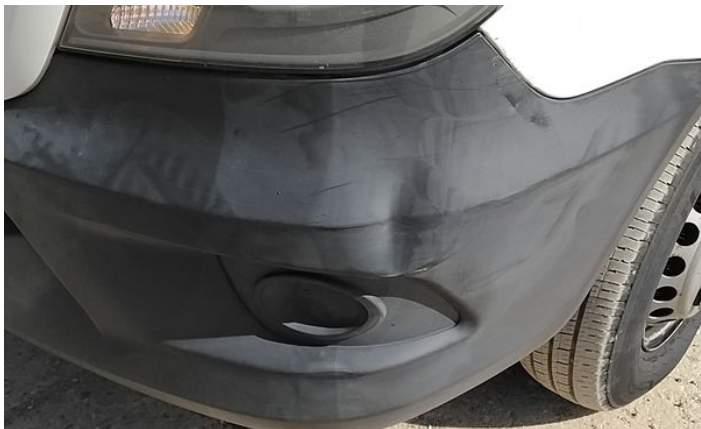
3: Bumper Front  
Dented  
Between 10mm + 30mm

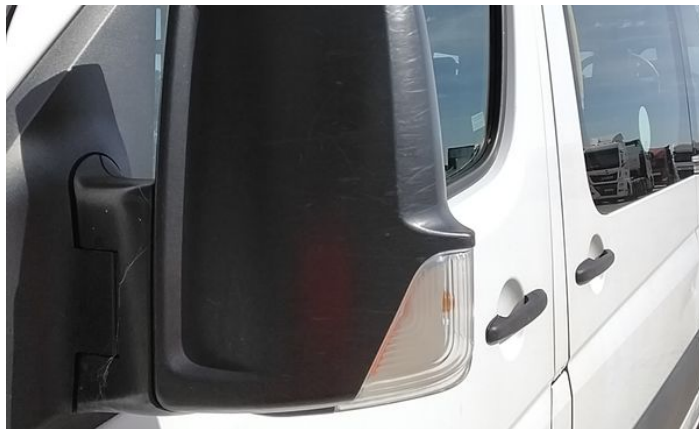
4: Door Mirror Assy nsf  
Scuffed (Unpainted)  
Over 100mm

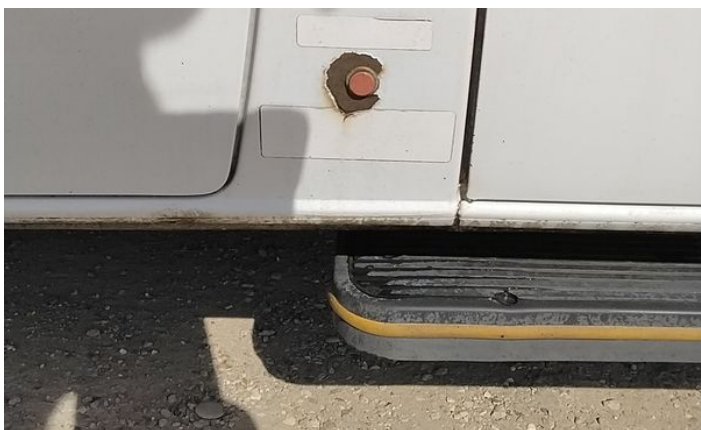
5: B Post ns  
Rusted  
Over 5mm

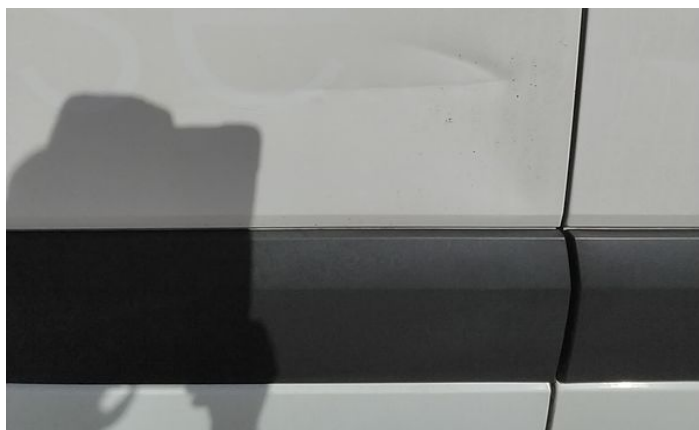
6: Door nsr  
Dented  
Between 10mm + 30mm

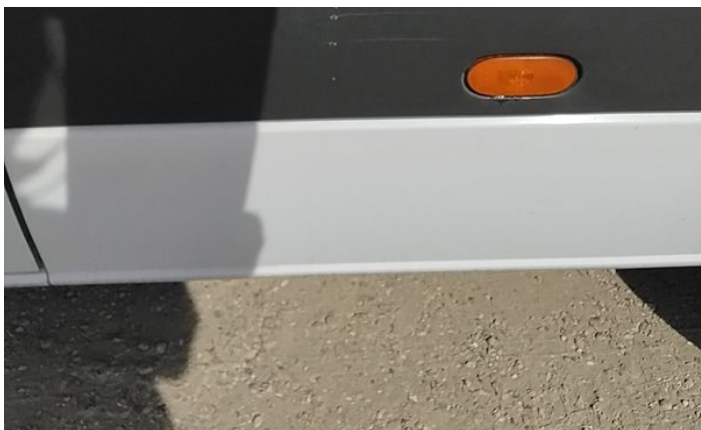
7: Qtr Panel Trim ns  
Scuffed  
Over 25mm

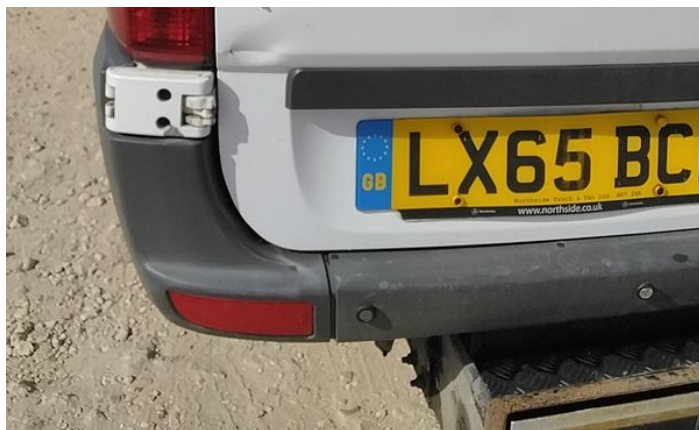
8: Door nsr  
Dented  
With Paint Damage

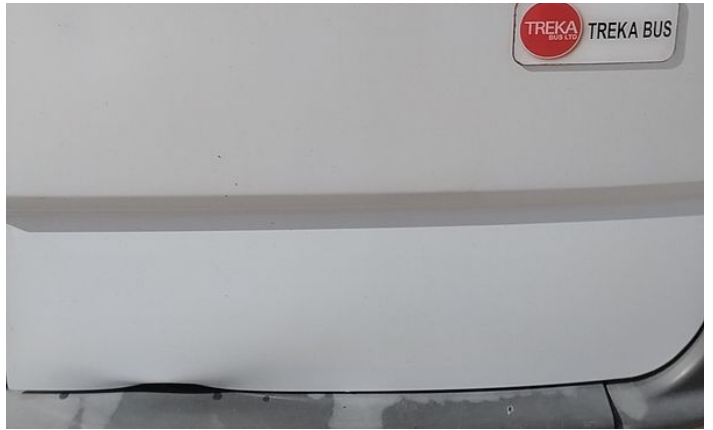
10: Door osr  
Chipped  
1 To 5

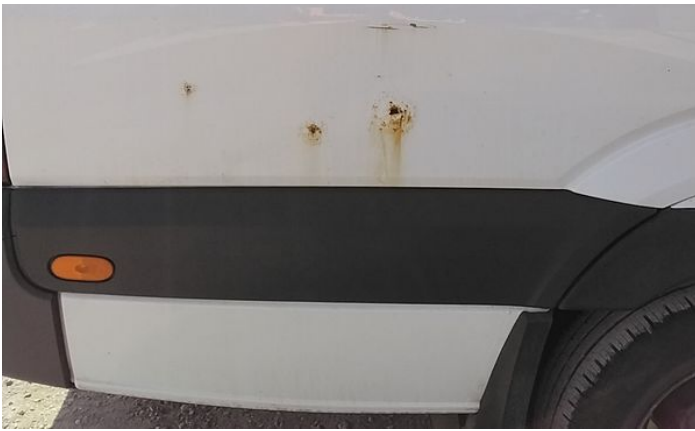
11: Qtr Panel osr  
Rusted  
Over 5mm

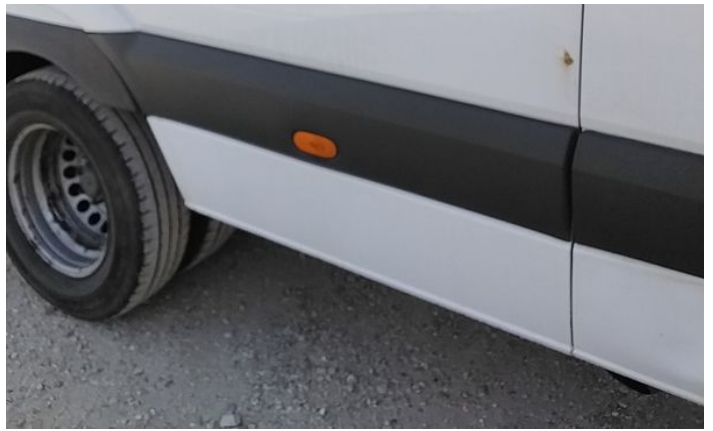
12: Qtr Panel osr  
Rusted  
Over 5mm

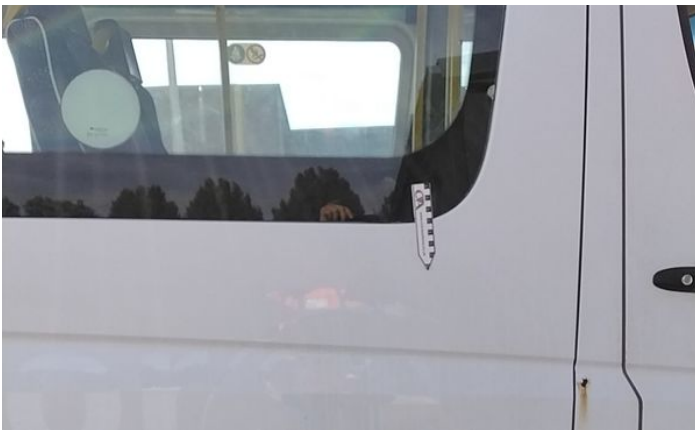
13: Qtr Panel osr  
Rusted  
Over 5mm

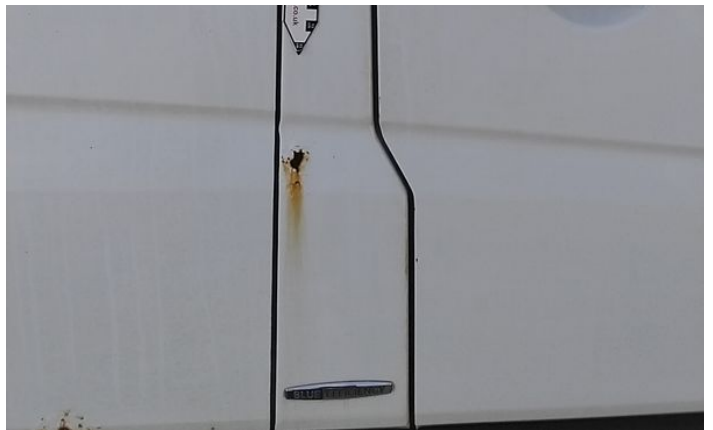
14: B Post os  
Rusted  
Over 5mm

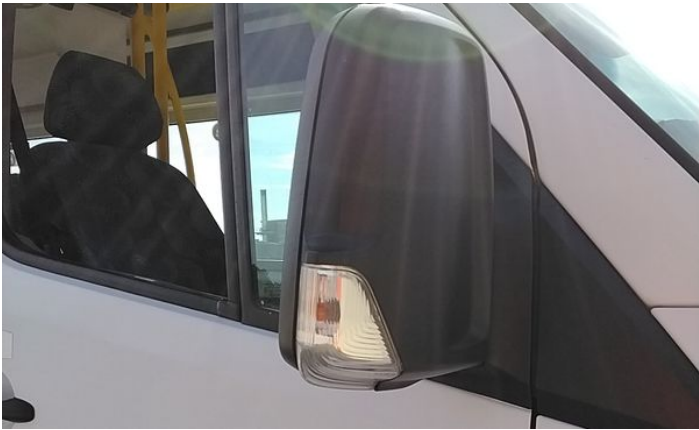
15: Door Mirror Assy osf  
Scuffed (Unpainted)  
UpTo 100mm
