# VEHICLE INSPECTION REPORT

**BX59DKE**

## Daf LF 45.160

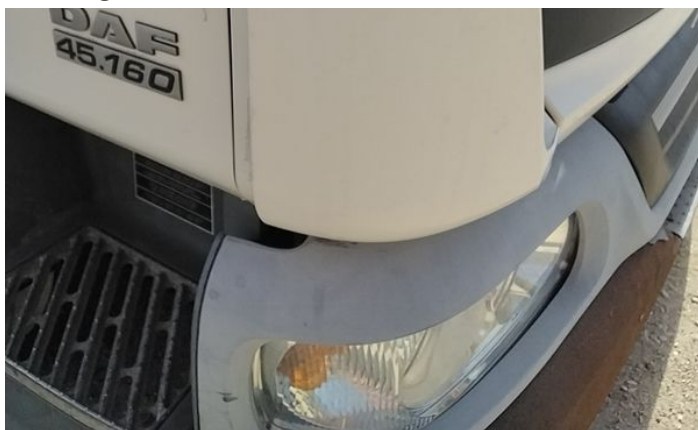
1: Wing osf  
Scratched  
Over 25mm Not Thru Paint

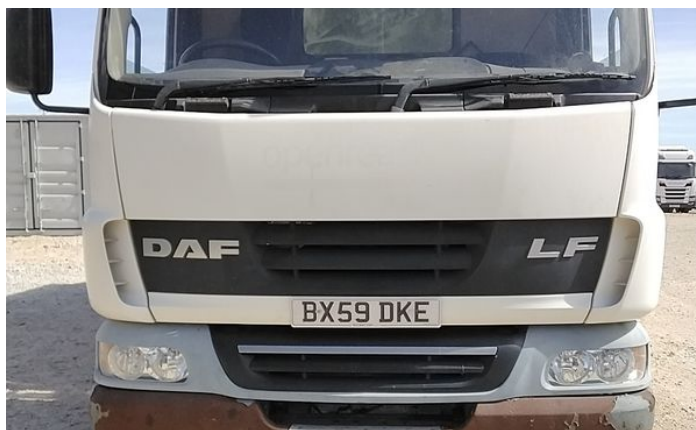
2: Bumper Front  
Rusted  
Over 5mm

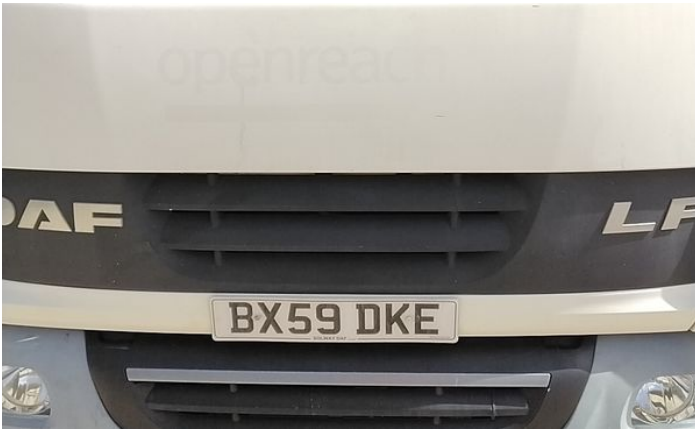
3: Bonnet  
Chipped  
Multiple Chips

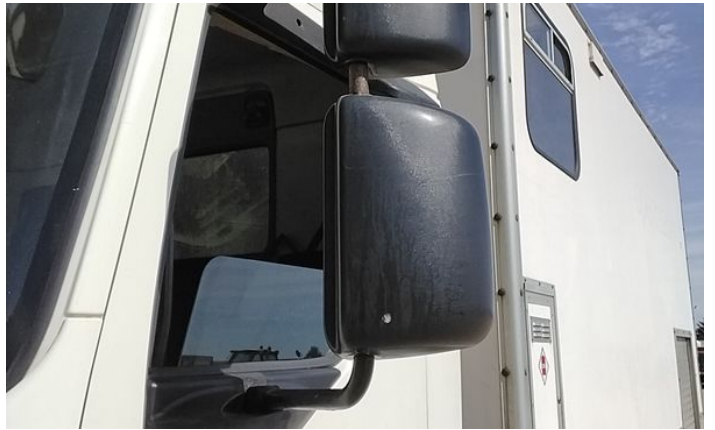
4: Door Mirror Assy nsf  
Scuffed (Unpainted)  
Over 100mm

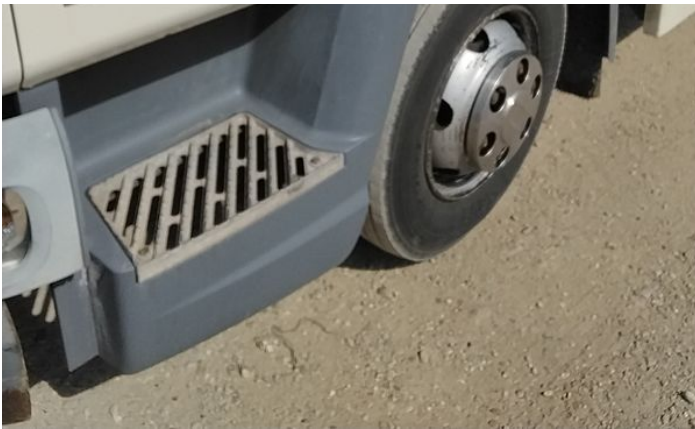
5: Wing Front Arch Extension ns  
Scuffed (Unpainted)  
Over 100mm

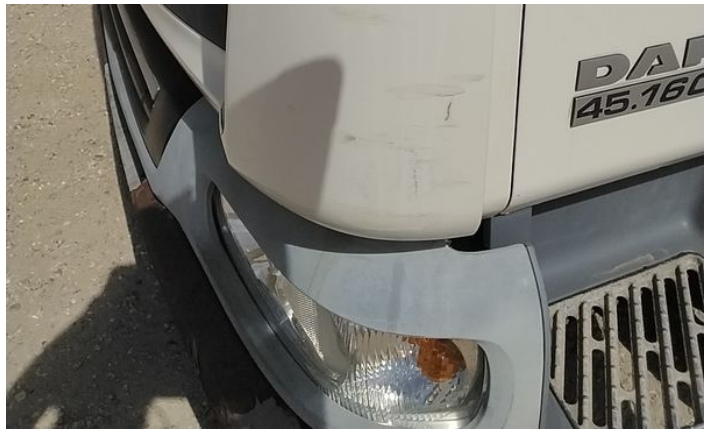
6: Wing nsf  
Scratched  
Over 25mm Thru Paint

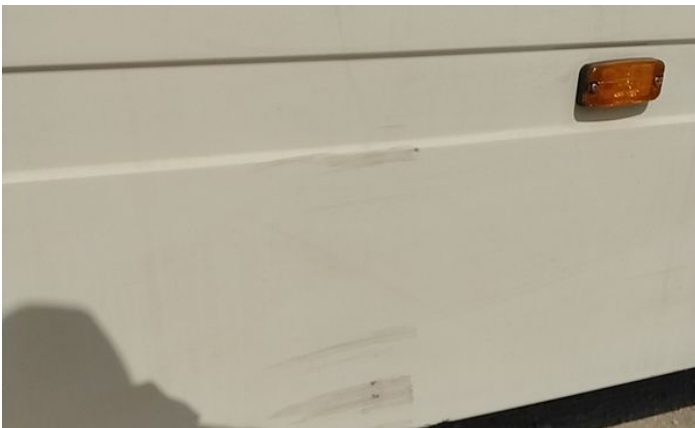
7: Qtr Panel nsr  
Cracked  
Replace

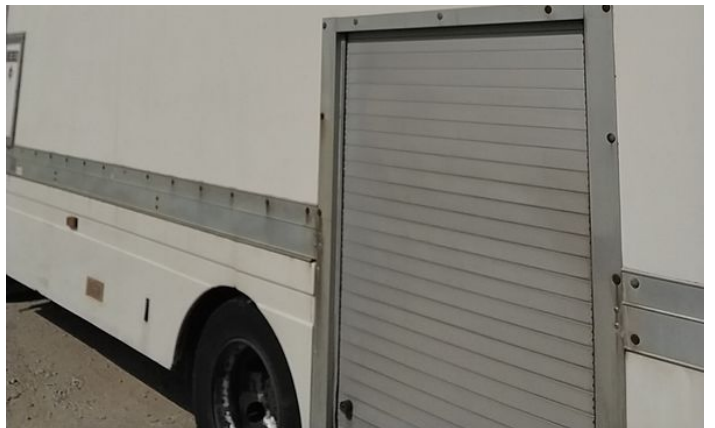
8: Qtr Panel nsr  
Scratched  
Over 25mm Not Thru Paint

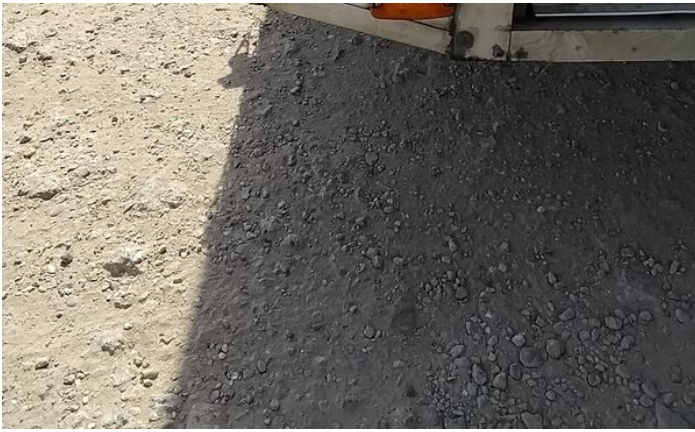
9: Qtr Panel osr  
Scratched  
Over 25mm Thru Paint

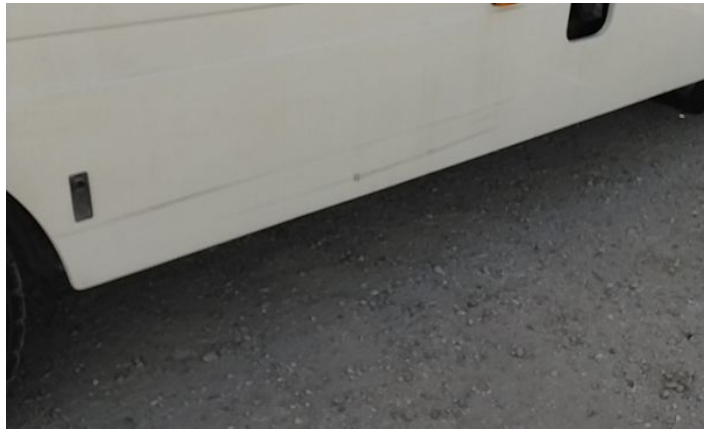
10: Qtr Panel osr  
Scratched  
Over 25mm Not Thru Paint

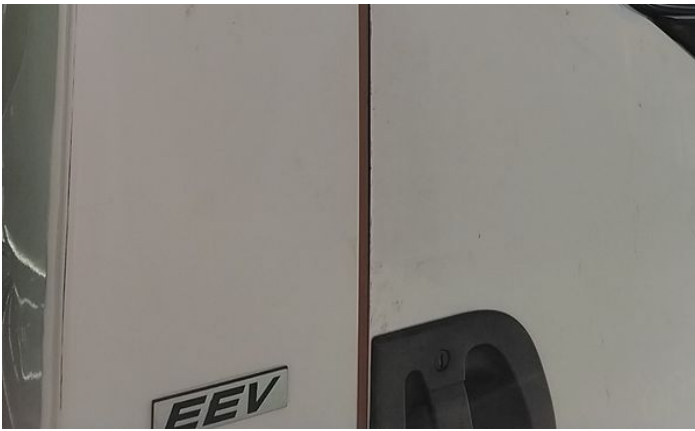
11: Door osf  
Chipped  
Edge Chip

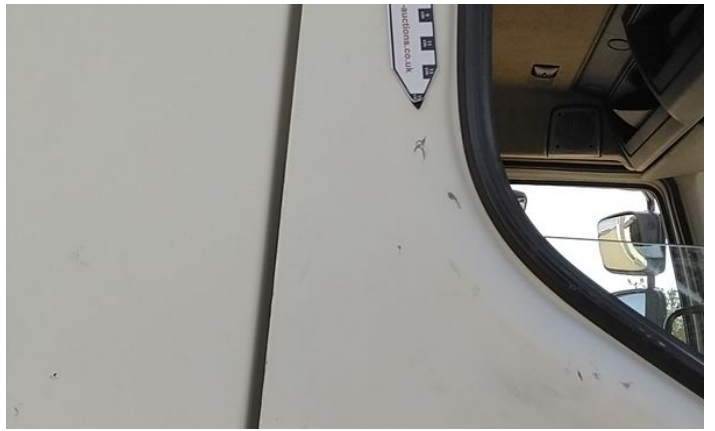
12: Door osf  
Scratched  
UpTo 25mm Thru Paint

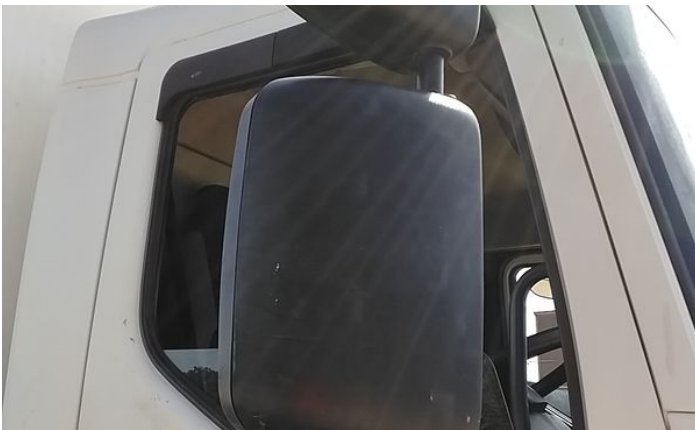
13: Door Mirror Assy osf  
Scuffed (Unpainted)  
Over 100mm

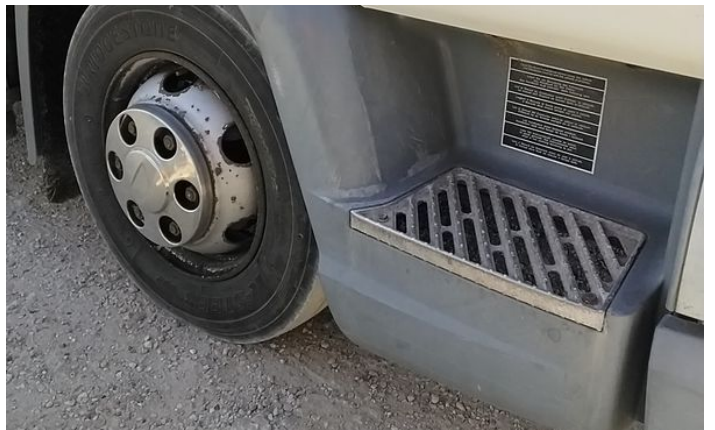
14: Wing Front Arch Extension os  
Scuffed (Unpainted)  
Over 100mm
