# VEHICLE INSPECTION REPORT

**BU69TPF**

## Daf LF 230

**Non Runner**  
Inspection

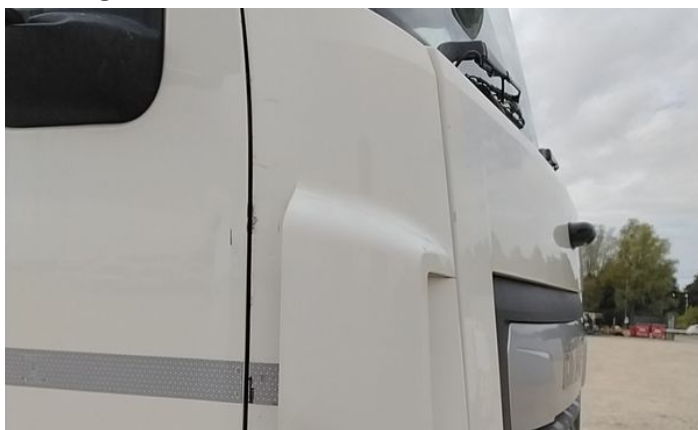
1: Wing osf  
Scratched  
Over 25mm Not Thru Paint

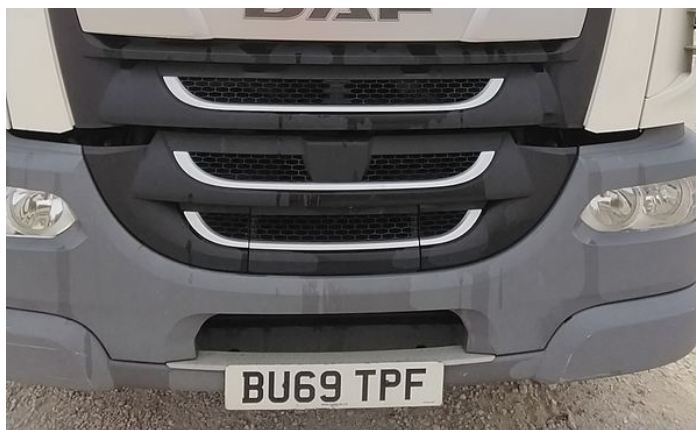
2: Bonnet  
Chipped  
Multiple Chips

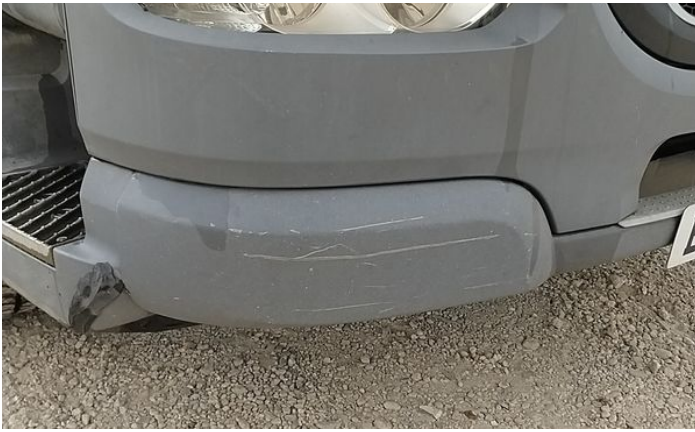
3: Bumper Front  
Scratched  
25 to 100mm Thru Paint

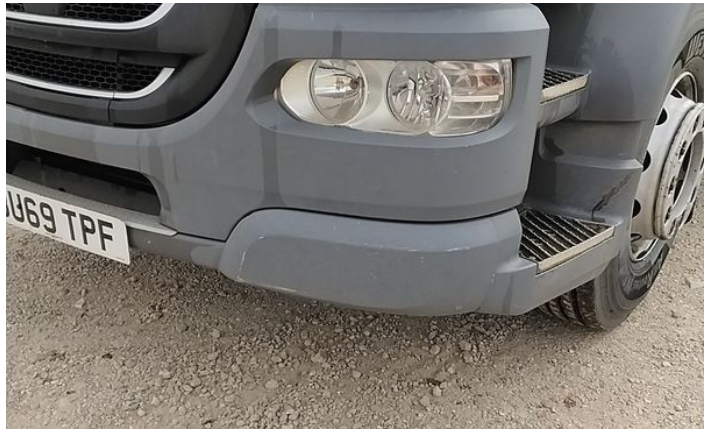
4: Bumper Front  
Scratched  
25 to 100mm Thru Paint

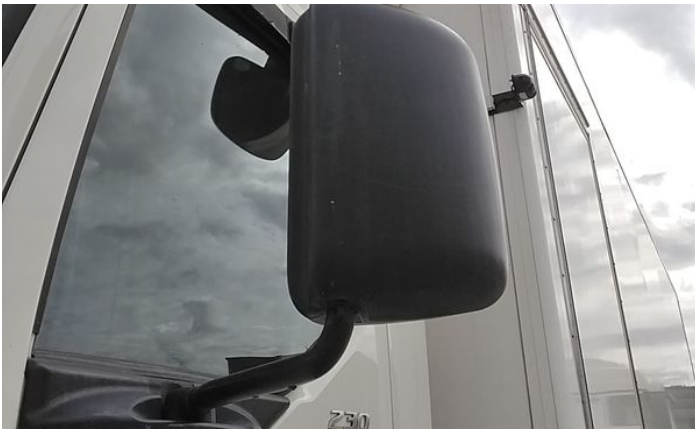
5: Door Mirror Assy nsf  
Scuffed (Unpainted)  
Over 100mm

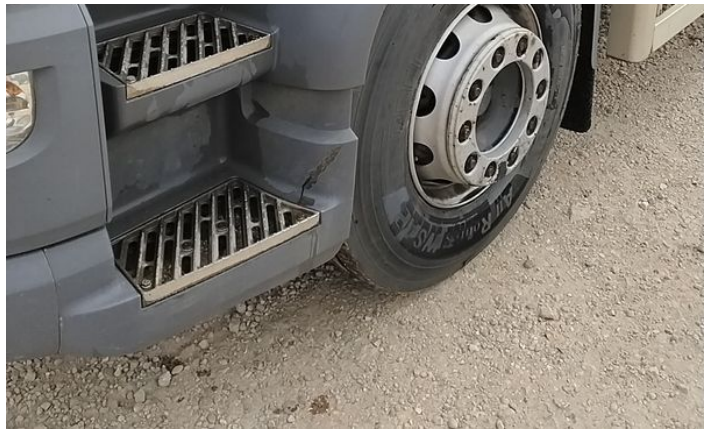
6: Wing Front Arch Extension ns  
Scuffed (Unpainted)  
Over 100mm

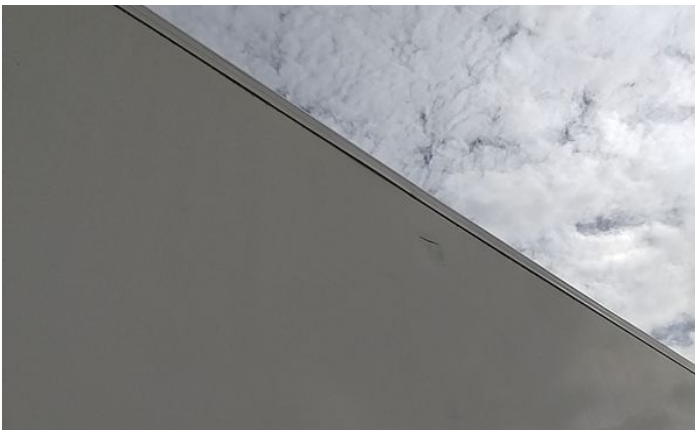
7: Qtr Panel nsr  
Scratched  
Over 25mm Thru Paint

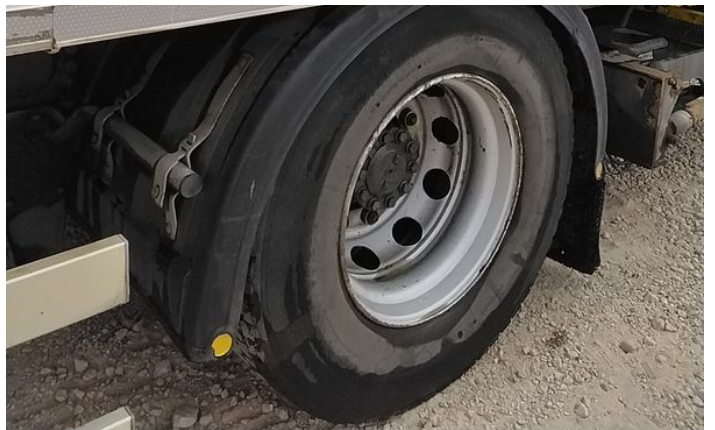
8: Qtr Panel nsr  
Poor Previous Repair  
Poor Paint

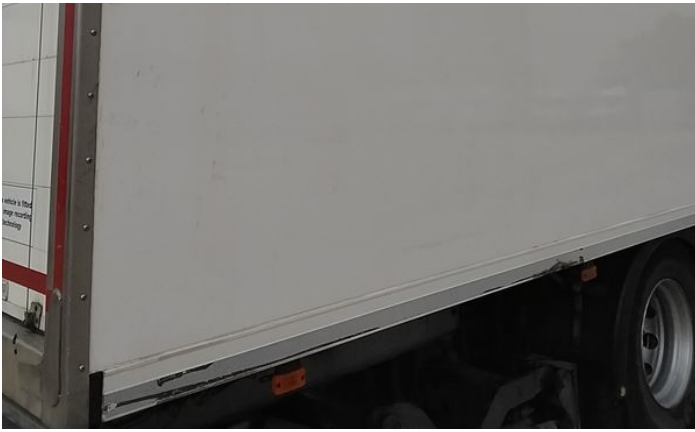
9: Qtr Panel osr  
Scratched  
Over 25mm Not Thru Paint

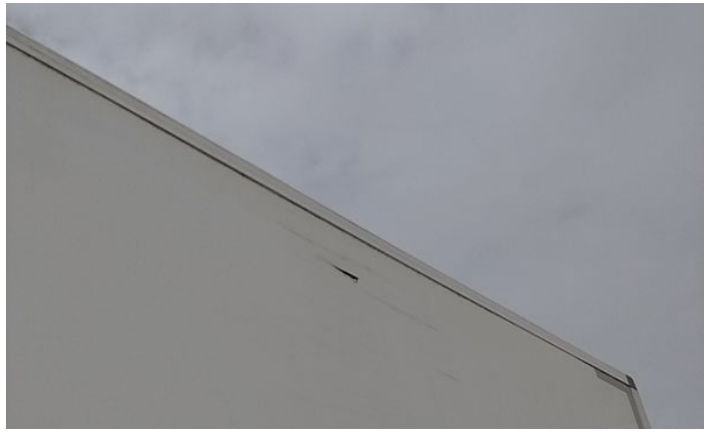
10: Qtr Panel osr  
Scratched  
Over 25mm Thru Paint

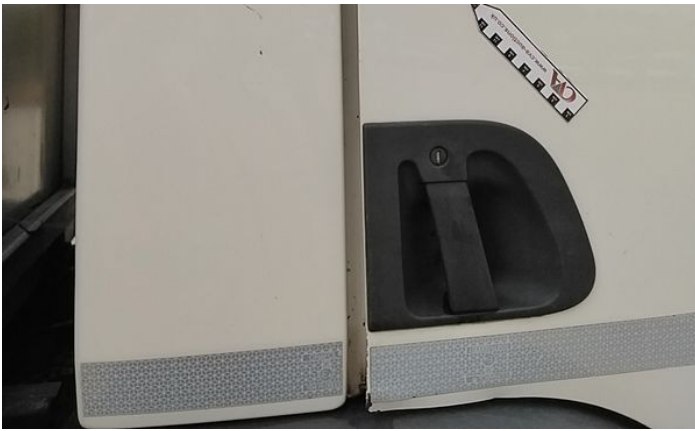
11: Door osf  
Scratched  
Over 25mm Not Thru Paint

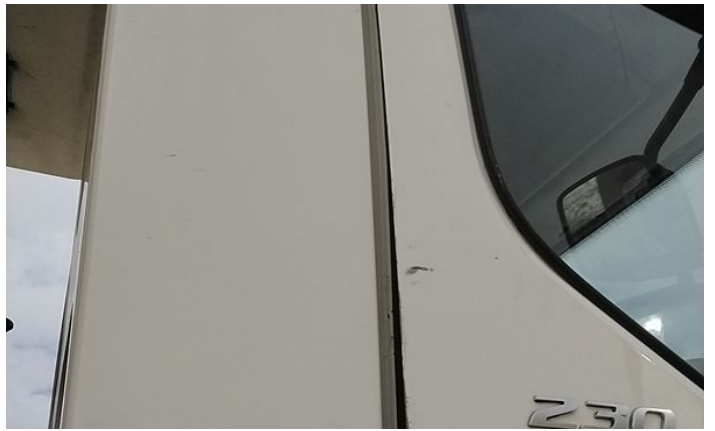
12: Door osf  
Chipped  
Edge Chip

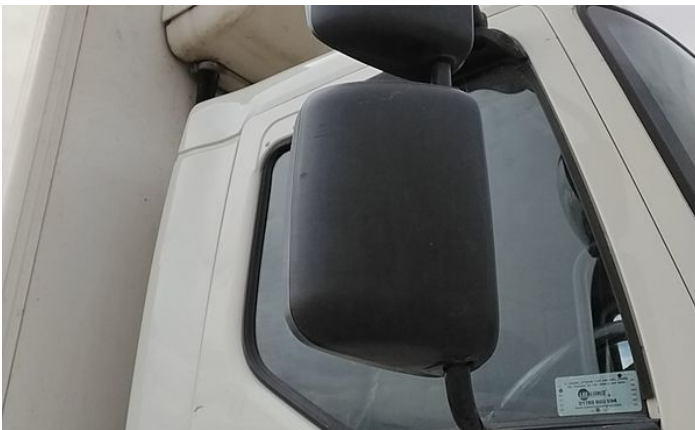
13: Door Mirror Assy osf  
Scuffed (Unpainted)  
UpTo 100mm

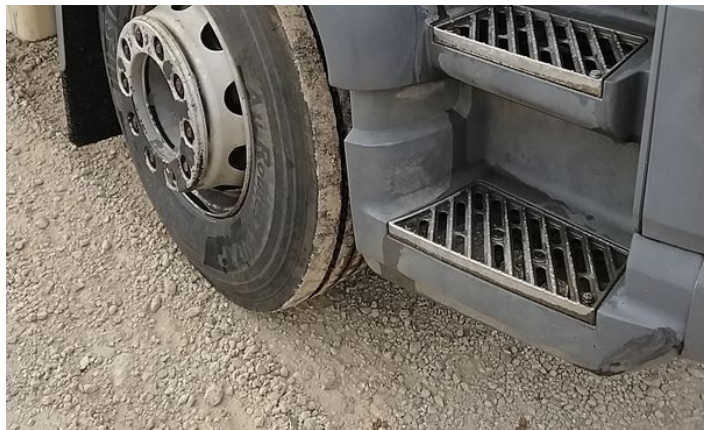
14: Wing Front Arch Extension os  
Scuffed (Unpainted)  
Over 100mm

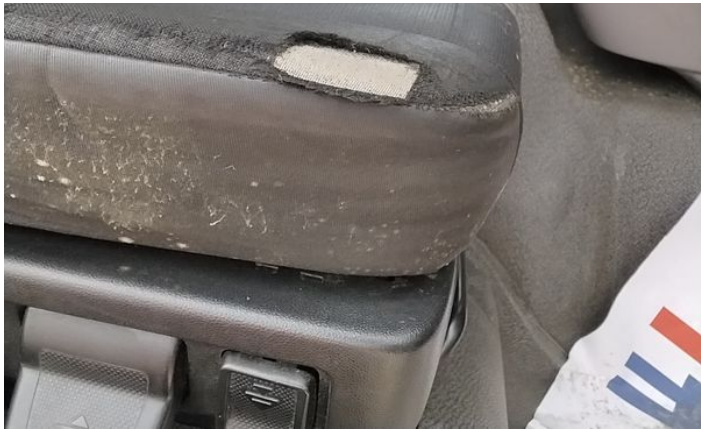
15: Seat Base Cover osf  
Holed  
Over 3mm
