# VEHICLE INSPECTION REPORT

**BC15ZCE**

## Iveco Daily 70-170

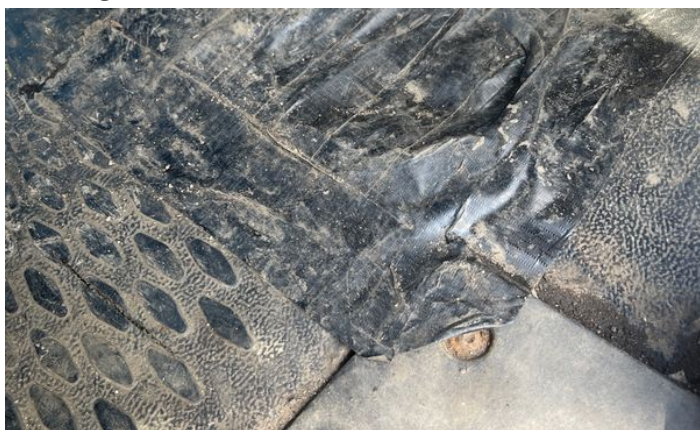
1: Carpets Front  
Torn  
Over 10mm

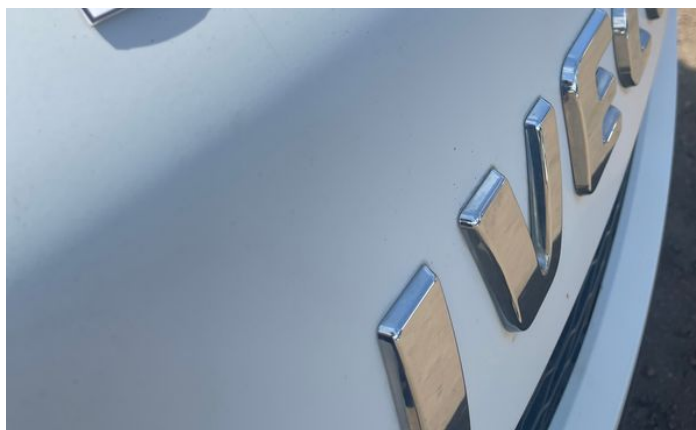
2: Bonnet  
Dented  
Over 30mm

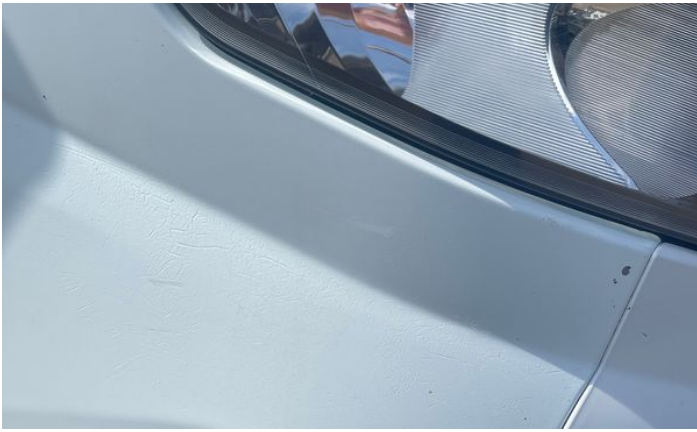
3: Wing osf  
Poor Previous Repair  
Poor Paint

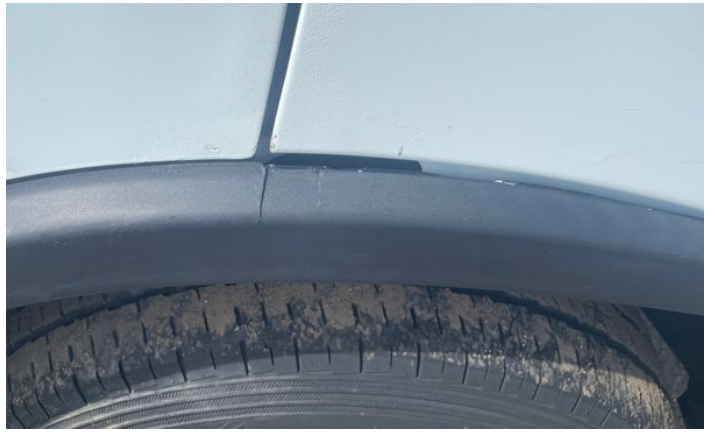
4: Wing Front Arch Extension os  
Scuffed (Unpainted)  
UpTo 100mm

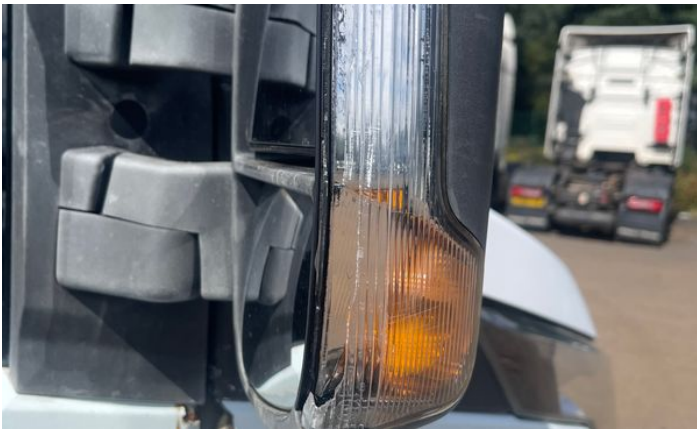
5: Flasher Side Repeater os  
Broken  
Replace

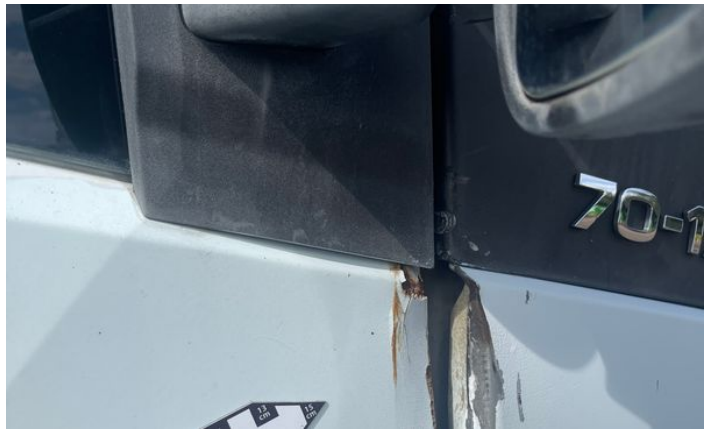
6: Door osf  
Dented  
With Paint Damage

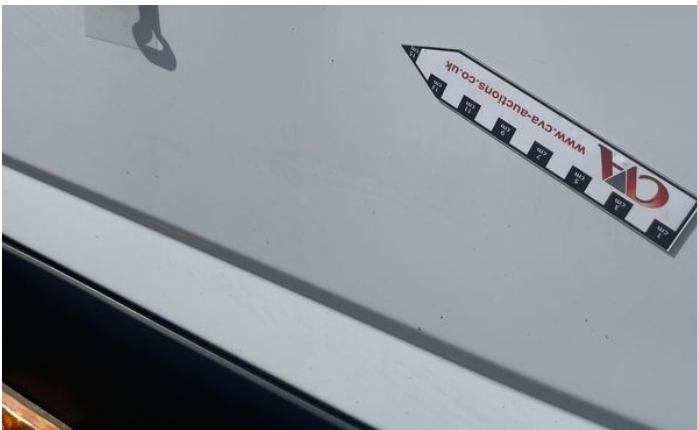
7: Qtr Panel osr  
Dented  
With Paint Damage

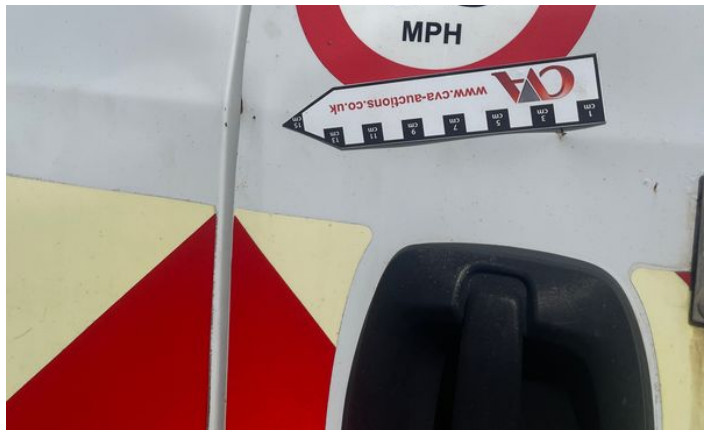
8: Tailgate  
Dented  
With Paint Damage

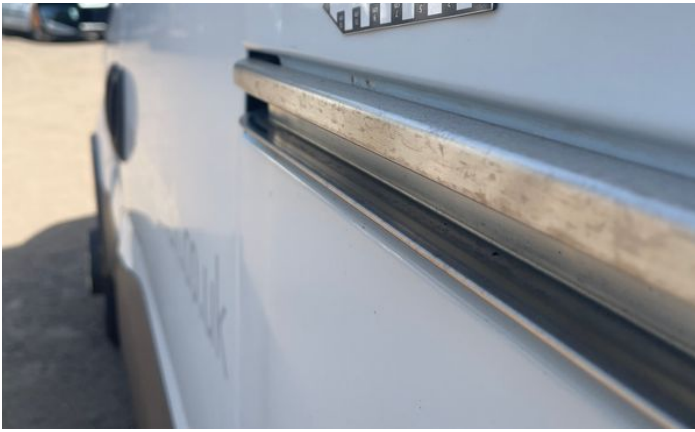
9: Qtr Panel nsr  
Dented  
Over 30mm

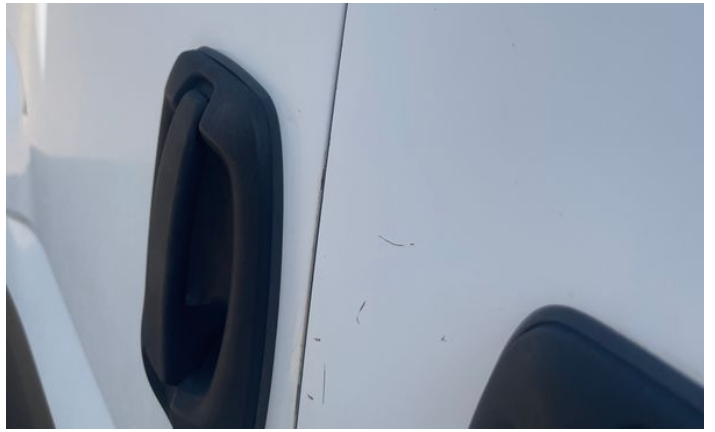
10: Door nsf  
Dented  
Over 30mm

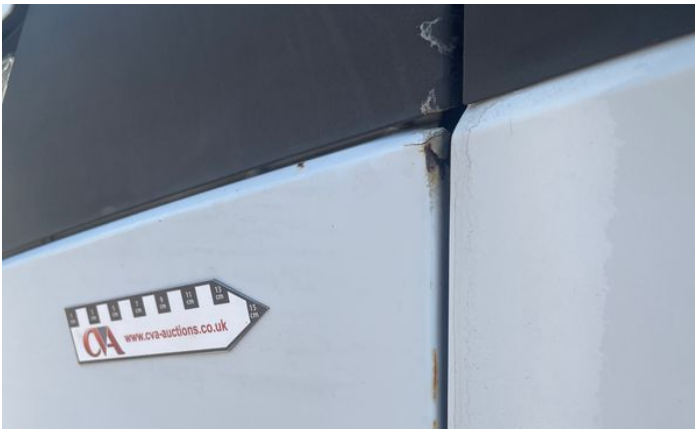
11: Wing nsf  
Dented  
With Paint Damage

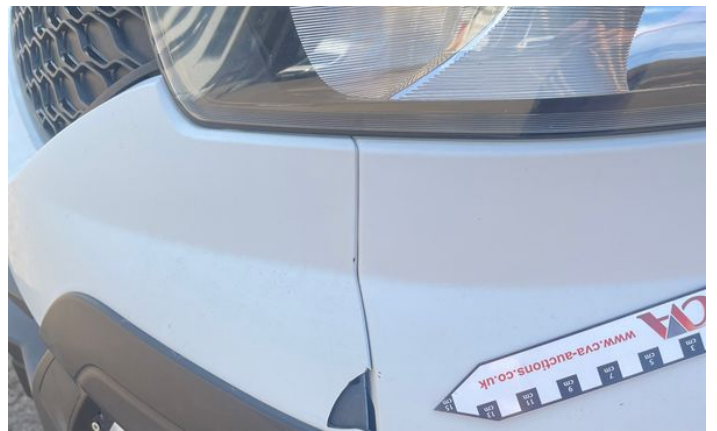
12: Bumper Front  
Cracked  
Over 25mm

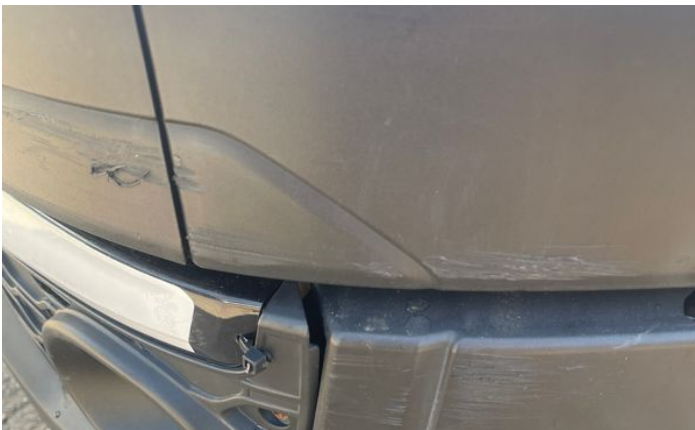
13: Bumper Front Moulding  
Scuffed (Unpainted)  
Over 100mm

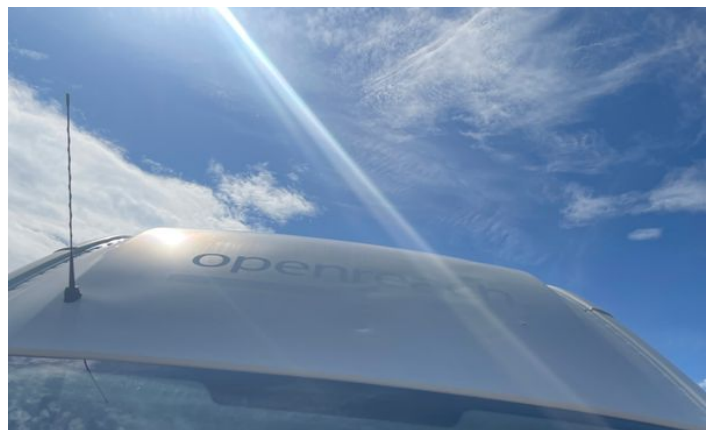
14: Roof  
Dented  
With Paint Damage
