# VEHICLE INSPECTION REPORT

**BT15MWK**

## Iveco Daily 70-170

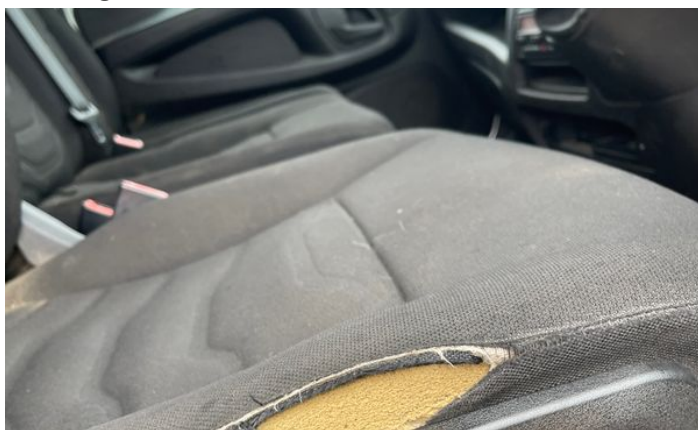
1: Seat Base Cover of  
Torn  
Over 3mm

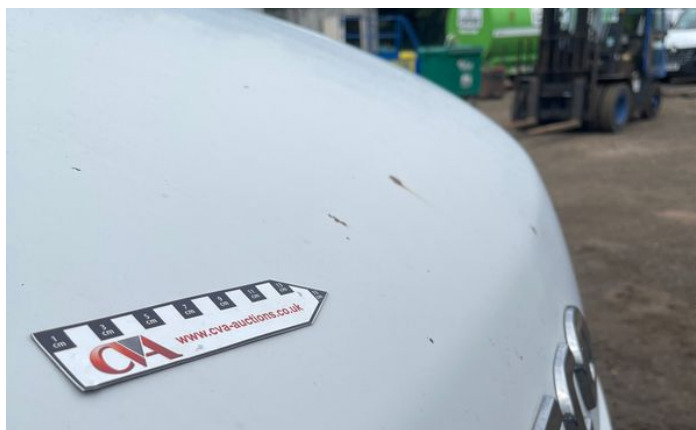
2: Bonnet  
Dented  
With Paint Damage

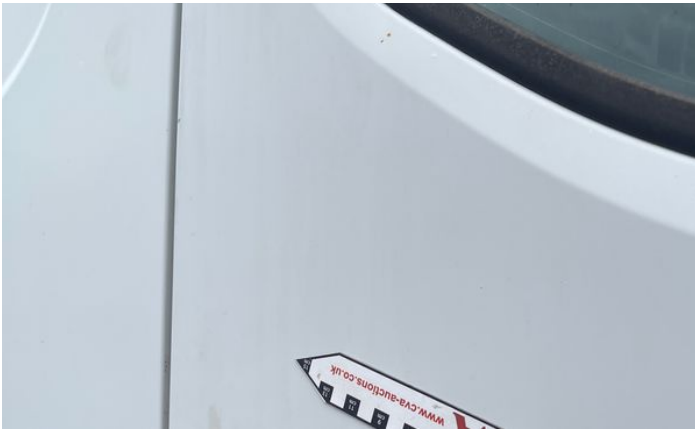
3: Door osf  
Dented  
With Paint Damage

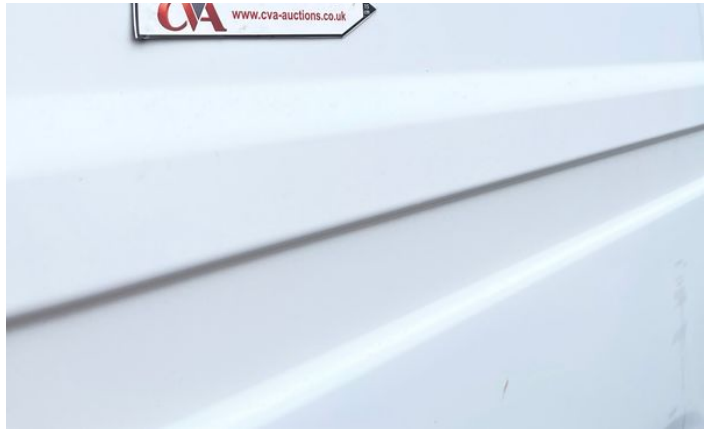
4: Qtr Panel osr  
Dented  
Over 30mm

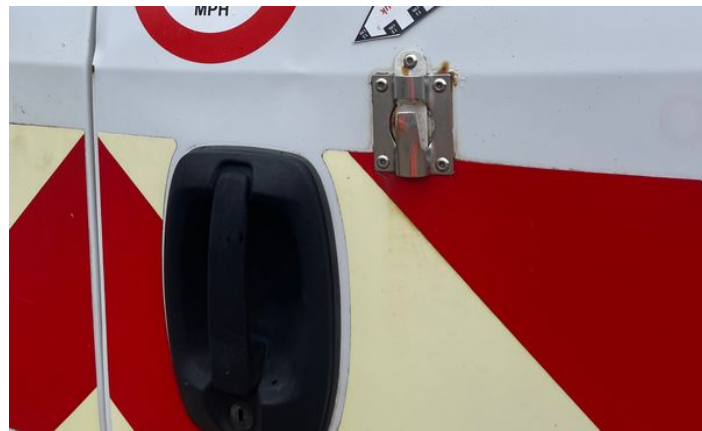
5: Tailgate  
Dented  
With Paint Damage

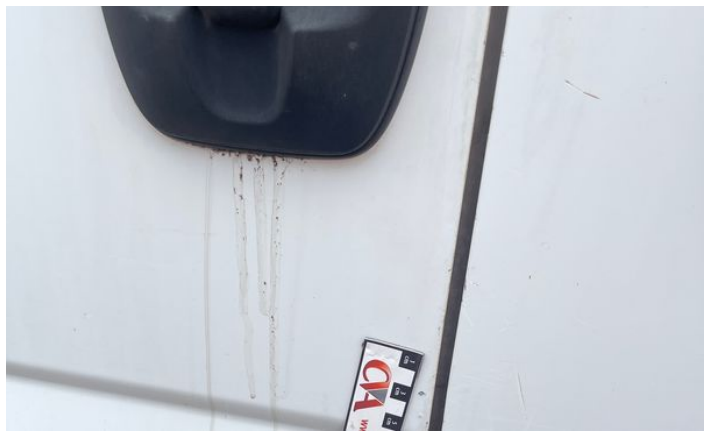
6: B Post ns  
Scratched  
Over 25mm Thru Paint
