# VEHICLE INSPECTION REPORT

**PJ70KRF**

## Mercedes-Benz Sprinter 314 CDI

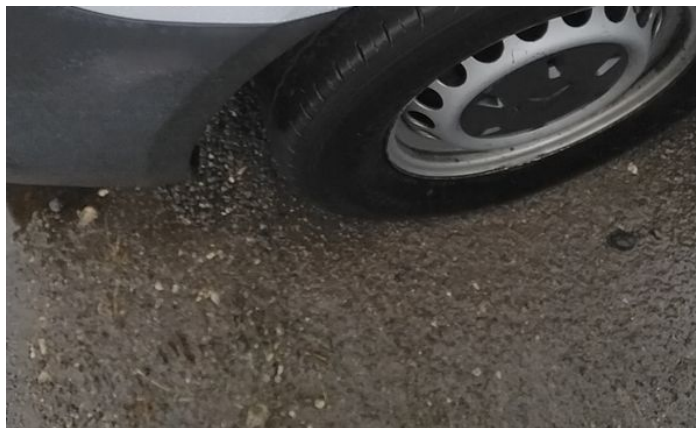
2: Wings  
Dented  
Over 30mm

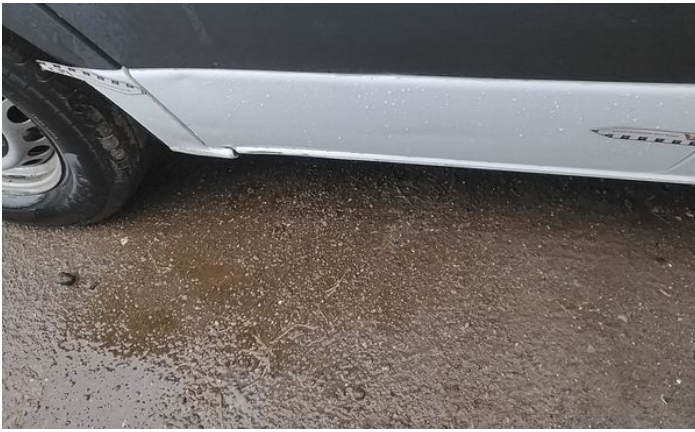
3: Door nsf  
Dented  
Over 30mm

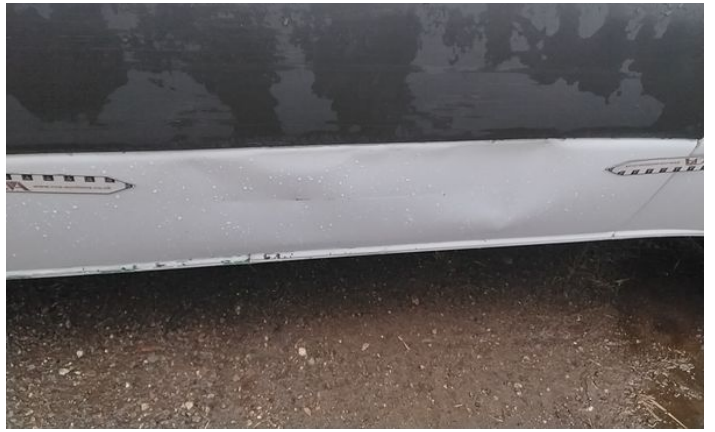
4: Qtr Panel nsr  
Dented  
Over 30mm

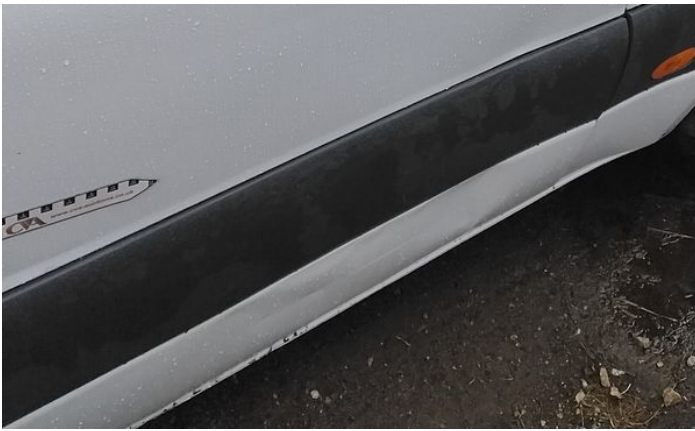
5: Qtr Panel nsr  
Dented  
Over 30mm

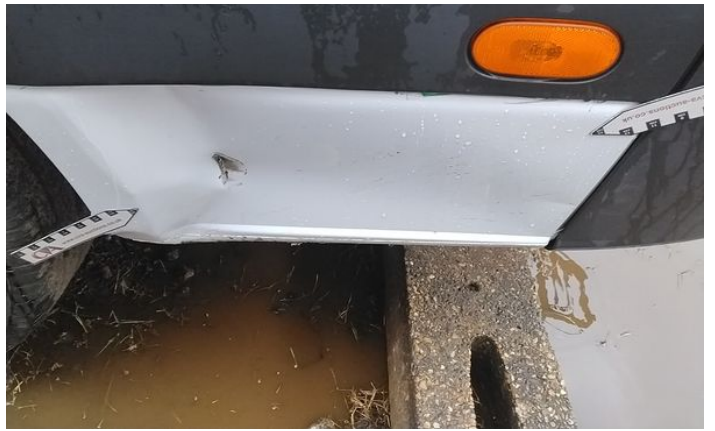
6: Qtr Panel nsr  
Dented  
With Paint Damage

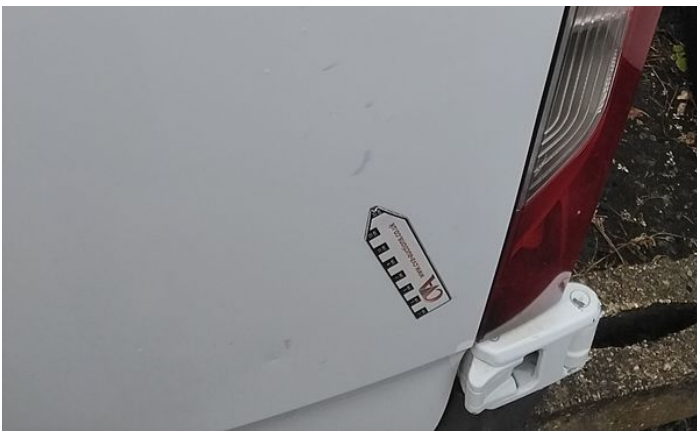
11: Door osr  
Scratched  
Over 25mm Thru Paint

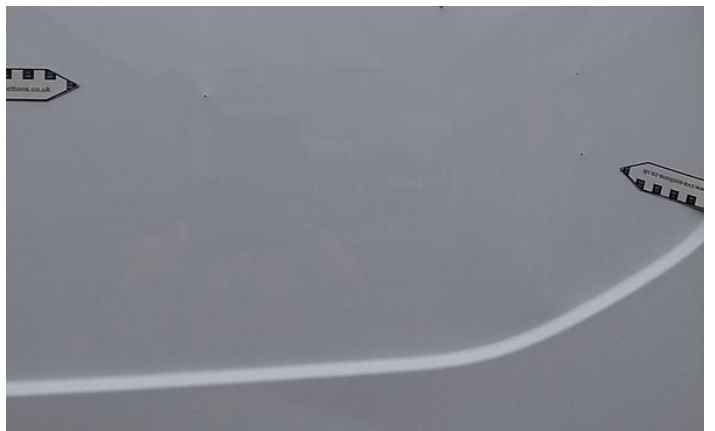
12: Door osr  
Dented  
With Paint Damage

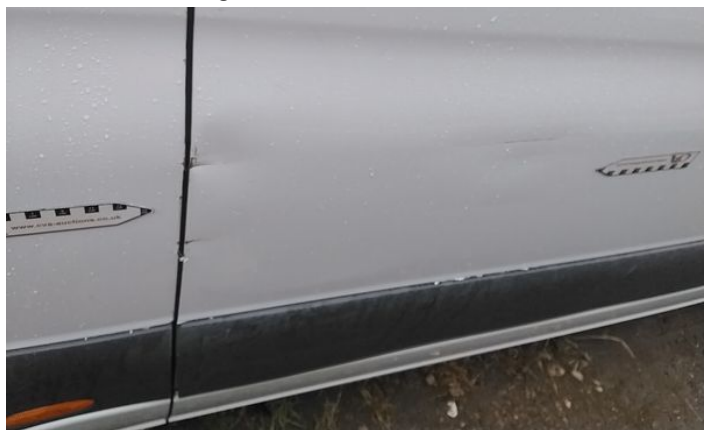
14: Qtr Panel osr  
Dented  
With Paint Damage

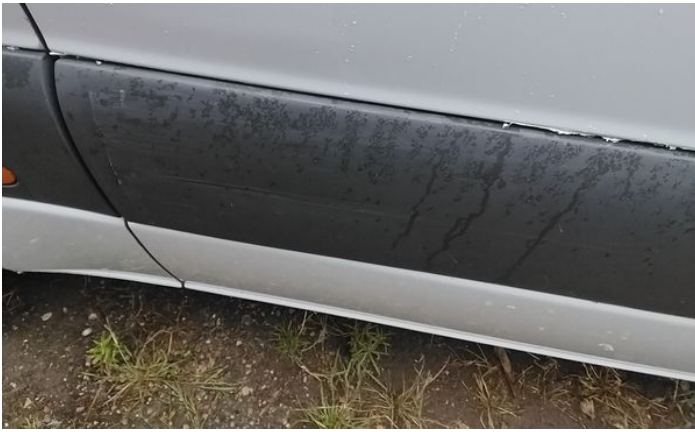
15: Qtr Panel Moulding os  
Scuffed (Unpainted)  
Over 100mm

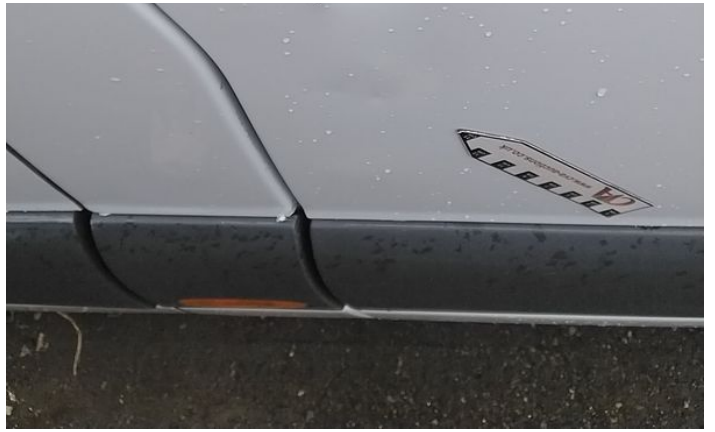
16: Door osf  
Dented  
With Paint Damage

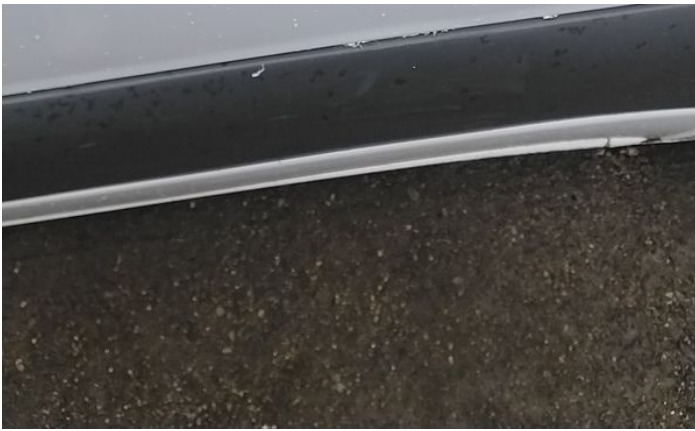
17: Door osf  
Dented  
Over 30mm

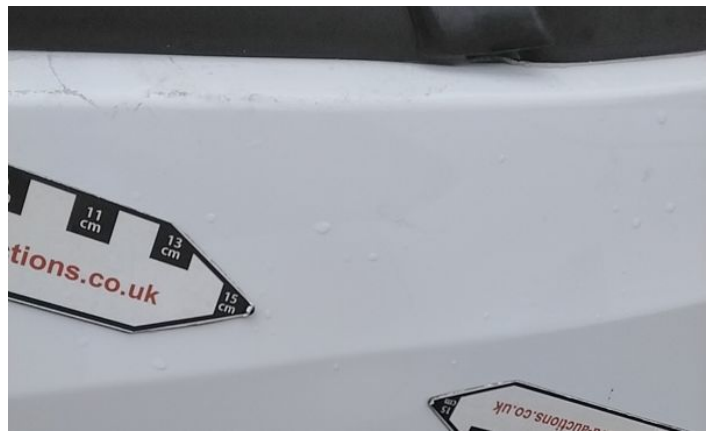
18: Door osf  
Dented  
Over 30mm

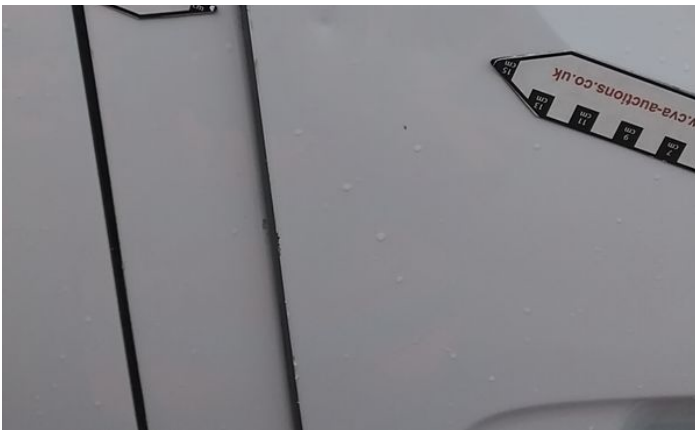
19: Door osf  
Dented  
With Paint Damage

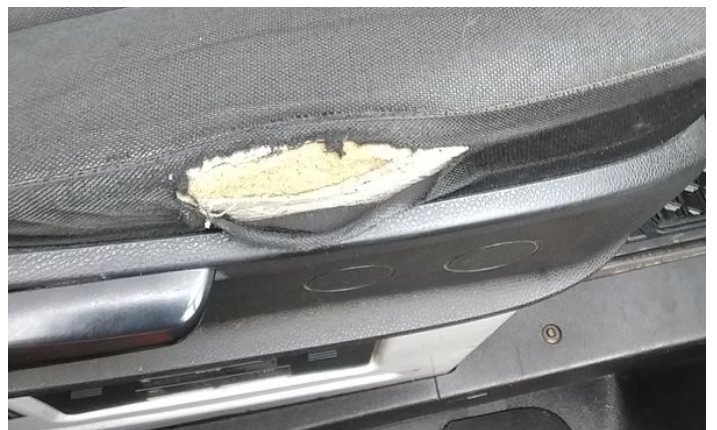
20: Seat Base Cover osf  
Torn  
Over 3mm

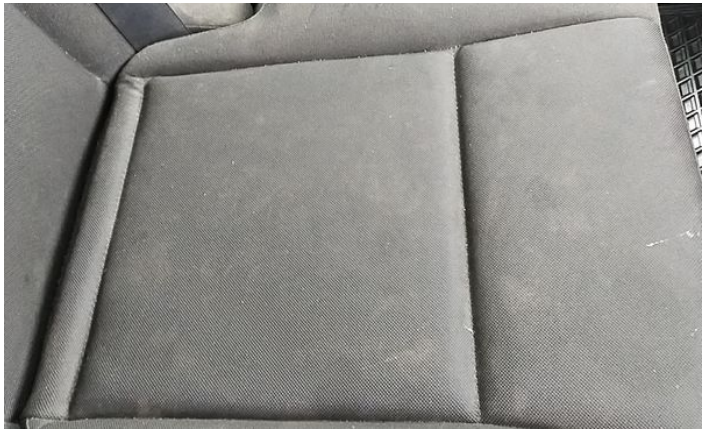
21: Seat Base Cover nsf  
Soiled  
Heavy
