# VEHICLE INSPECTION REPORT

**BU69TNZ**

## Daf LF 230

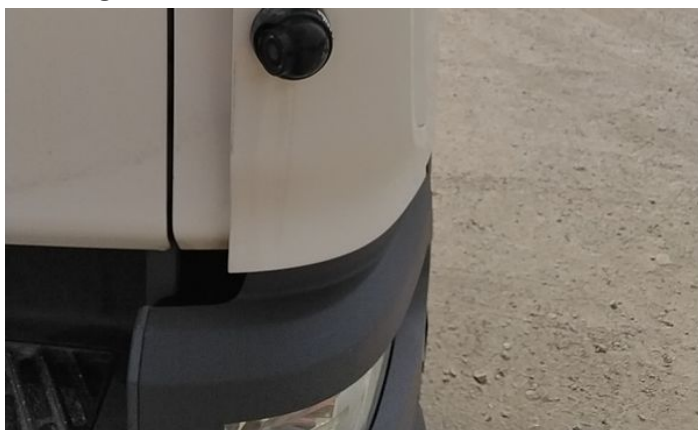
1: Wing osf  
Scratched  
Over 25mm Not Thru Paint

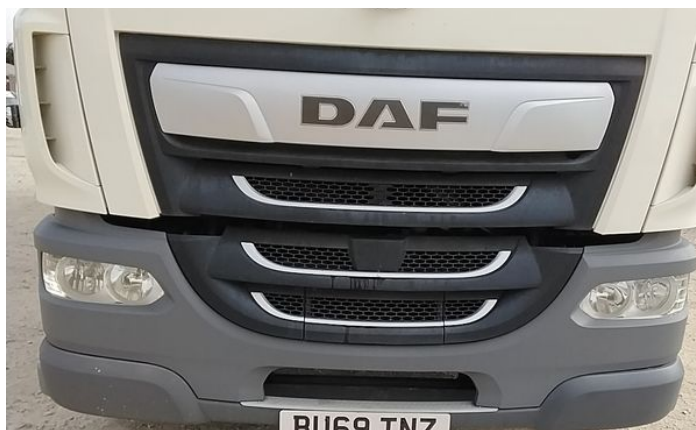
2: Bumper Front  
Chipped  
Multiple Chips

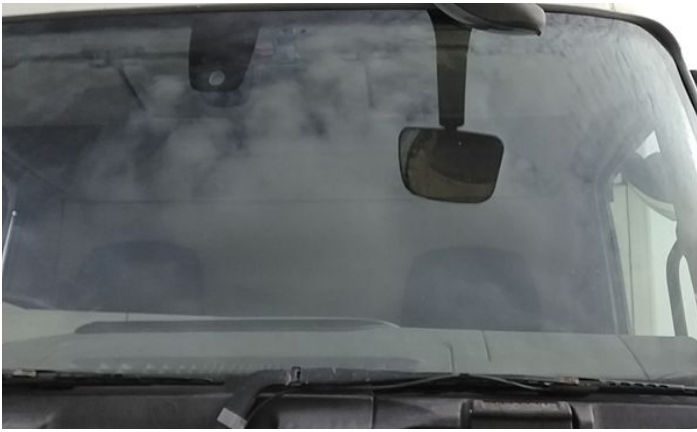
3: Screen Front  
Chipped  
UpTo 10mm

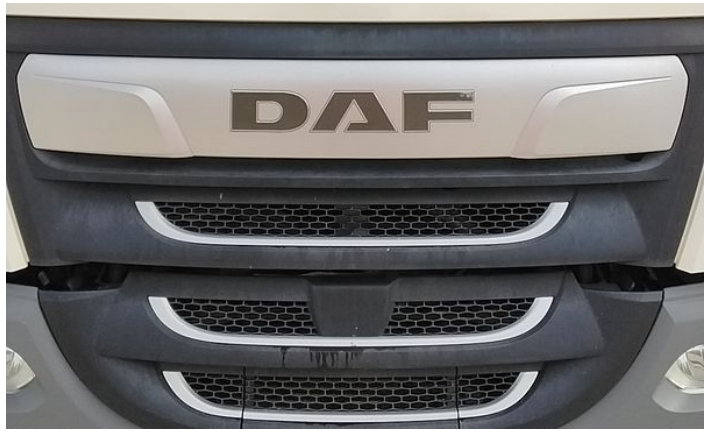
4: Bonnet  
Chipped  
Multiple Chips

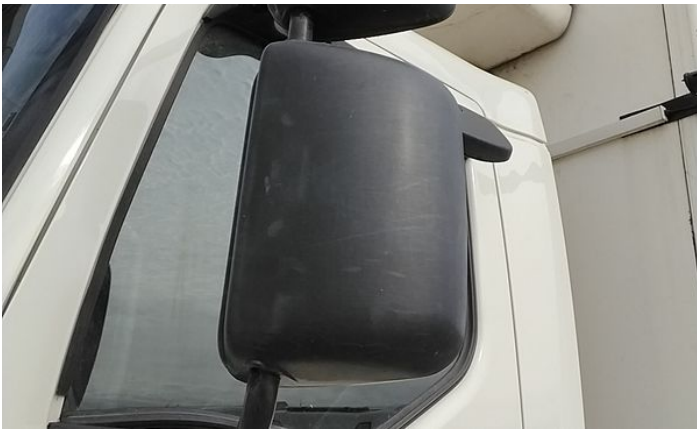
5: Door Mirror Assy nsf  
Scuffed (Unpainted)  
Over 100mm

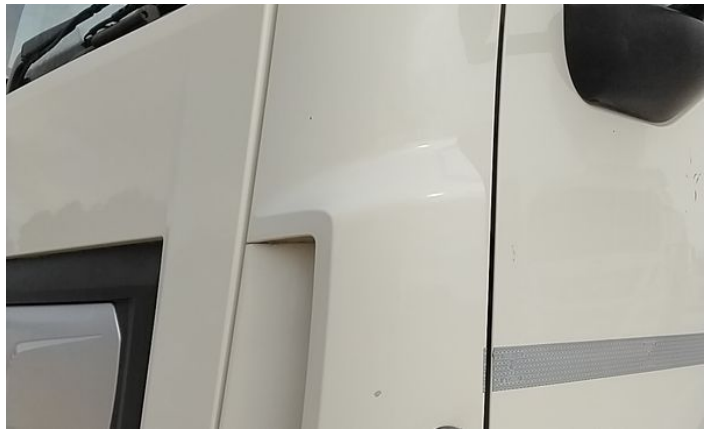
6: Wing nsf  
Chipped  
1 To 5

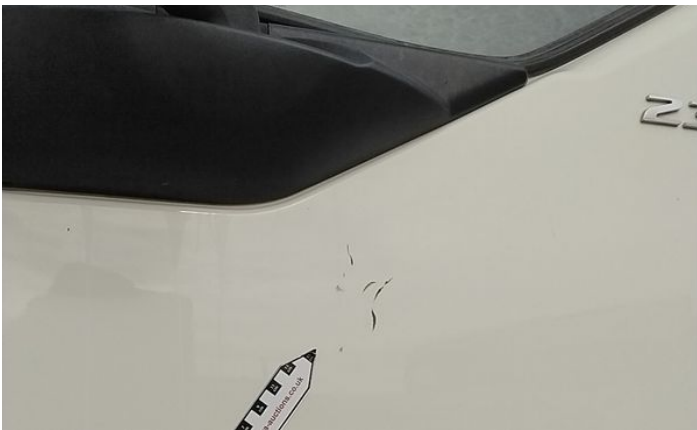
7: Door nsf  
Scratched  
UpTo 25mm Not Thru Paint

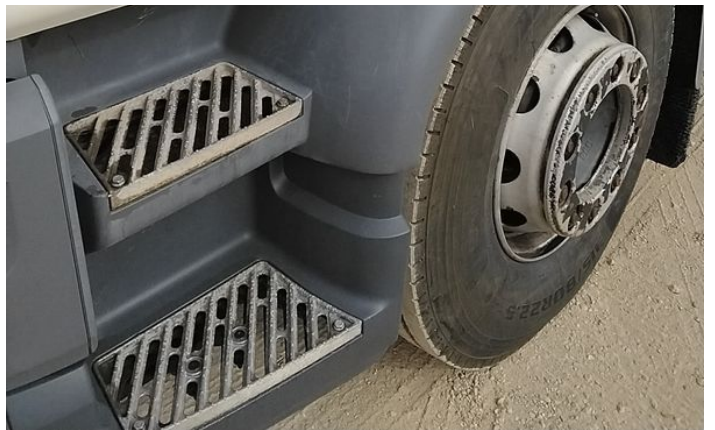
8: Wing Front Arch Extension ns  
Scuffed (Unpainted)  
Over 100mm

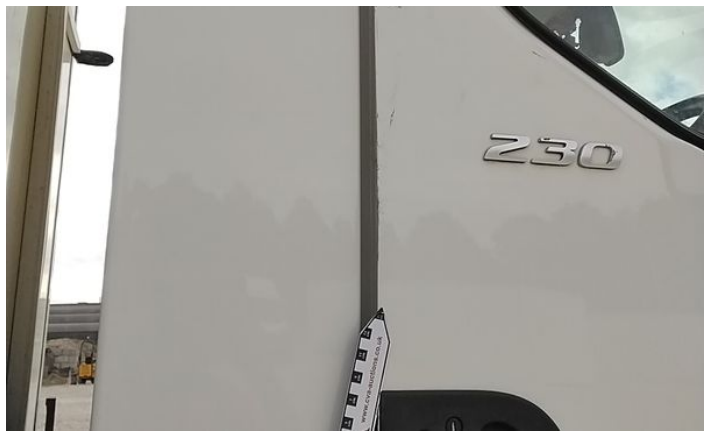
11: Door osf  
Scratched  
Over 25mm Not Thru Paint

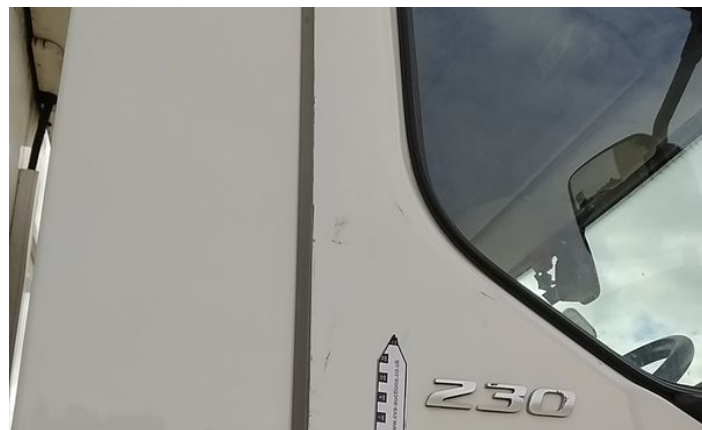
12: Door osf  
Chipped  
Edge Chip
