## VEHICLE INSPECTION REPORT

**WS19AEW**

### Fiat Ducato 35 2.3 MULTIJET II 130PS

#### Inspection

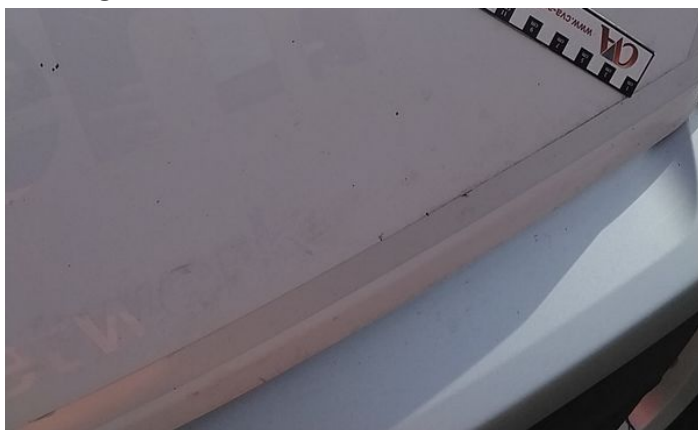
1: Bonnet  
Dented  
With Paint Damage

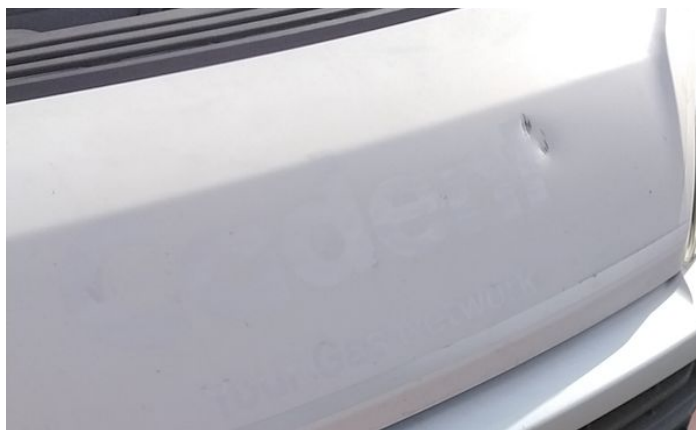
2: Bonnet  
Chipped  
Multiple Chips

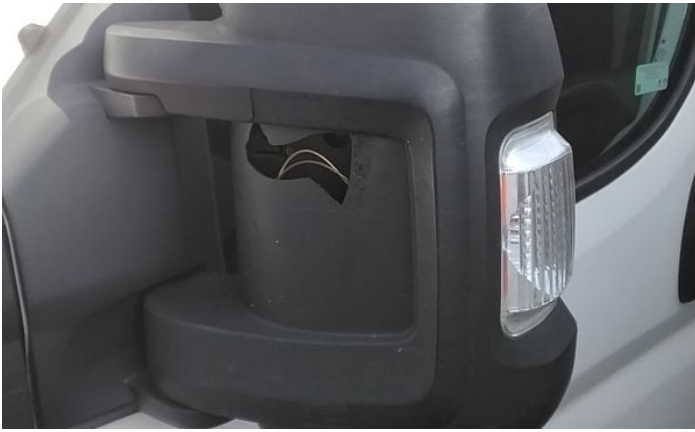
3: Door Mirror Assy nsf  
Broken  
Replace

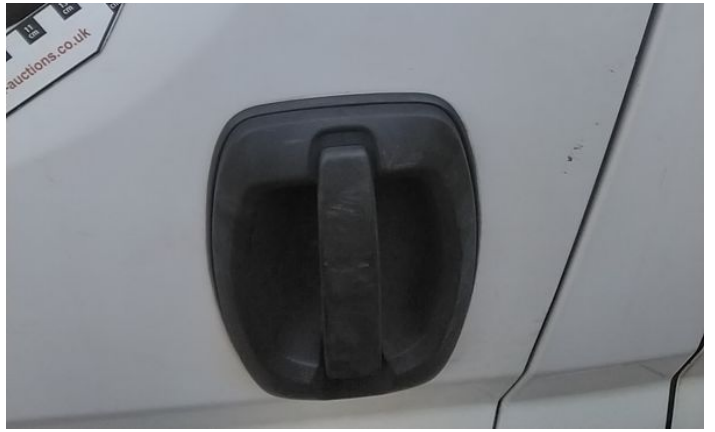
4: Door nsf  
Scratched  
Over 25mm Thru Paint

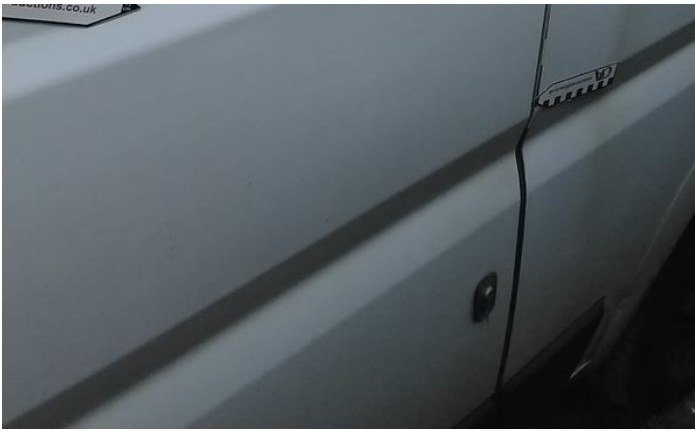
5: Qtr Panel nsr  
Dented  
Over 30mm

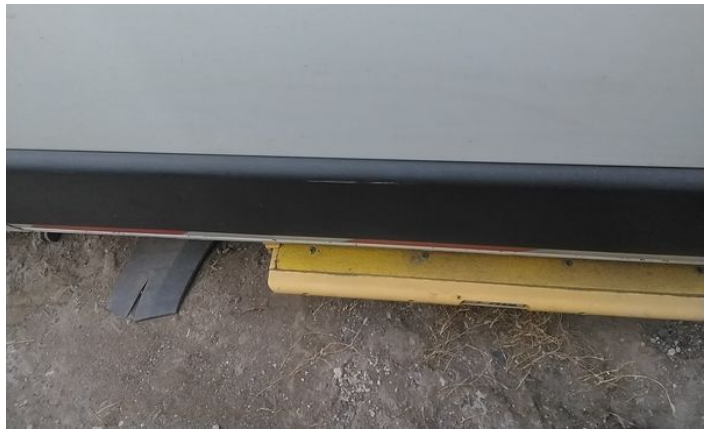
6: Qtr Panel Moulding ns  
Scuffed (Unpainted)  
Over 100mm

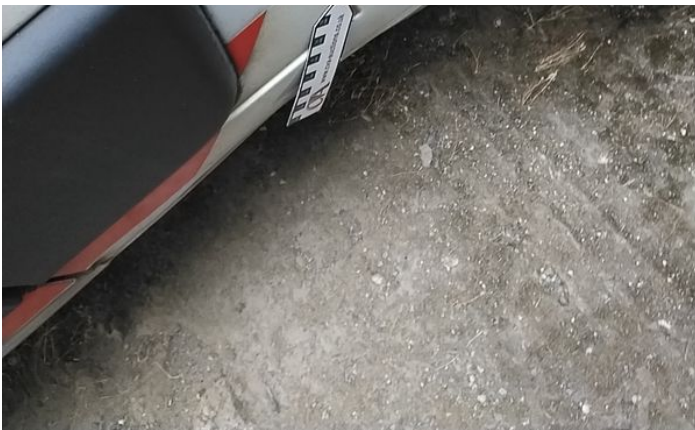
7: Qtr Panel nsr  
Dented  
Over 30mm

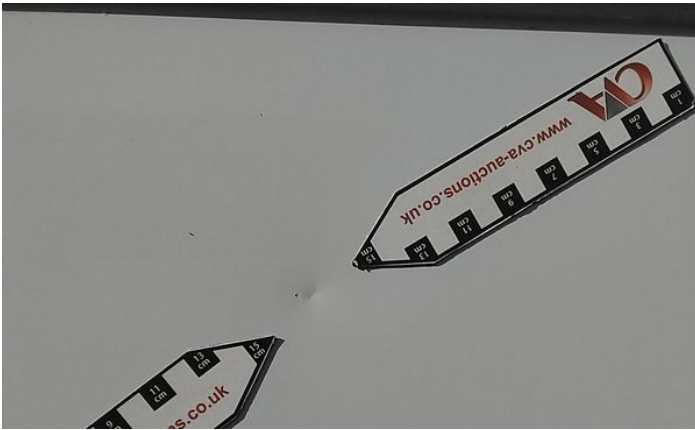
9: Door nsr  
Dented  
Over 30mm

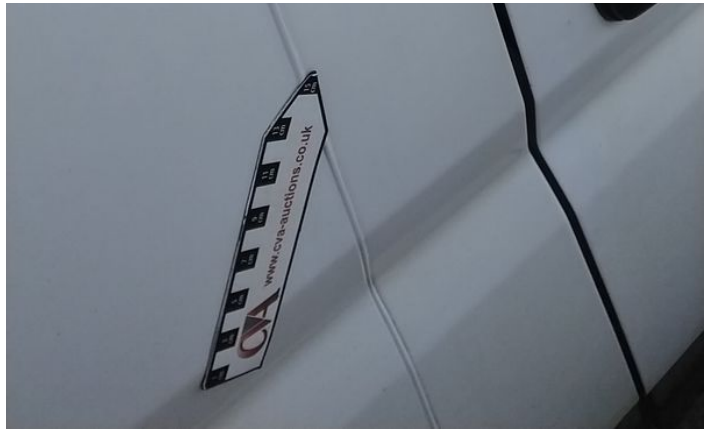
10: Qtr Panel osr  
Dented  
Over 30mm

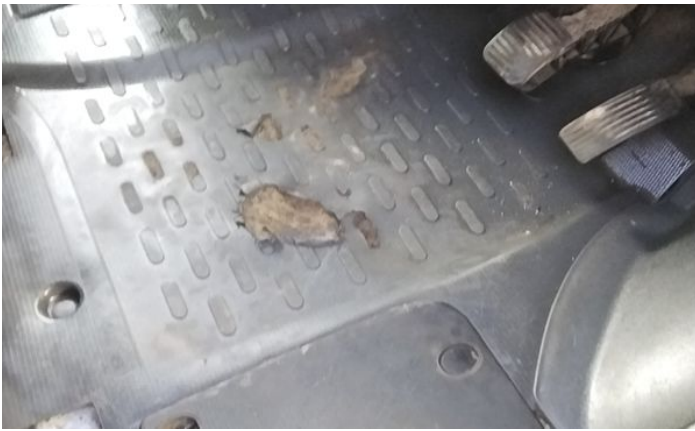
11: Carpets Front  
Holed  
Over 3mm

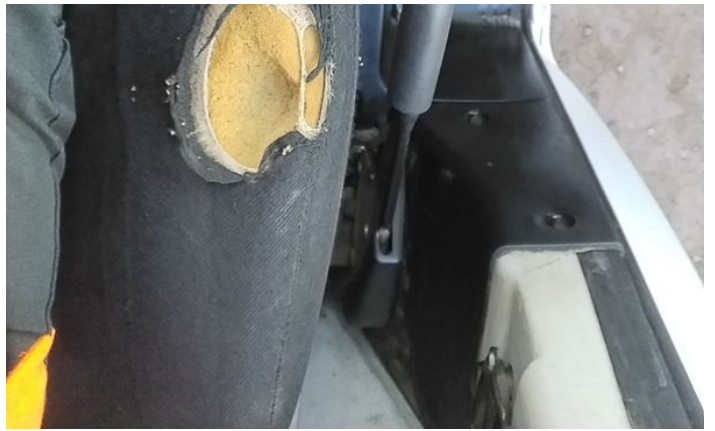
12: Seat Base Cover osf  
Holed  
Over 3mm

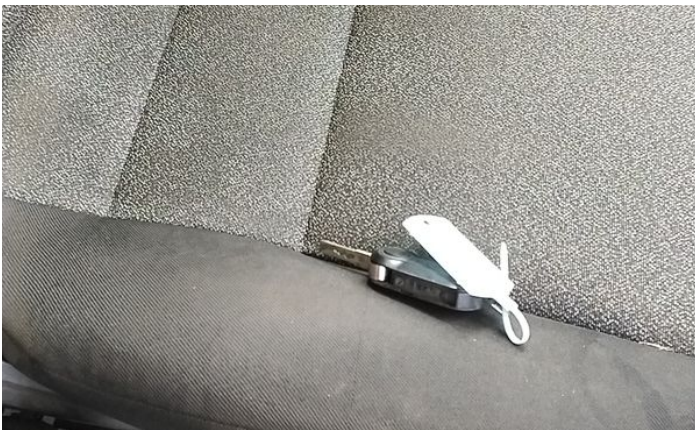
13: Seat Base Cover nsf  
Soiled  
Heavy
