## VEHICLE INSPECTION REPORT

**YC70BVU**

### Ford Transit 350 2.0 EcoBlue 130ps

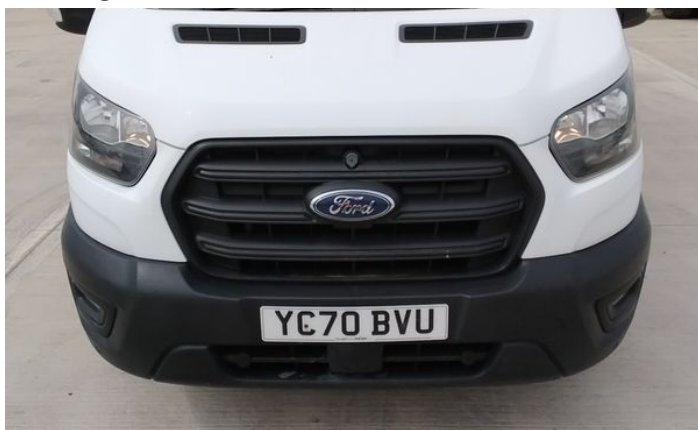
1: Bonnet  
Chipped  
Multiple Chips

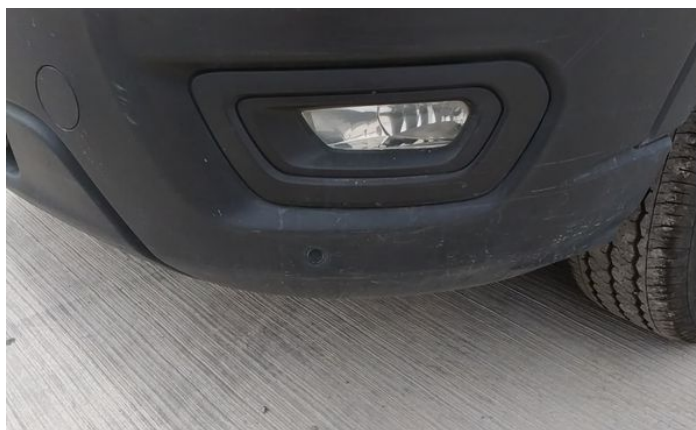
2: Bumper Front  
Scratched  
Over 100mm Thru Paint

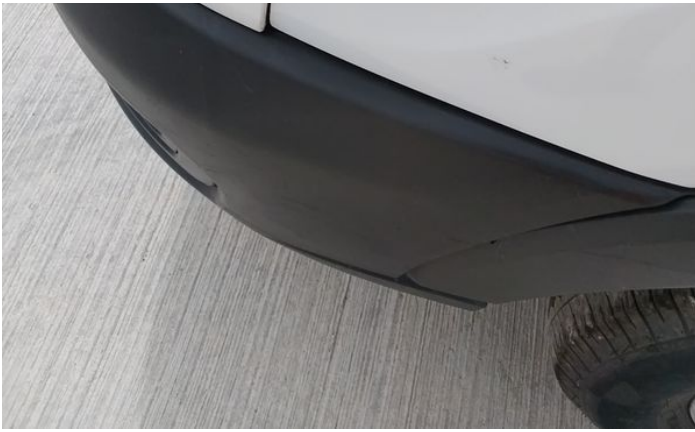
3: Wing nsf  
Dented  
Over 30mm

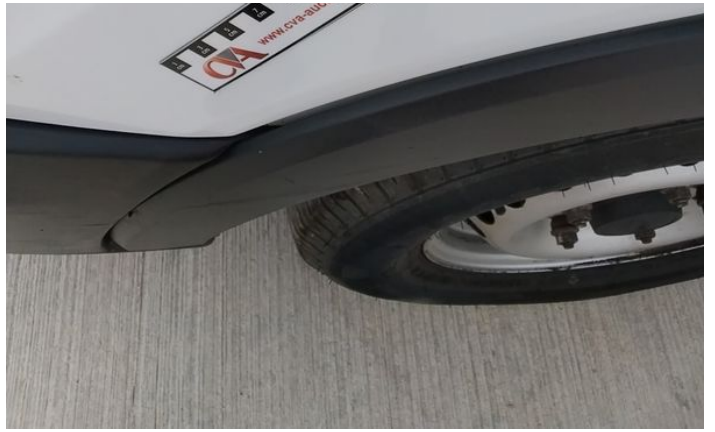
4: Wing nsf  
Scratched  
Over 25mm Thru Paint

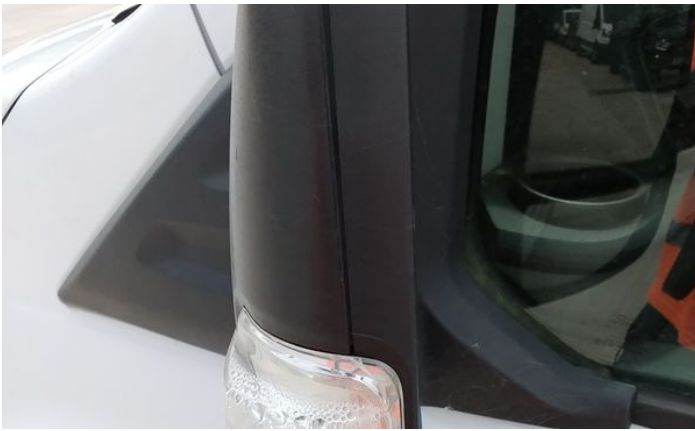
5: Door Mirror Assy nsf  
Broken  
Replace

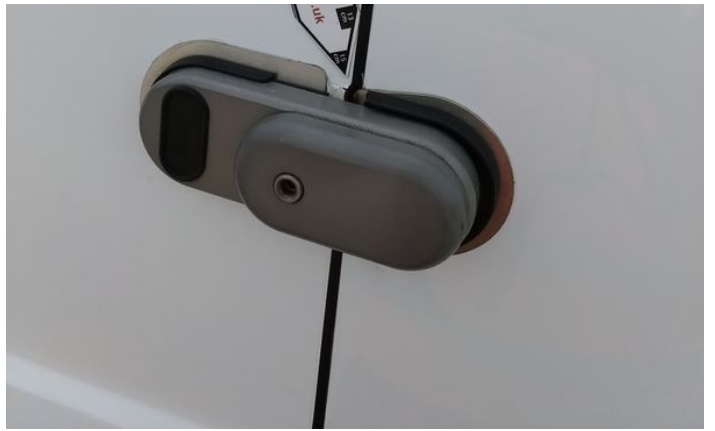
6: Qtr Panel nsr  
Dented  
With Paint Damage

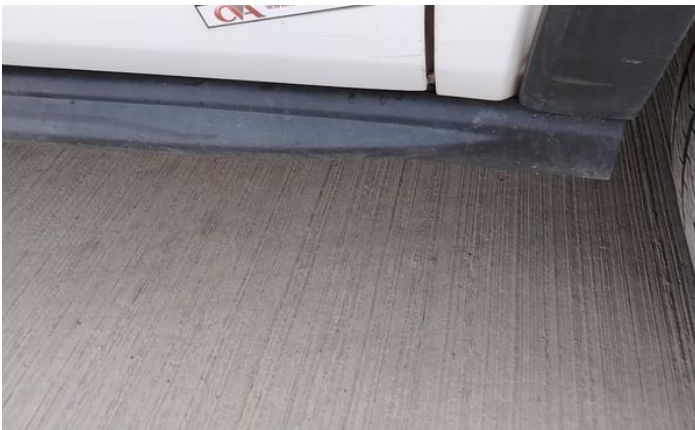
7: Qtr Panel nsr  
Scratched  
Rusted

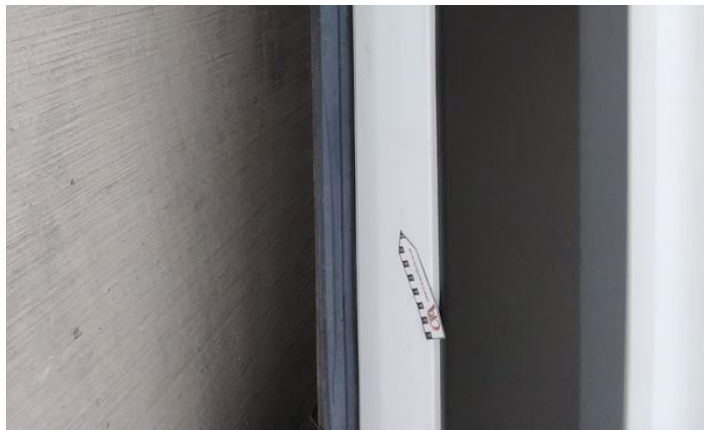
8: Qtr Panel nsr  
Scratched  
Over 25mm Not Thru Paint

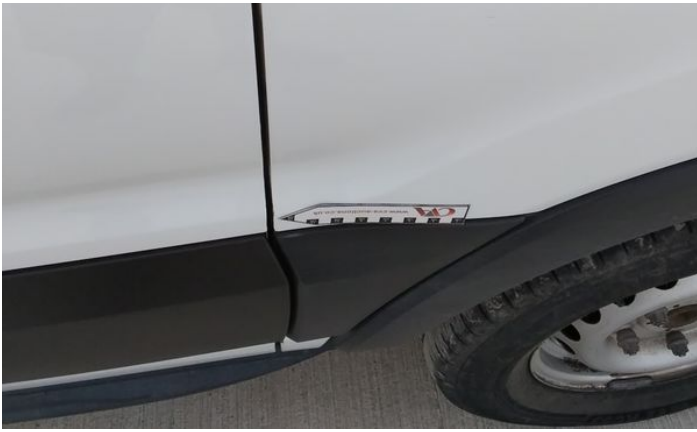
9: Qtr Panel nsr  
Scratched  
Over 25mm Thru Paint

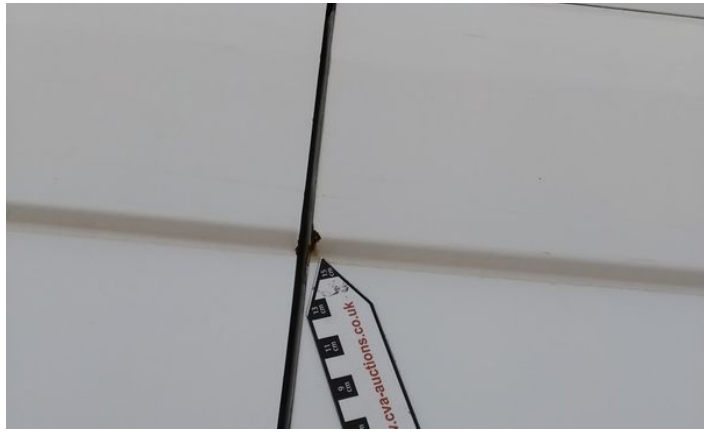
10: Qtr Panel nsr  
Scratched  
Rusted

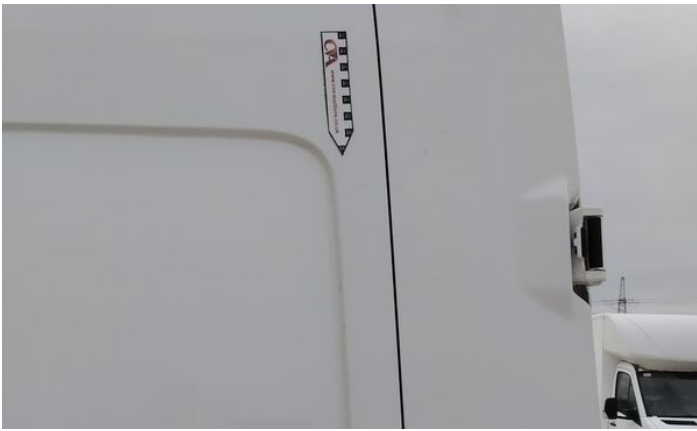
11: Qtr Panel nsr  
Scratched  
Over 25mm Not Thru Paint

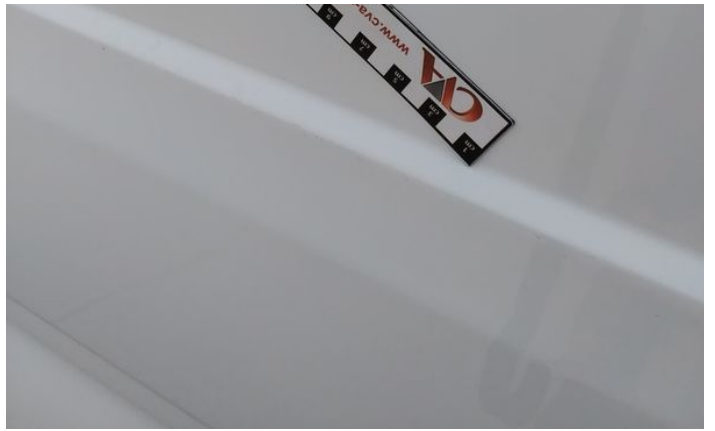
12: Qtr Panel nsr  
Dented  
Between 10mm + 30mm

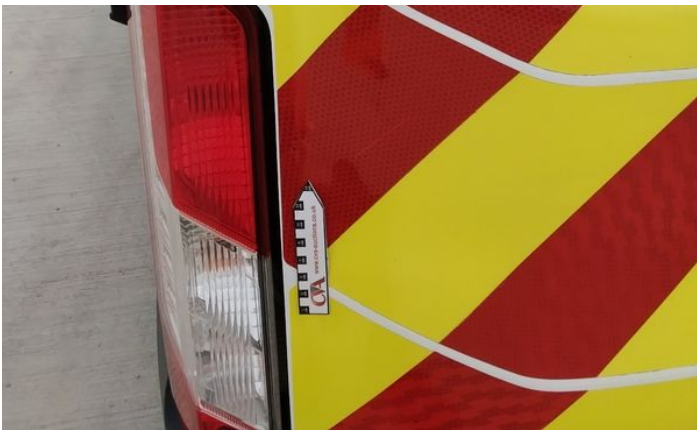
13: Door nsr  
Dented  
Over 30mm

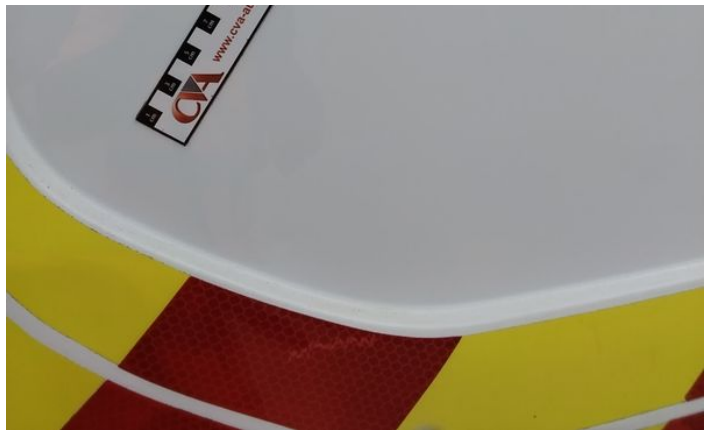
14: Door nsr  
Dented  
Over 30mm

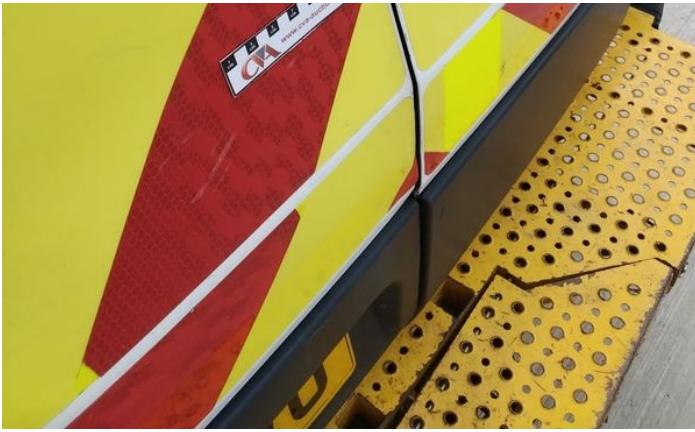
15: Door nsr  
Dented  
Over 30mm

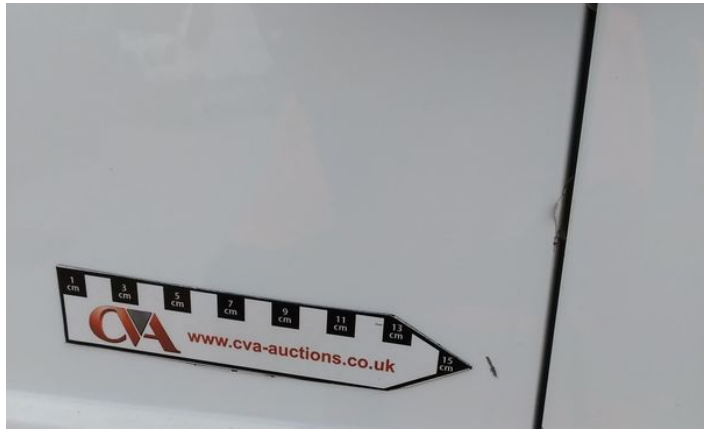
16: Door nsr  
Scratched  
Over 25mm Thru Paint

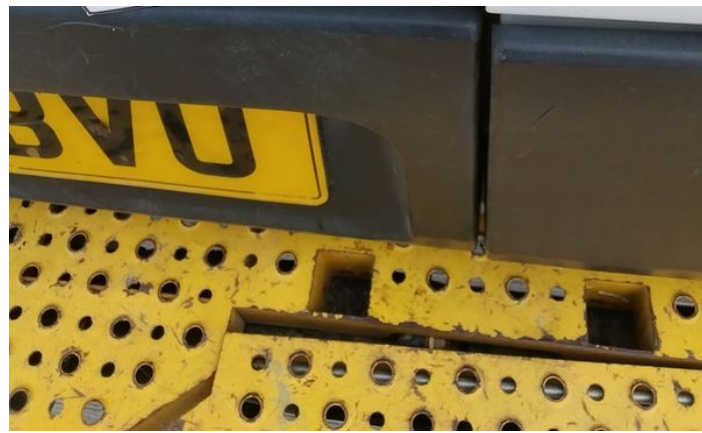
17: Door nsr  
Dented  
With Paint Damage

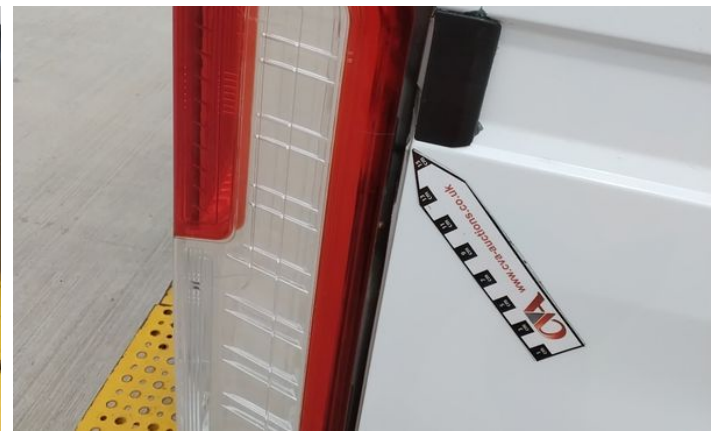
18: Lamp osr  
Broken  
Replace

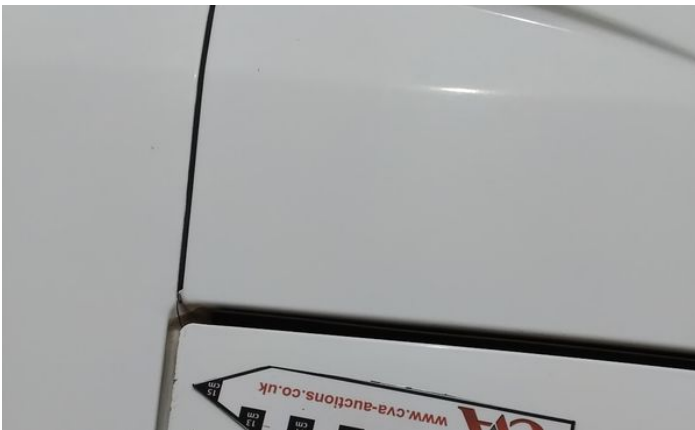
19: Door osf  
Chipped  
Multiple Chips

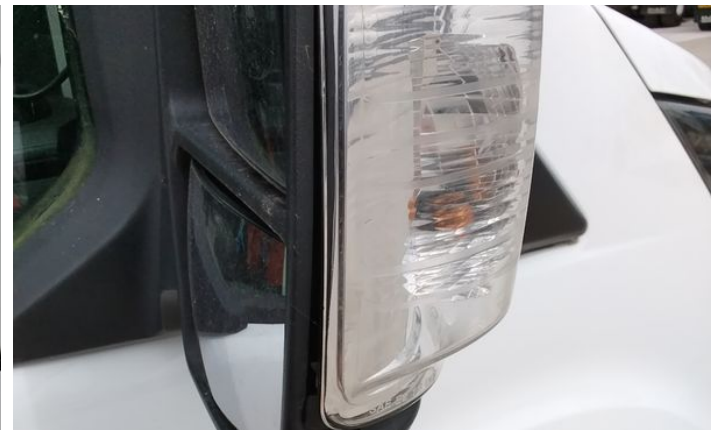
20: Door Mirror Assy osf  
Broken  
Replace

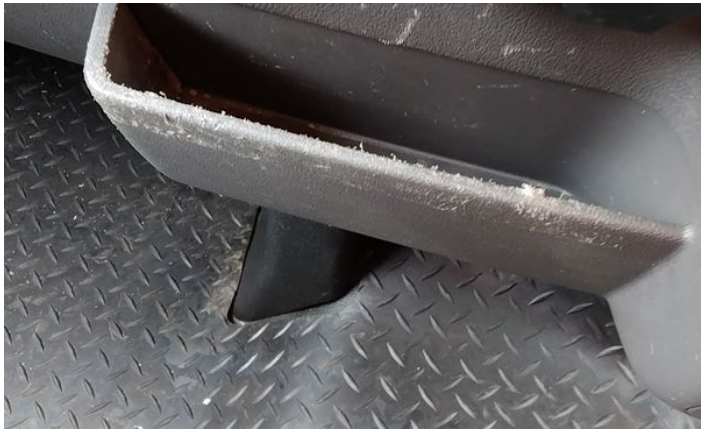
21: Centre Console Front  
 Scuffed  
 Over 25mm
