# VEHICLE INSPECTION REPORT

**BU69TRX**

## Daf LF 230

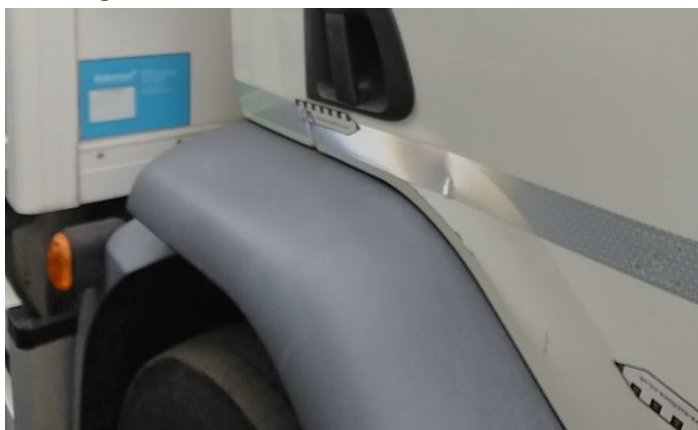
1: Door osf  
Dented  
Over 30% Of Panel

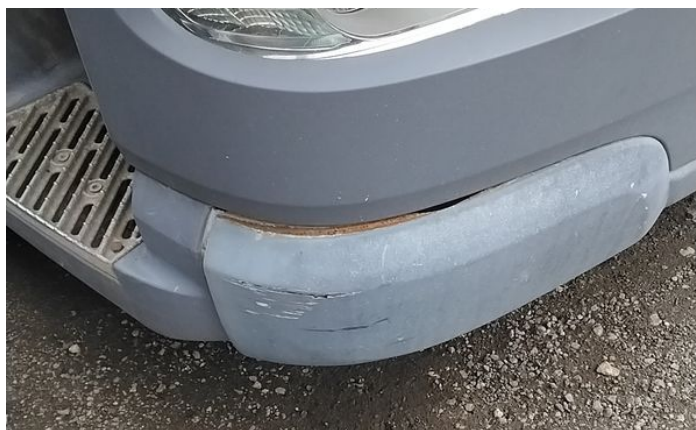
2: Bumper Front  
Scratched  
Over 100mm Thru Paint

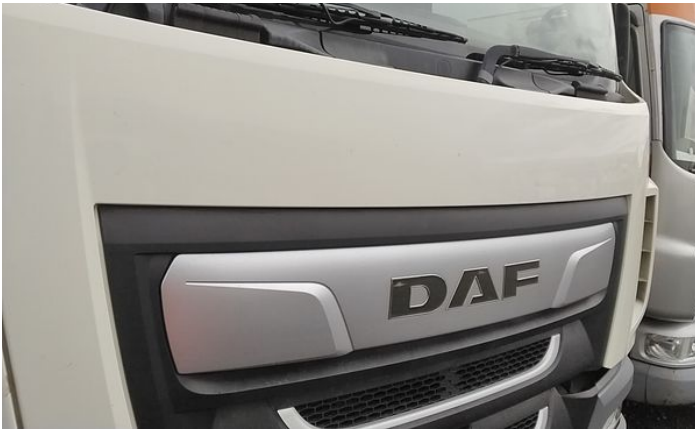
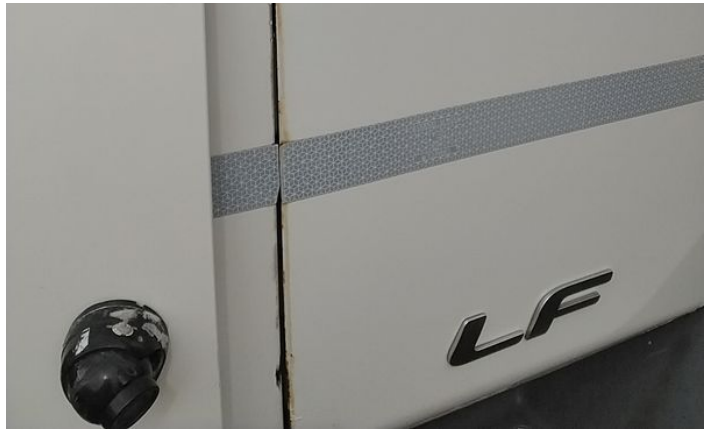
3: Bonnet  
Chipped  
Multiple Chips

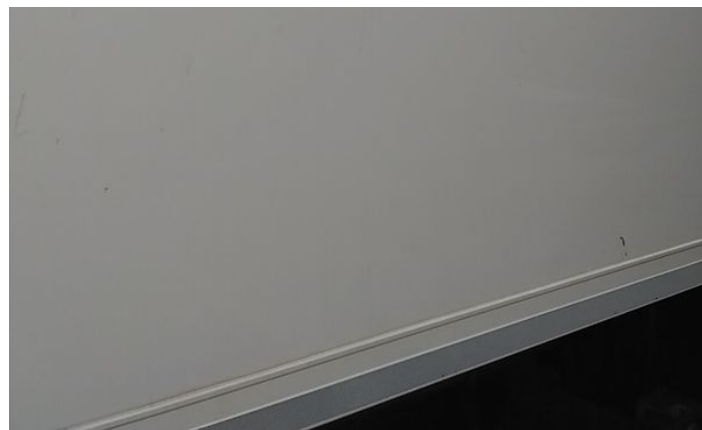
6: Qtr Panel nsr  
Dented  
With Paint Damage

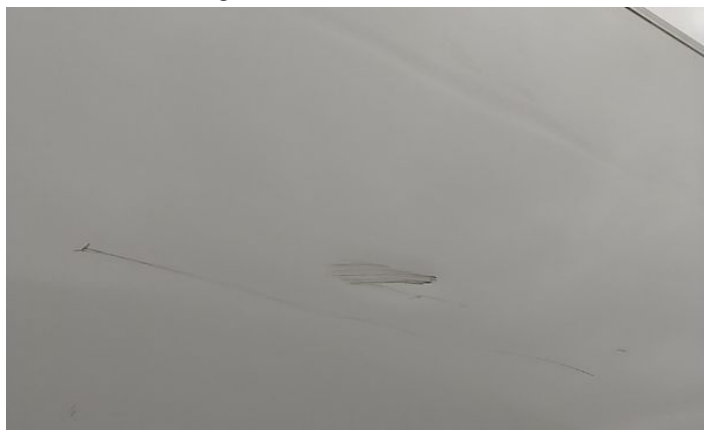
7: Qtr Panel osr  
Scratched  
Over 25mm Thru Paint

8: Qtr Panel osr  
Scratched  
Over 25mm Thru Paint

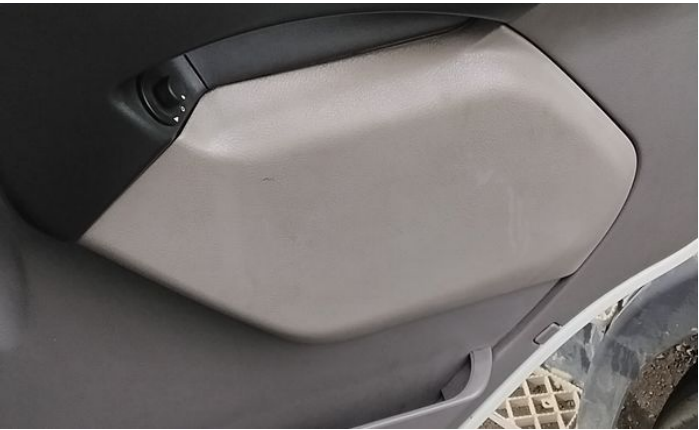
9: Qtr Panel osr  
 Scratched  
 Over 25mm Thru Paint

10: Door Pad osf  
 Soiled  
 Heavy

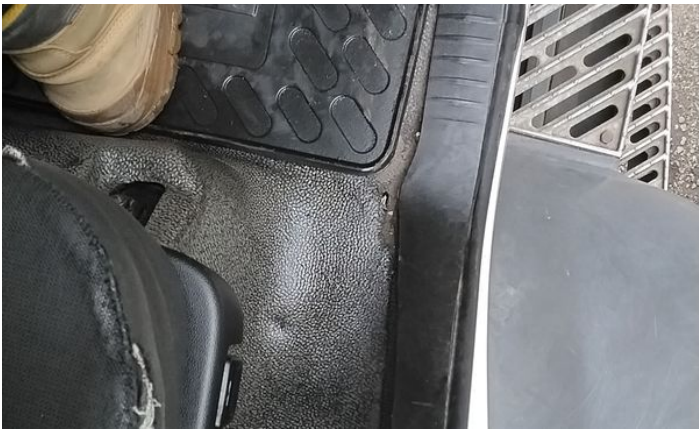
11: Seat Base Cover osf  
 Torn  
 Over 3mm
