## VEHICLE INSPECTION REPORT

**LF16RSX**

### Ford Transit Custom 310 2.2 TDCi 100ps EConetic

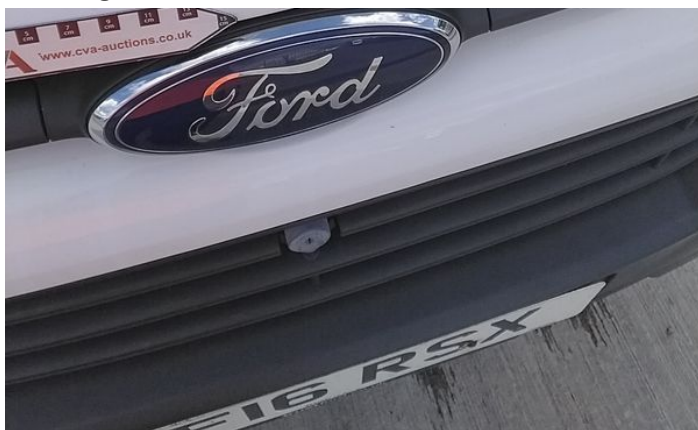
1: Bonnet  
Dented  
With Paint Damage

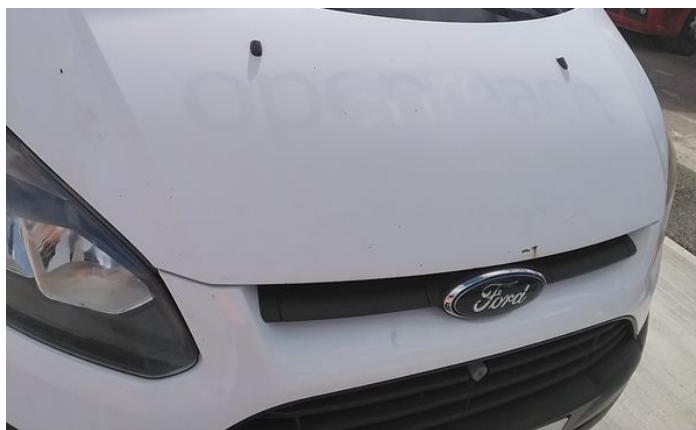
2: Bonnet  
Chipped  
Multiple Chips

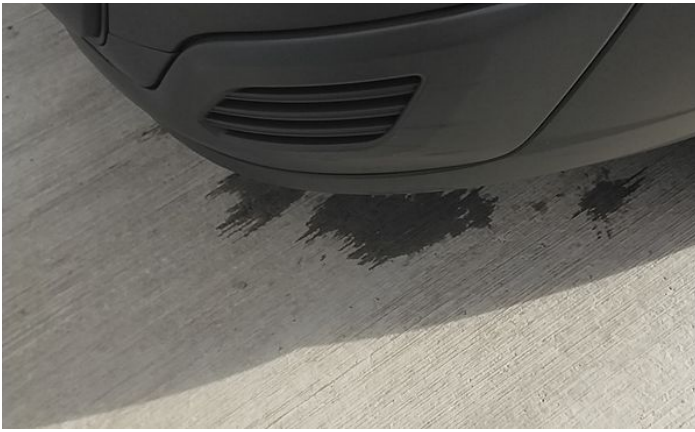
3: Bumper Front Moulding  
Scuffed (Unpainted)  
Over 100mm

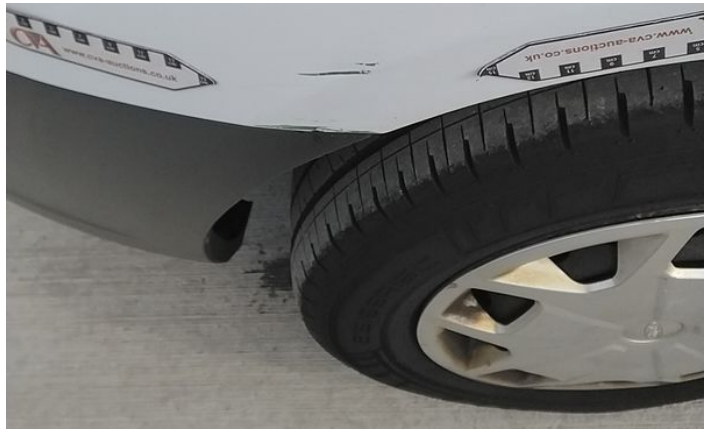
4: Wing nsf  
Dented  
With Paint Damage

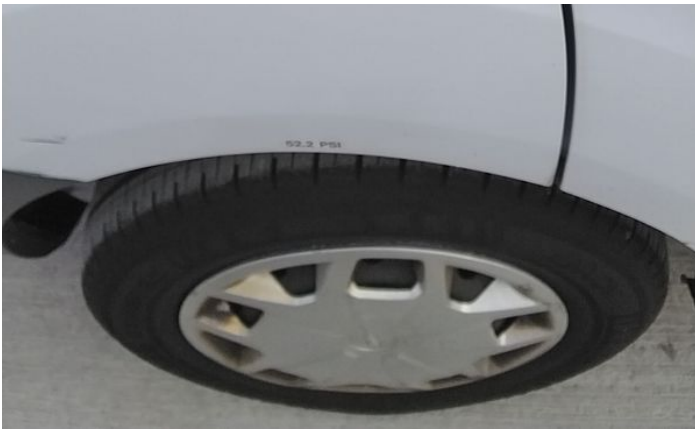
5: Wing nsf  
Scratched  
Over 25mm Not Thru Paint

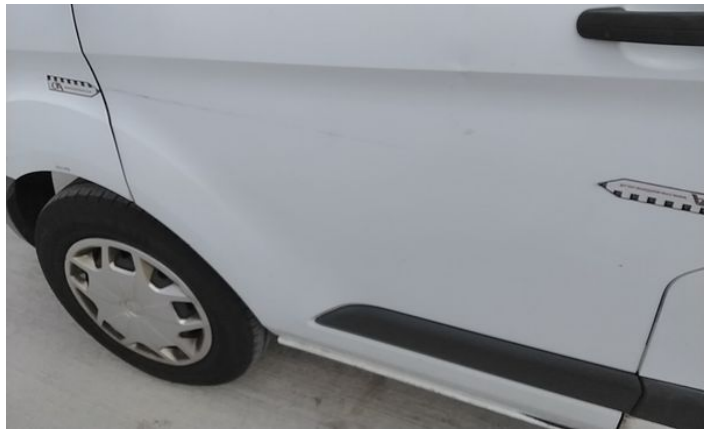
6: Door nsf  
Scratched  
Over 25mm Thru Paint

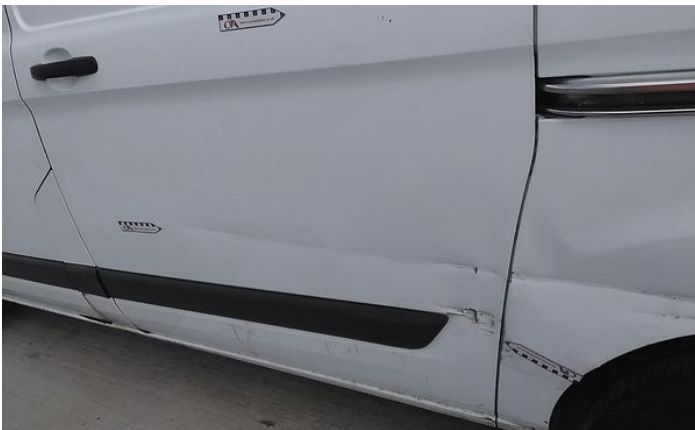
7: Qtr Panel nsr  
Dented  
With Paint Damage

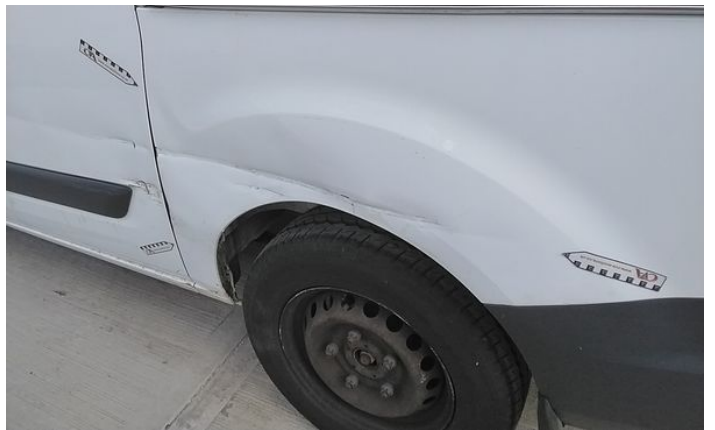
8: Qtr Panel nsr  
Dented  
With Paint Damage

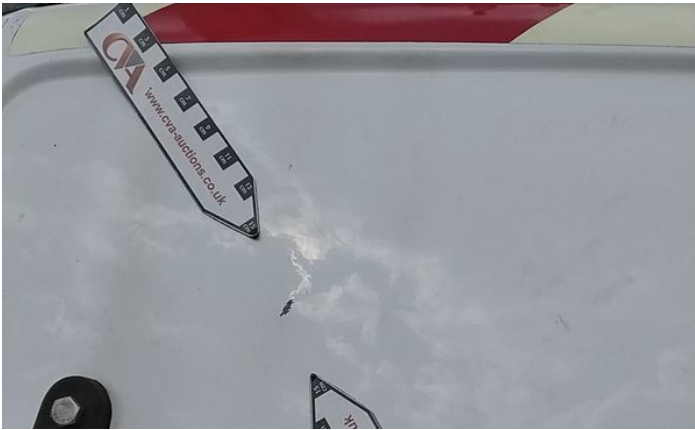
9: Door nsr  
Dented  
With Paint Damage

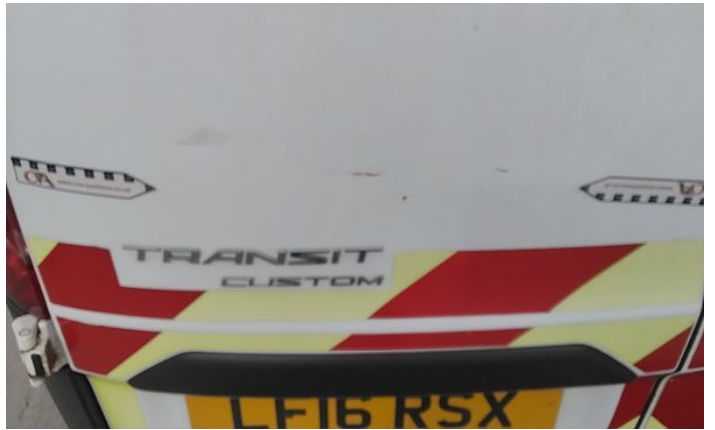
10: Door nsr  
Scratched  
Over 25mm Thru Paint

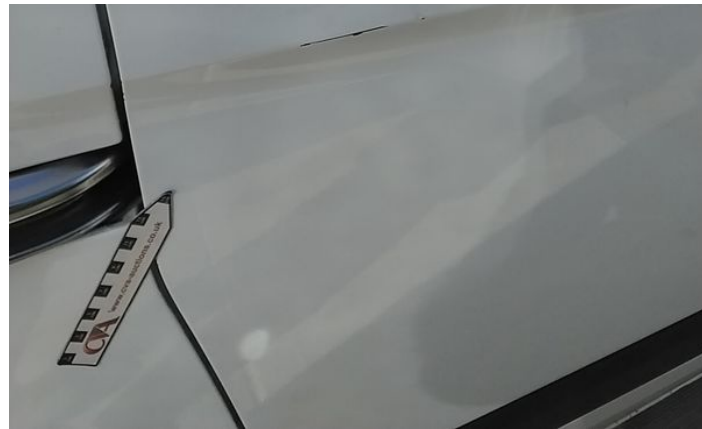
11: Qtr Panel osr  
Dented  
With Paint Damage

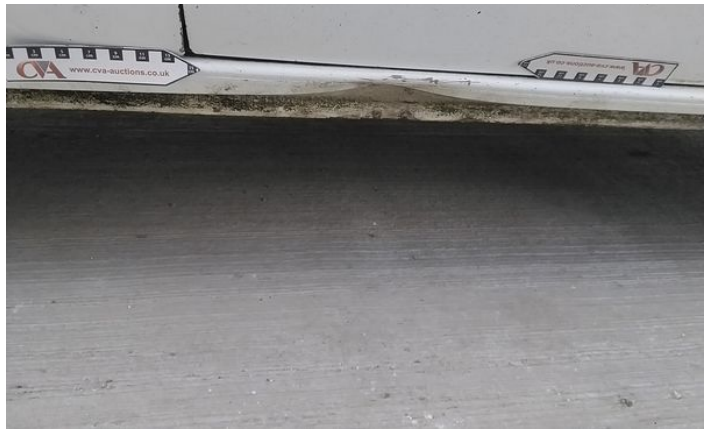
12: Sill os  
Dented  
With Paint Damage

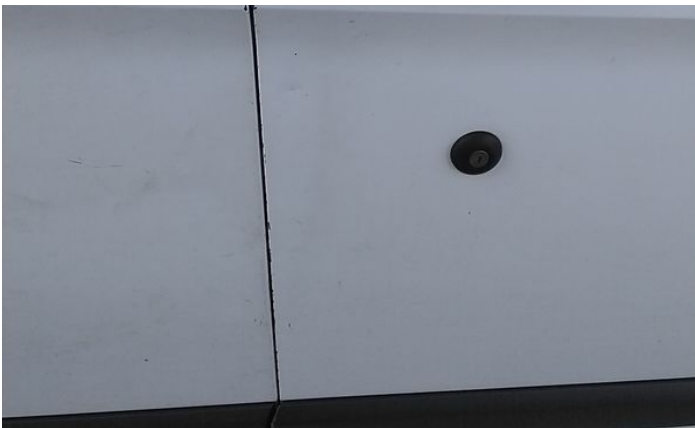
13: Door osf  
Chipped  
Multiple Chips

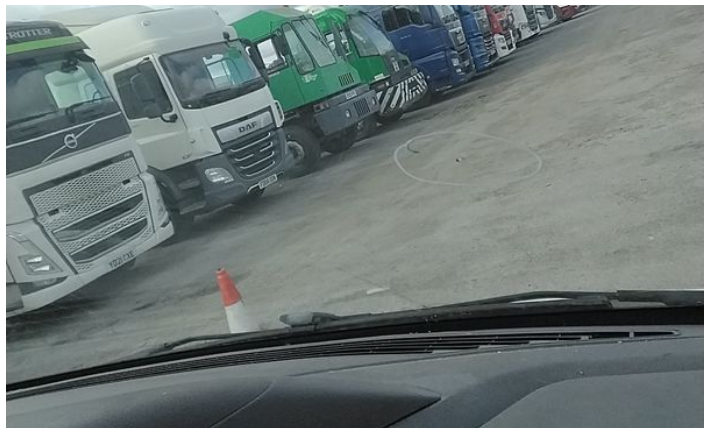
14: Screen Front  
Chipped  
Over 10mm

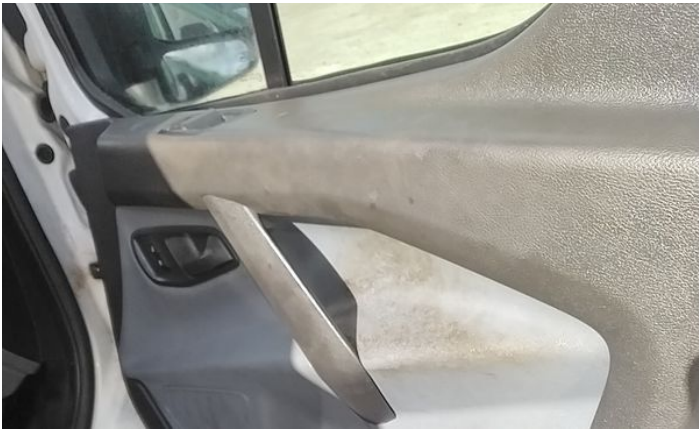
15: Door Pad osf  
Soiled  
Heavy

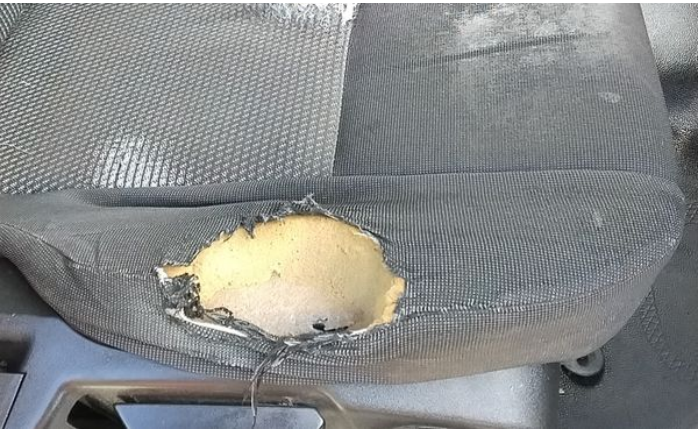
16: Seat Base Cover osf  
Holed  
Over 3mm

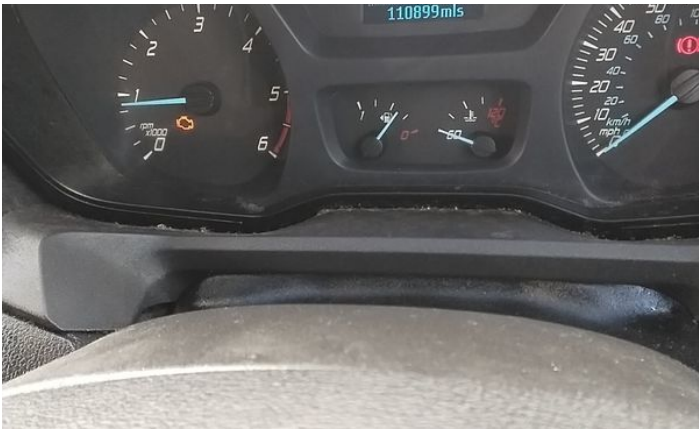
17: Dash Warning Lights  
Displayed  
No Action

| EML light illuminated | | Fault | DPF light illuminated | | OK |
