# VEHICLE INSPECTION REPORT

**EF17XJW**

## Scania P 360

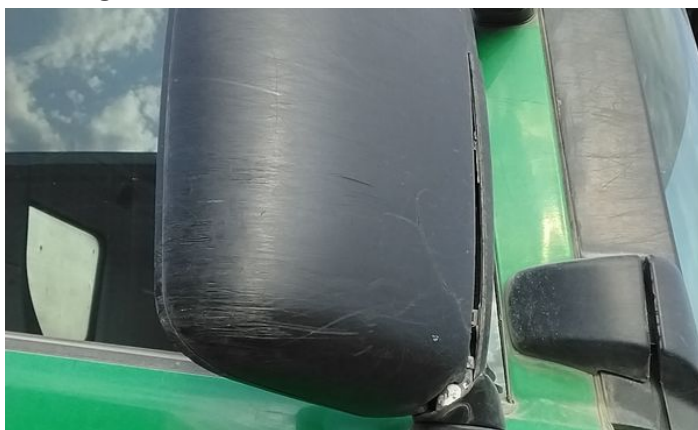
1: Door Mirror Assy osf  
Broken  
Replace

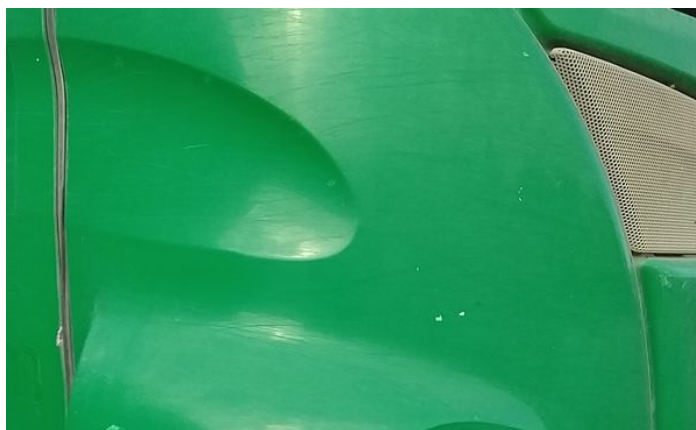
2: Panel Front  
Scratched  
Over 25mm Thru Paint

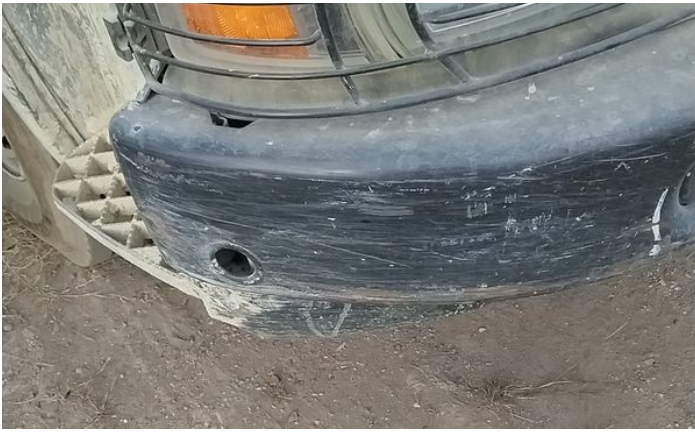
3: Bumper Front  
Scratched  
Over 100mm Thru Paint

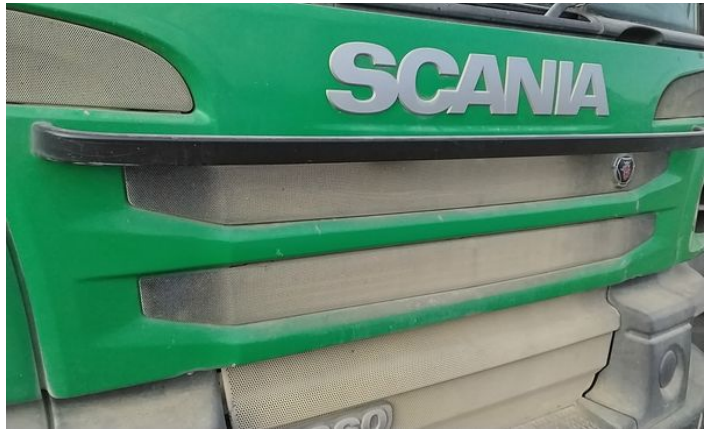
4: Bonnet  
Chipped  
Multiple Chips

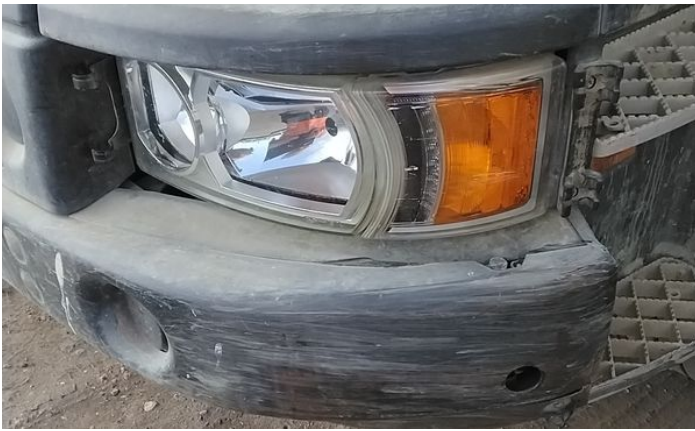
5: Bumper Front  
Scratched  
Over 100mm Thru Paint

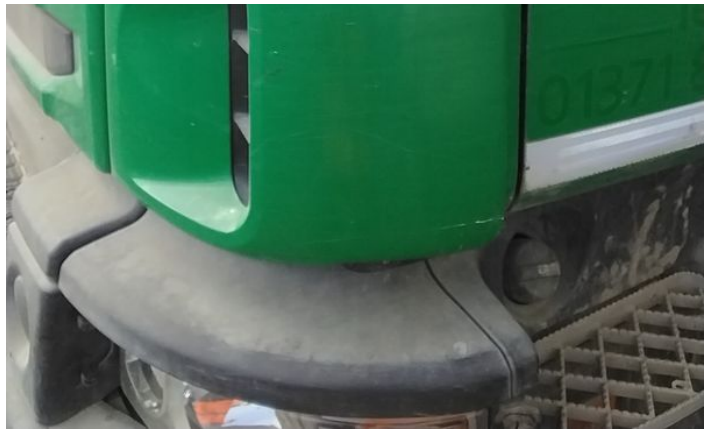
6: Panel Front  
Scratched  
Over 25mm Thru Paint

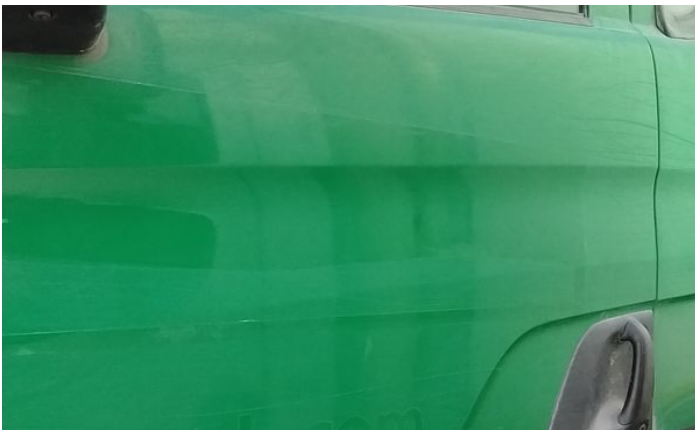
7: Door nsf  
Scratched  
Over 25mm Thru Paint

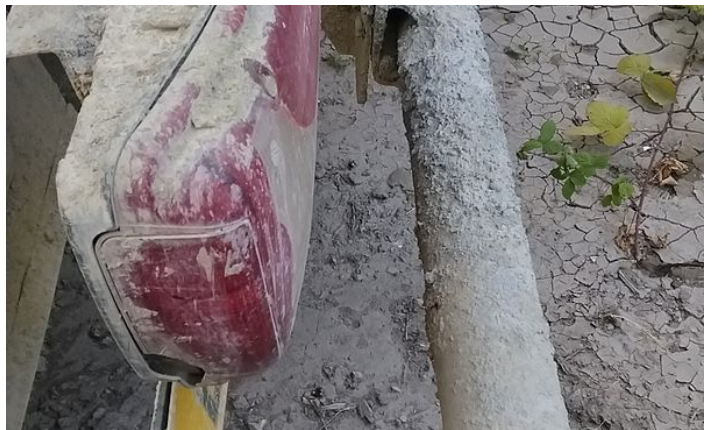
8: Lamp nsr  
Broken  
Replace

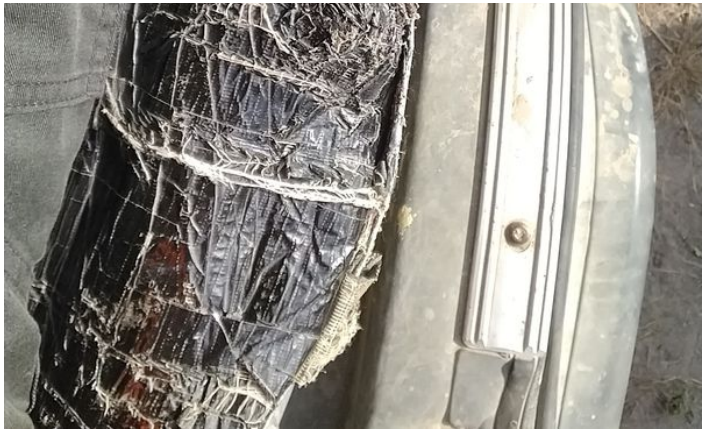
9: Seat Base Cover osf  
Holed  
Over 3mm
