# VEHICLE INSPECTION REPORT

**EG19AEG**

## Daf XF 530

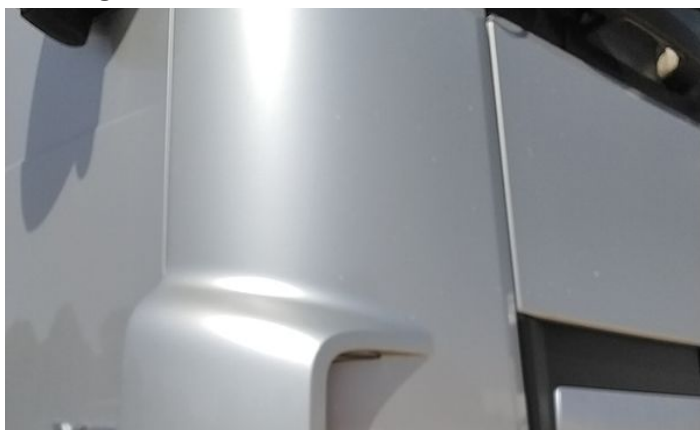
1: Wing of  
Chipped  
Multiple Chips

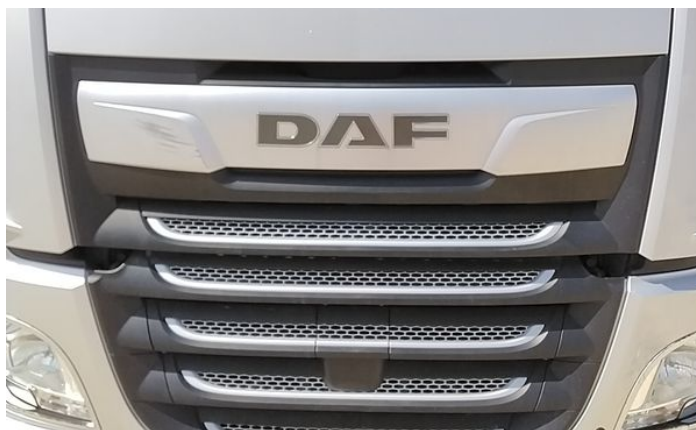
2: Bonnet  
Chipped  
Multiple Chips

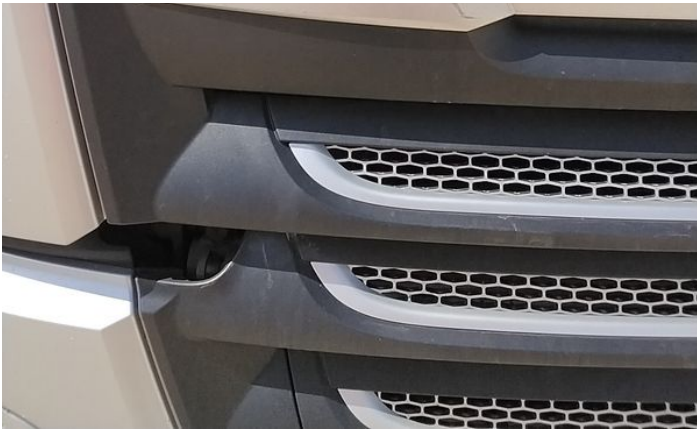
3: Bonnet  
Scratched  
Over 25mm Thru Paint

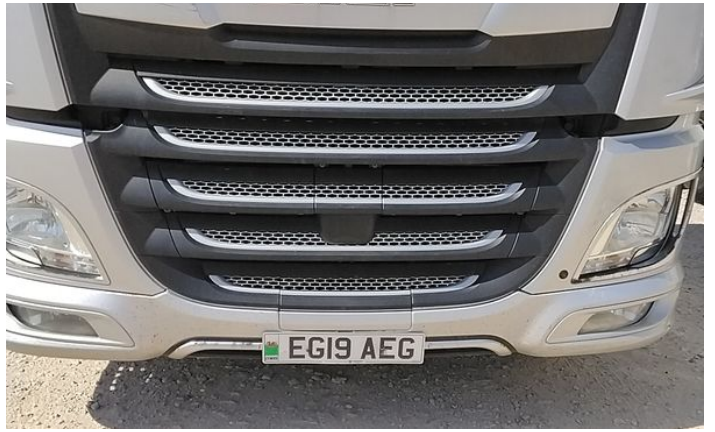
4: Bumper Front  
Chipped  
Multiple Chips

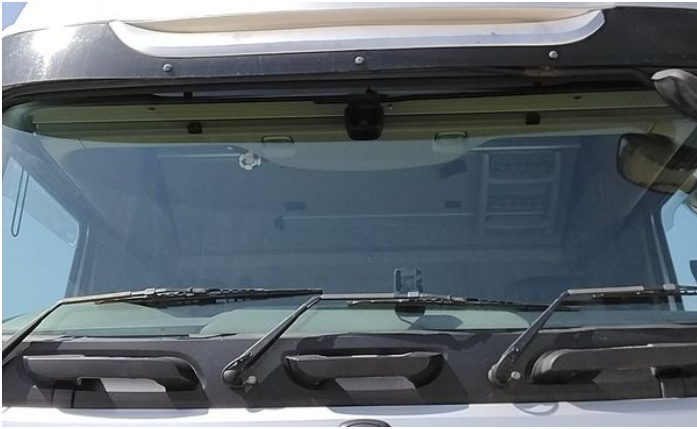
5: Screen Front  
Chipped  
UpTo 10mm

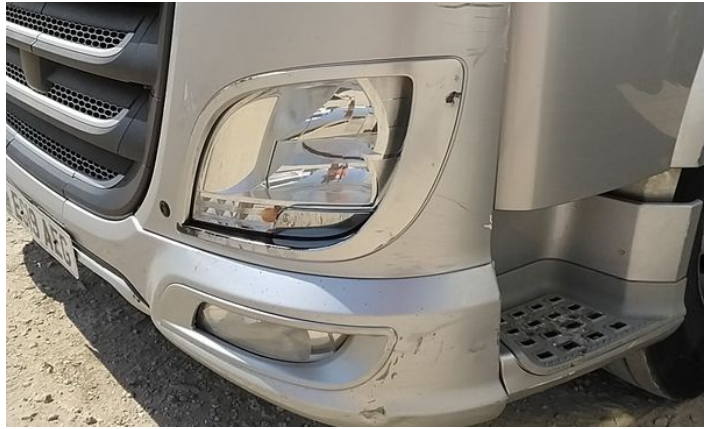
6: Bumper Front  
Dented  
With Paint Damage

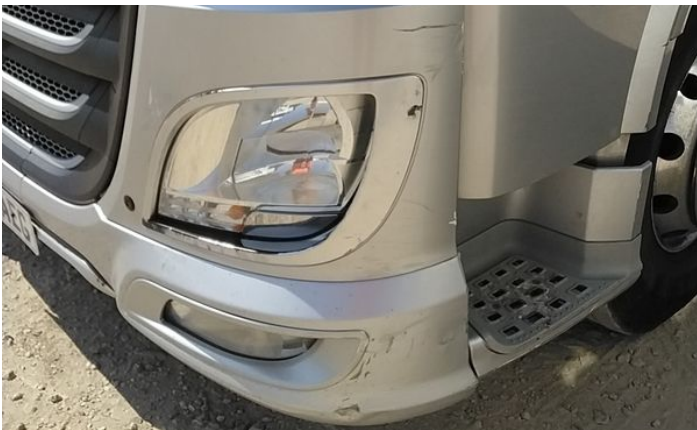
7: Fog Lamp Surround ns  
Scratched (Painted)  
Over 25mm Thru Paint

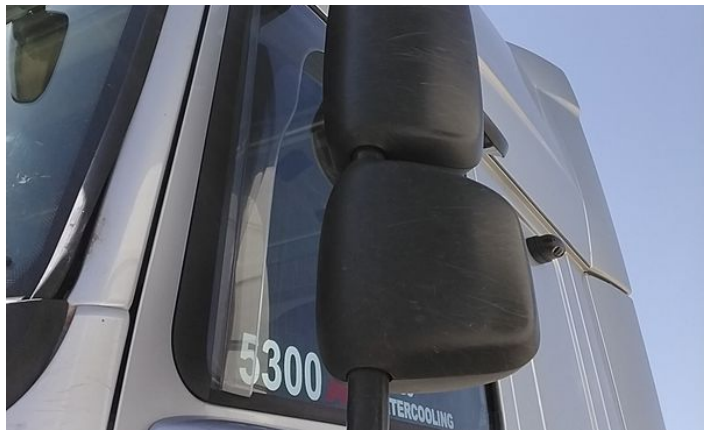
8: Door Mirror Assy nsf  
Scuffed (Unpainted)  
Over 100mm

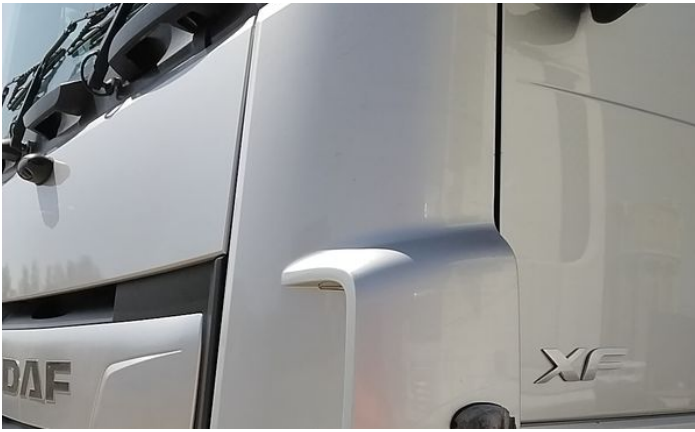
9: Wing nsf  
Scratched  
Over 25mm Not Thru Paint

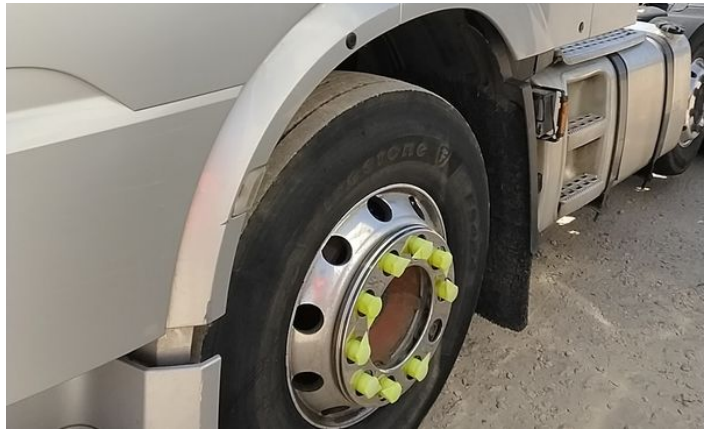
10: Wing Front Arch Extension ns  
Scratched (Painted)  
Over 25mm Thru Paint

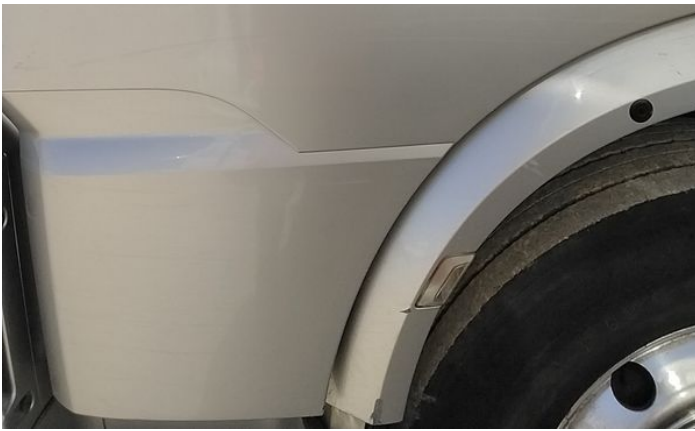
11: Door nsf  
Scratched  
Over 25mm Not Thru Paint

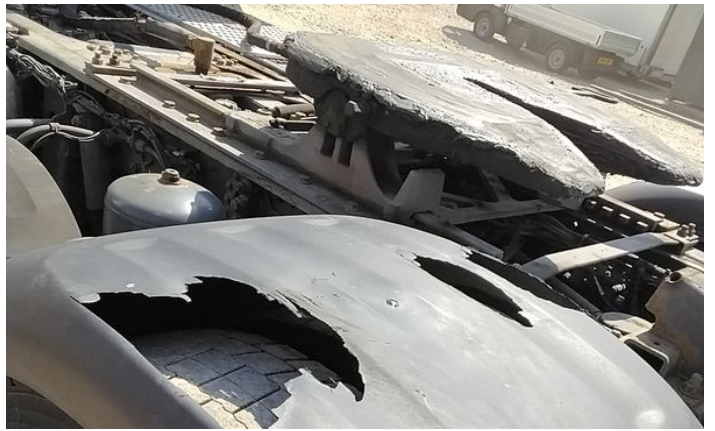
12: Qtr Panel Arch Extension ns  
Broken  
Replace

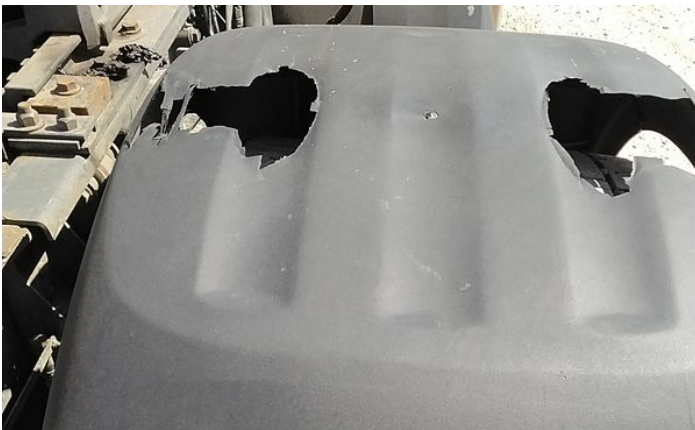
13: Qtr Panel Arch Extension os  
Broken  
Replace

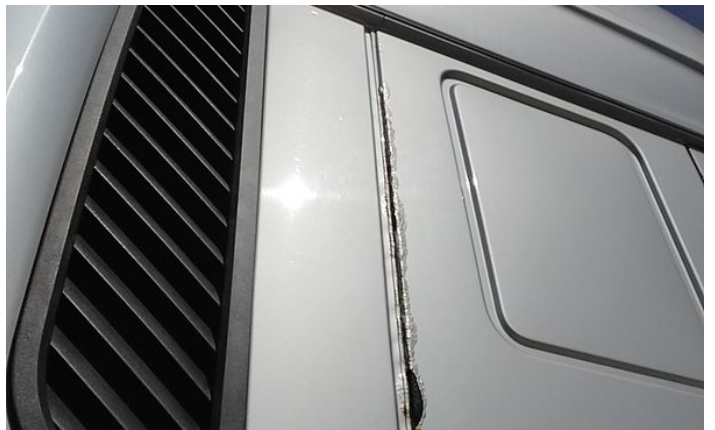
14: Qtr Panel osr  
Rusted  
Over 5mm

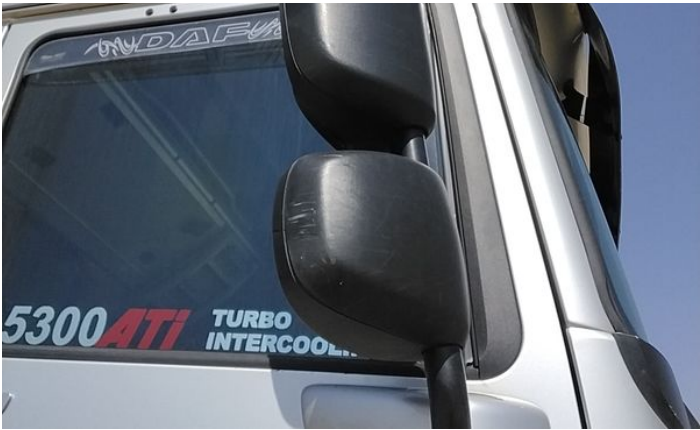
15: Door Mirror Assy osf  
Broken  
Replace

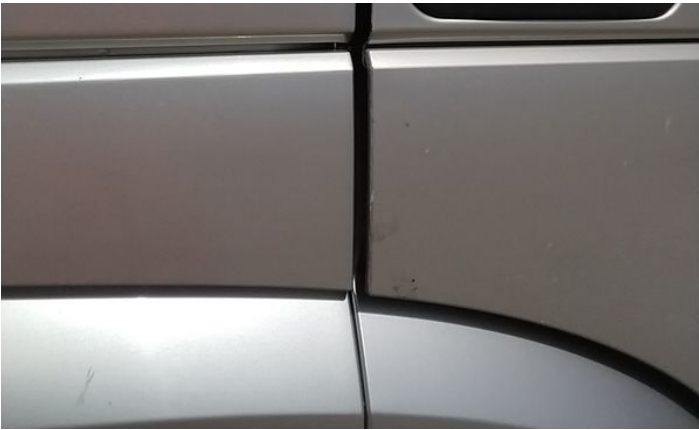
16: Door osf  
Chipped  
Edge Chip
