# VEHICLE INSPECTION REPORT

**BG72GYT**

## Mercedes-Benz Sprinter 315 CDI PROGRESSIVE

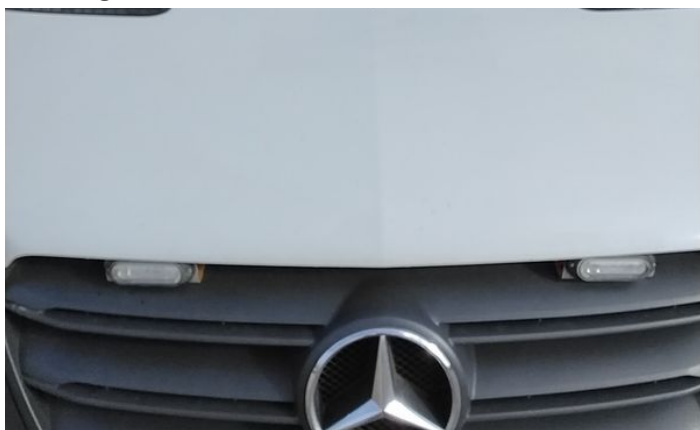
1: Bonnet  
Chipped  
Multiple Chips

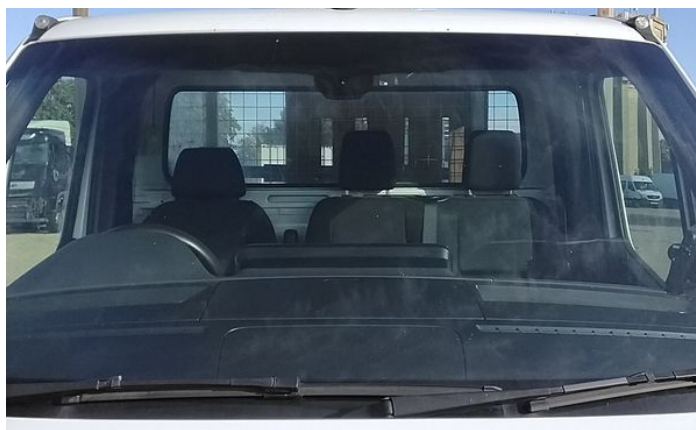
2: Screen Front  
Cracked  
Replace

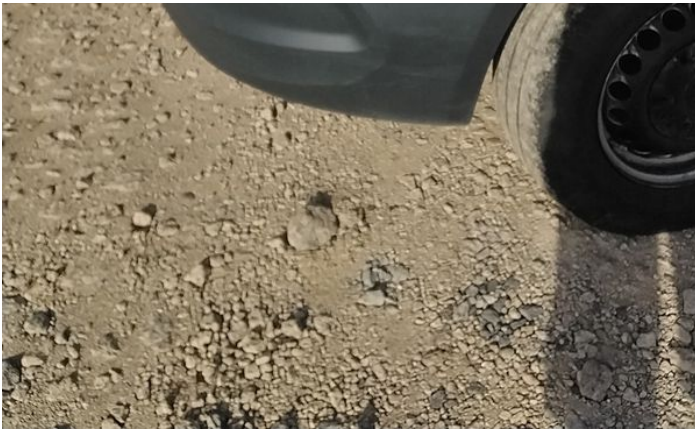
3: Bumper Front Moulding  
Scuffed (Unpainted)  
UpTo 100mm

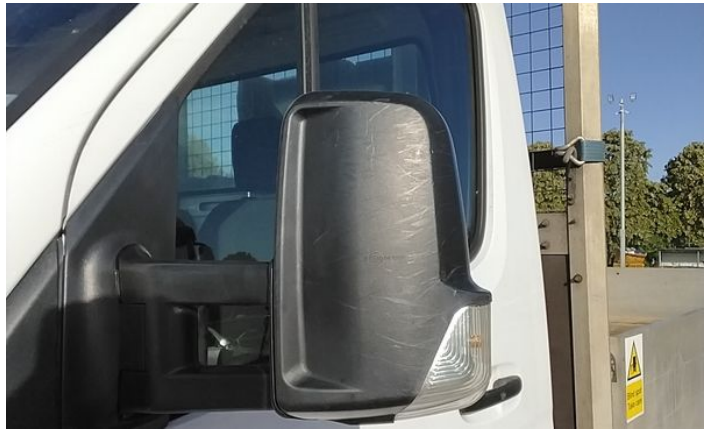
4: Door Mirror Assy nsf  
Scuffed (Unpainted)  
UpTo 100mm

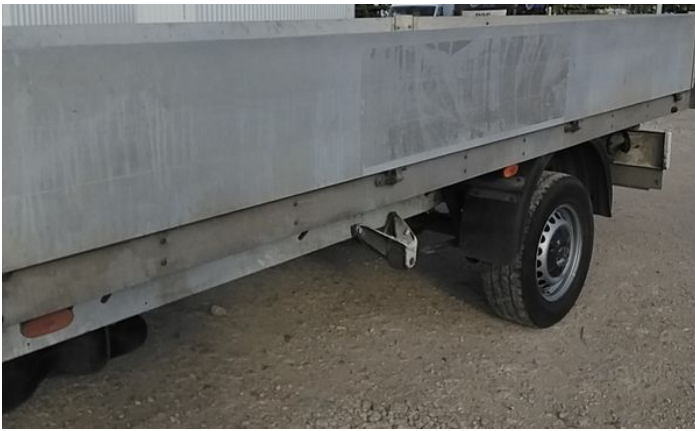
5: Qtr Panel nsr  
Scratched  
Over 25mm Not Thru Paint

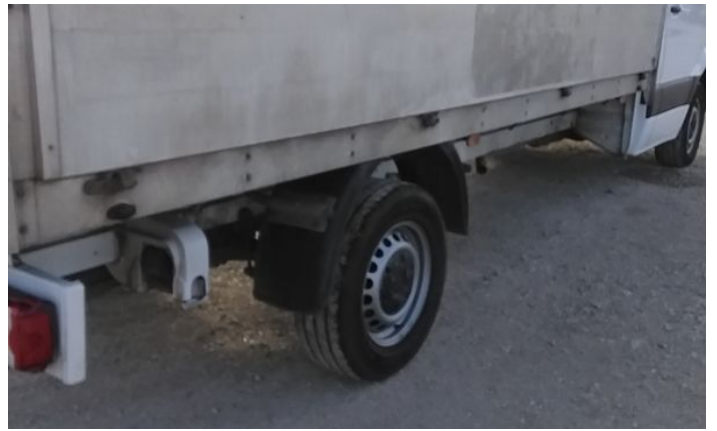
6: Qtr Panel osr  
Scratched  
Over 25mm Not Thru Paint

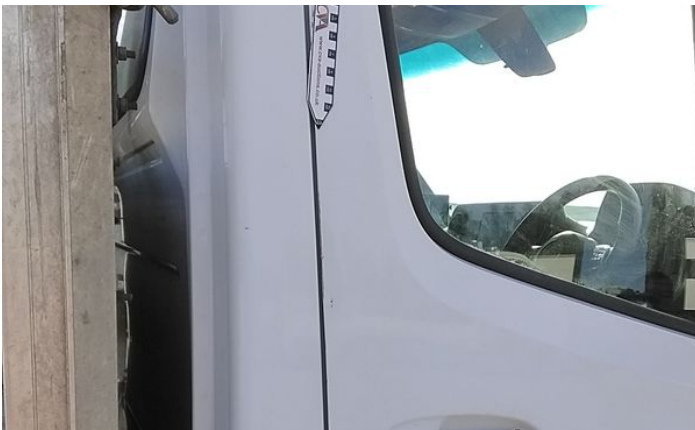
7: Door osf  
Chipped  
Edge Chip

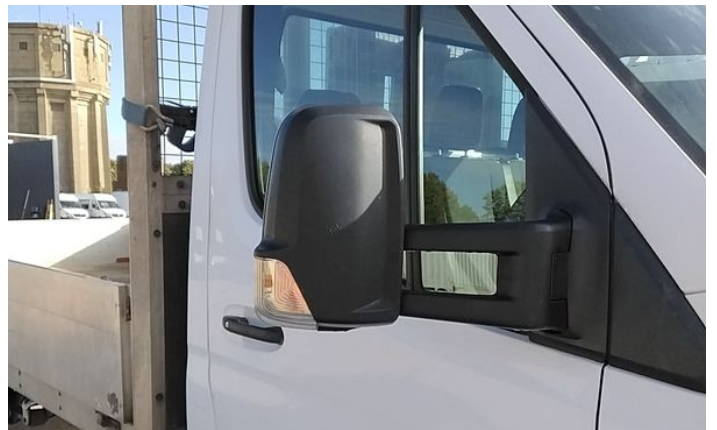
8: Door Mirror Assy osf  
Scuffed (Unpainted)  
UpTo 100mm
