# VEHICLE INSPECTION REPORT

**DK62WYW**

## Mercedes-Benz Axor 1843

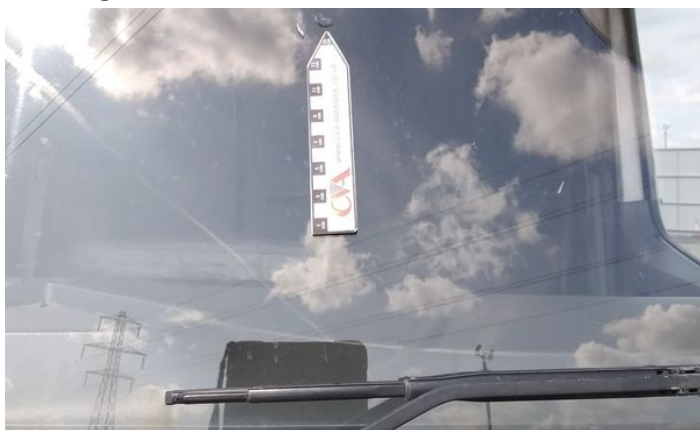
1: Screen Front  
Cracked  
Replace

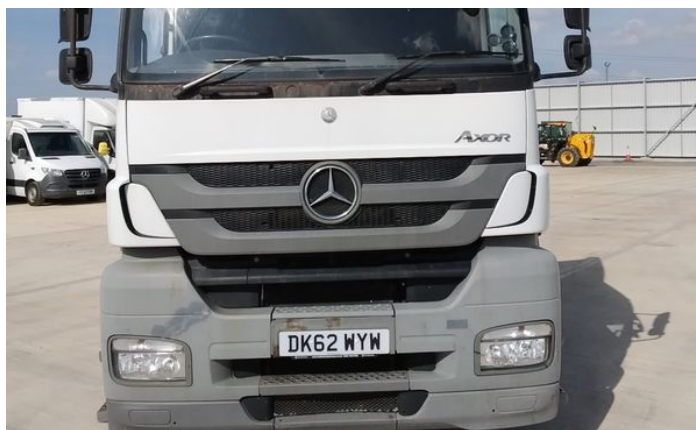
2: Bonnet  
Chipped  
Multiple Chips

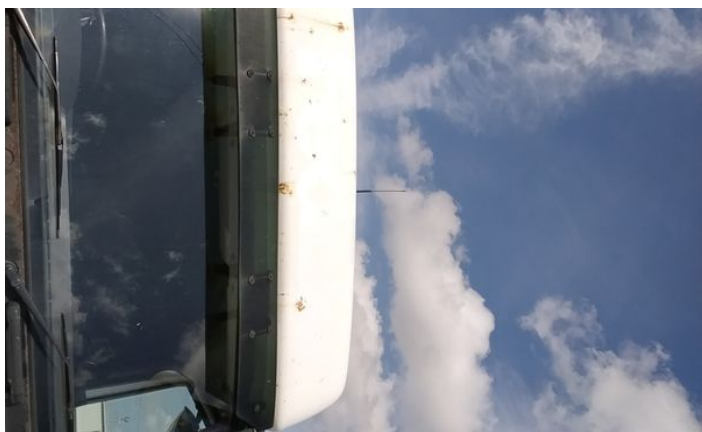
3: Roof  
Rusted  
Over 5mm

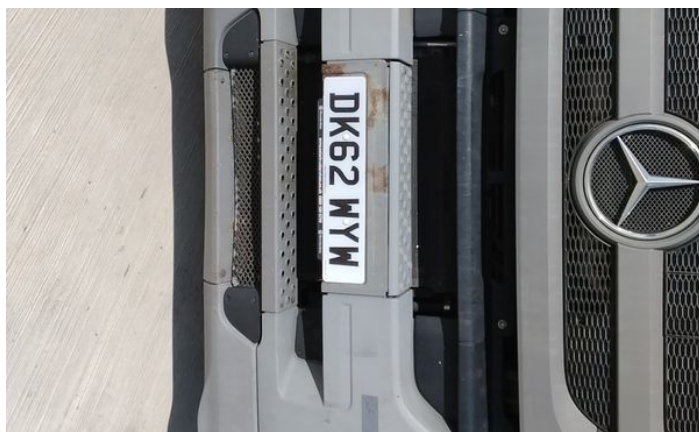
4: Bumper Front  
Cracked  
Over 25mm

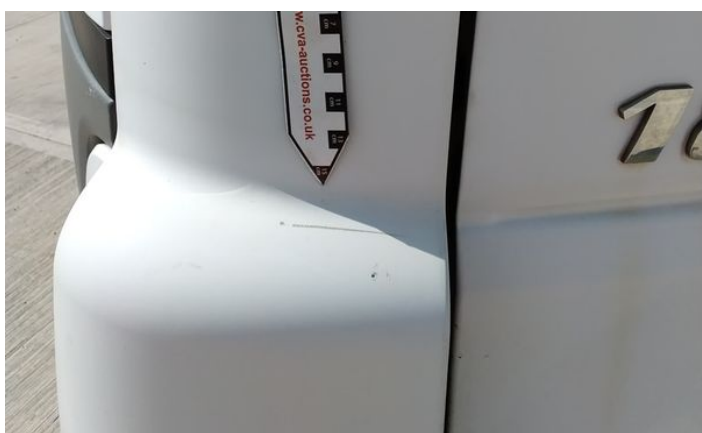
5: Moulding nsf Wing  
Scratched (Painted)  
Over 25mm Thru Paint

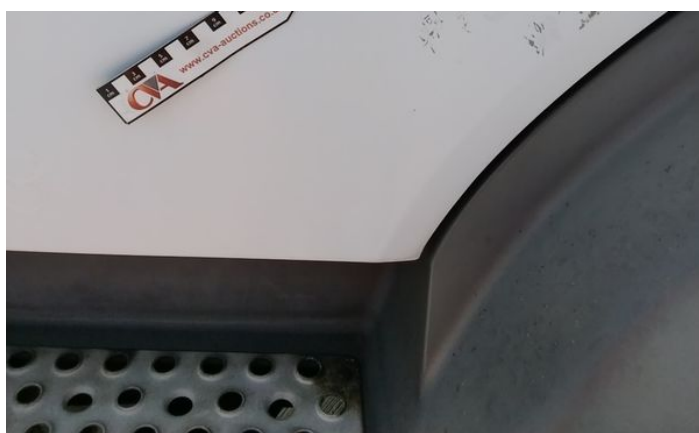
6: Door nsf  
Scratched  
Over 25mm Thru Paint

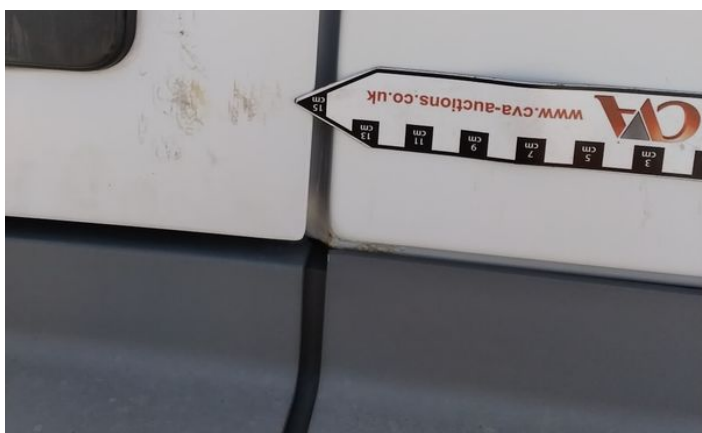
7: Door nsf  
Scratched  
Over 25mm Thru Paint

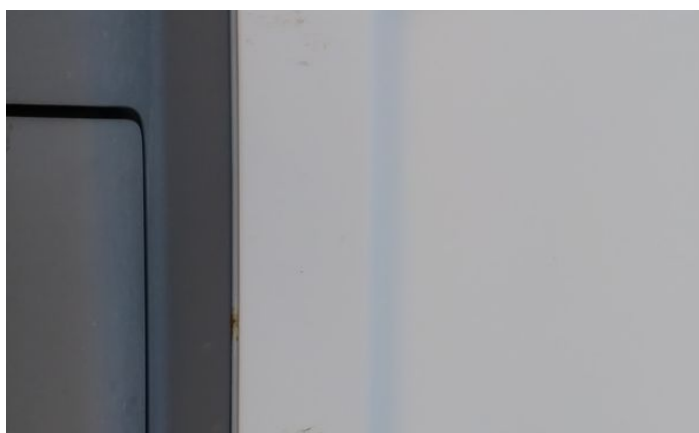
8: Qtr Panel nsr  
Scratched  
Over 25mm Thru Paint

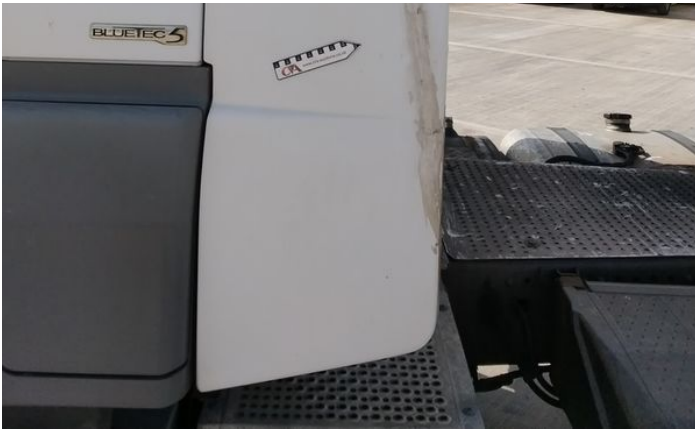
9: Qtr Panel nsr  
Cracked  
Replace

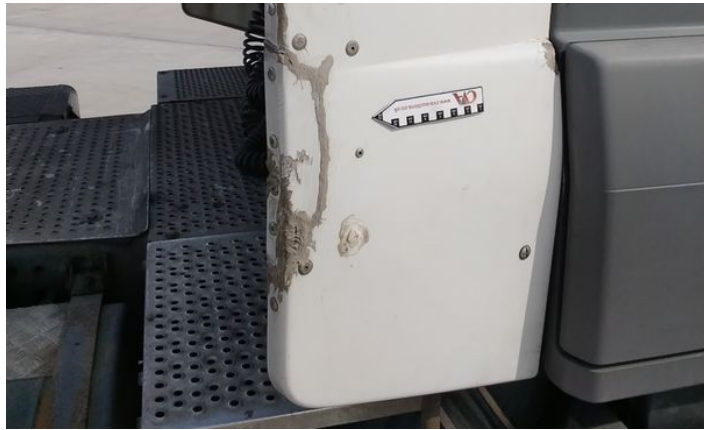
10: Qtr Panel osr  
Cracked  
Replace

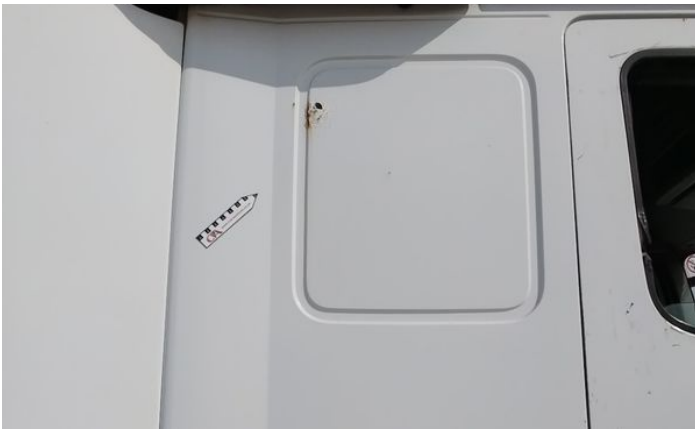
11: Qtr Panel osr  
Rusted  
Over 5mm

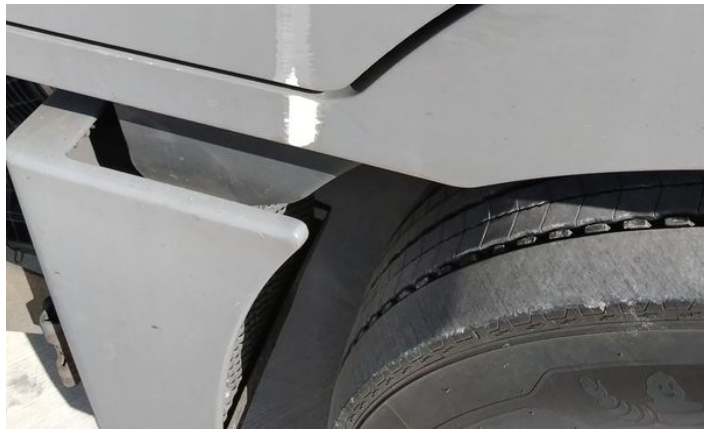
12: Qtr Panel osr  
Scratched  
Over 25mm Thru Paint

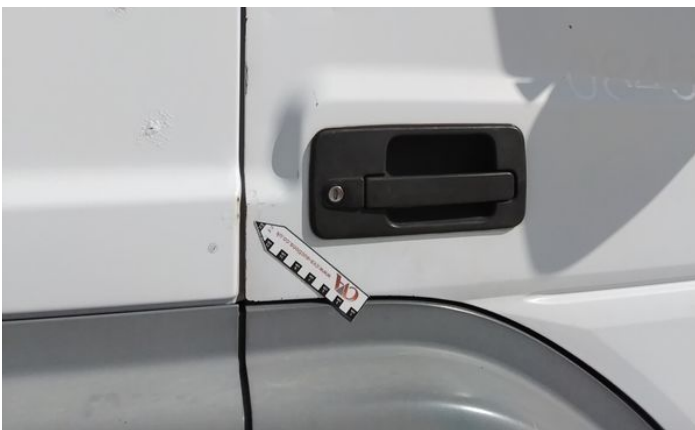
13: Door osf  
Dented  
With Paint Damage

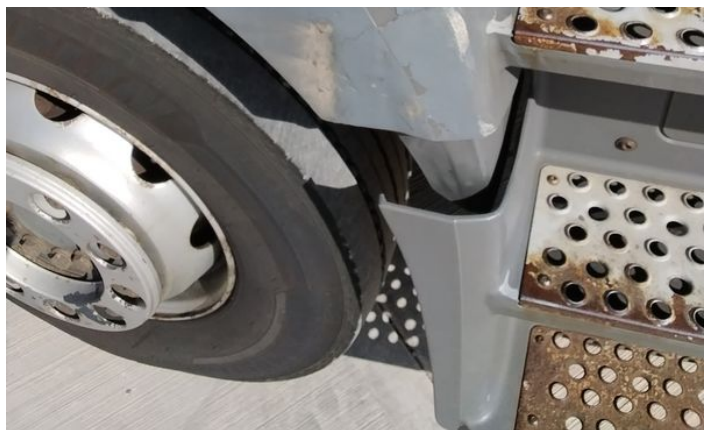
14: Wing Front Arch Extension os  
Broken  
Replace

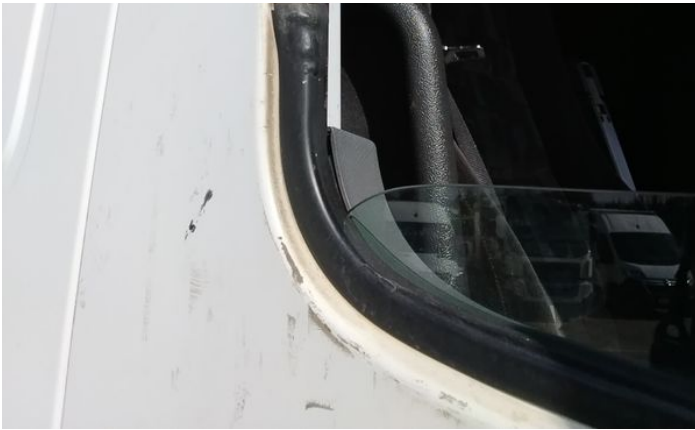
15: Aperture Seal of  
Broken  
Replace

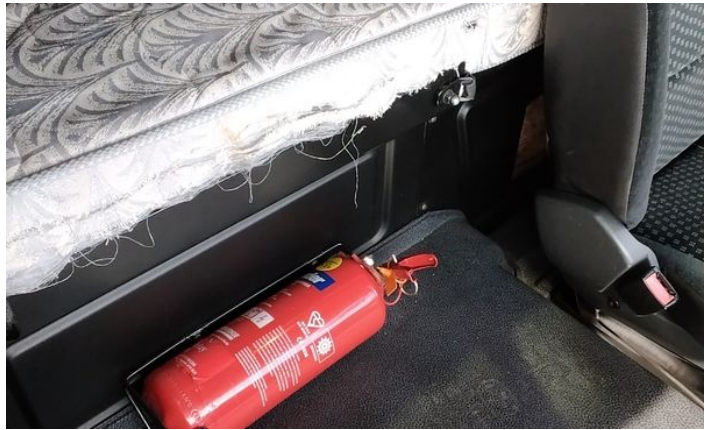
16: Rear Panel Trim Int  
Broken  
Replace

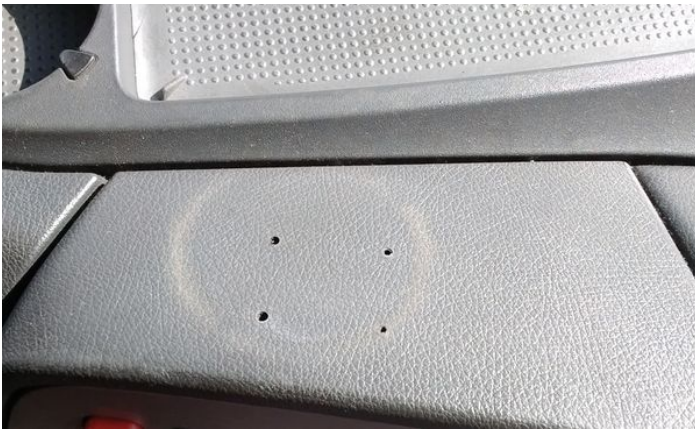
17: Centre Console Front  
Holed  
Over 3mm

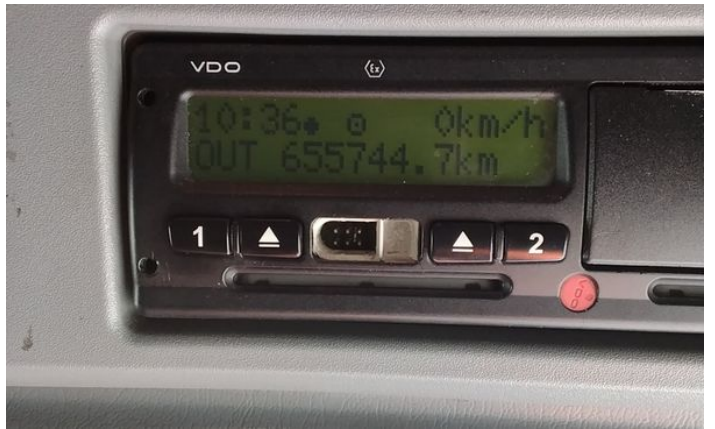
18: Switches And Controls  
Missing  
Replace

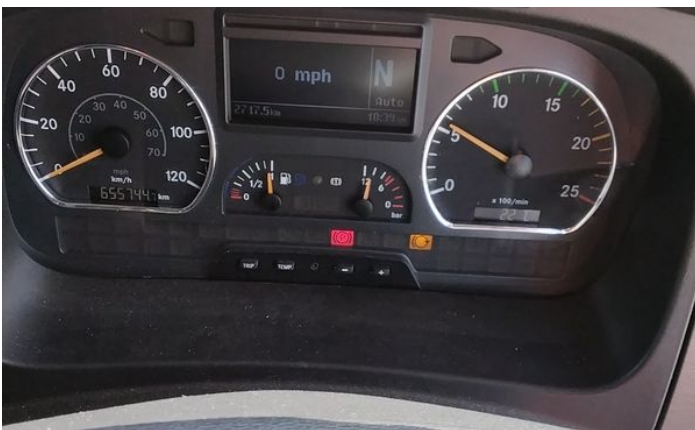
19: Dash Warning Lights  
Displayed  
No Action
