# VEHICLE INSPECTION REPORT

**BU69TNX**

## Daf LF 230

\*COLLECTED AS NON-RUNNER-LIMP MODE, WARNING LIGHTS ON DASH\*, THERMOKING T-1000R UNIT, STANDBY PLUG, SIDE LOAD DOOR

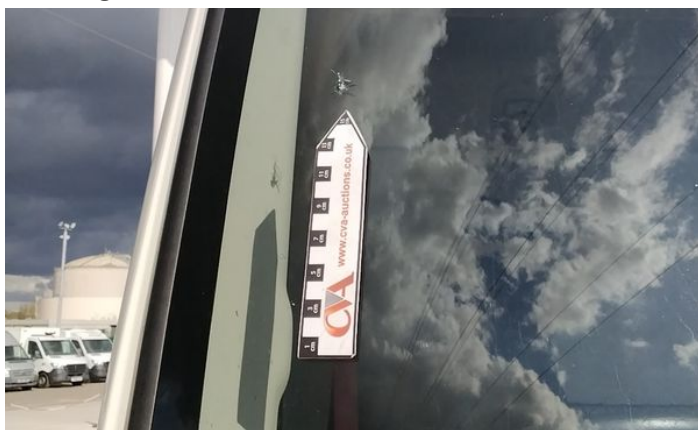
1: Screen Front  
Cracked  
Replace

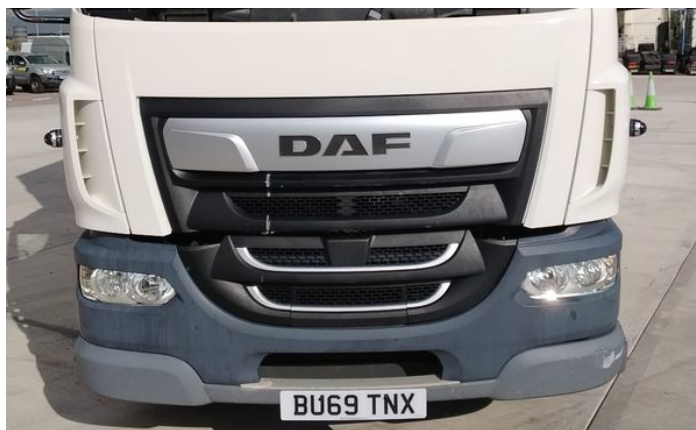
2: Bonnet  
Chipped  
Multiple Chips

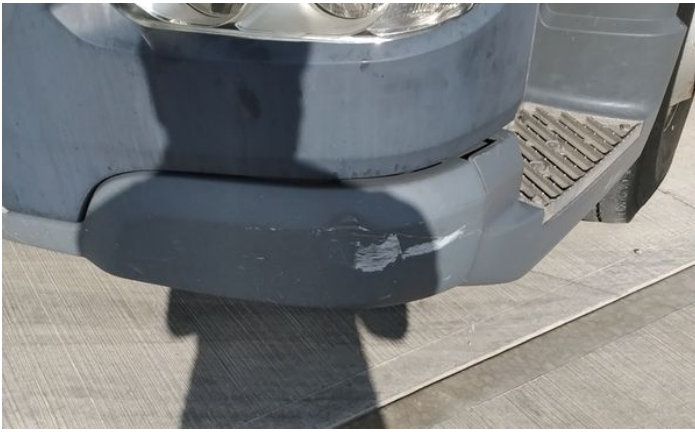
3: Bumper Front  
Scratched  
Over 100mm Thru Paint

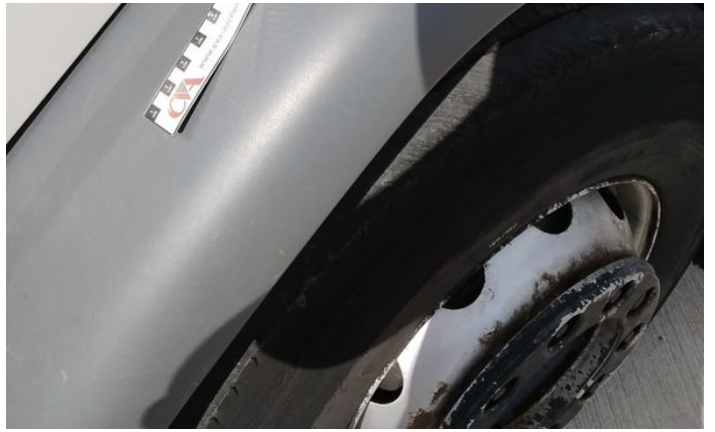
4: Wing Front Arch Extension ns  
Scratched (Painted)  
Over 25mm Thru Paint

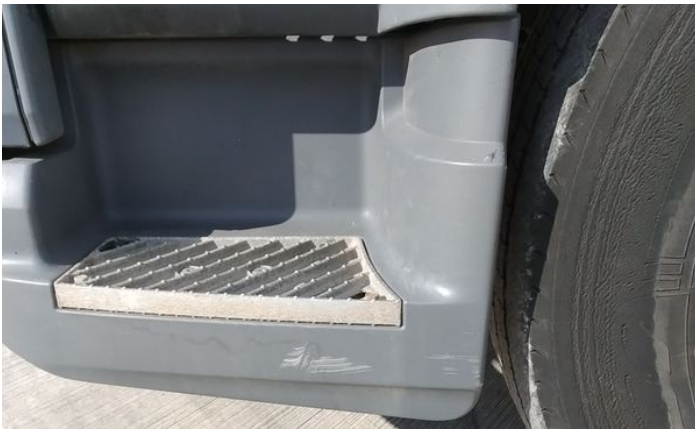
5: Wing nsf  
Scratched  
Over 25mm Thru Paint

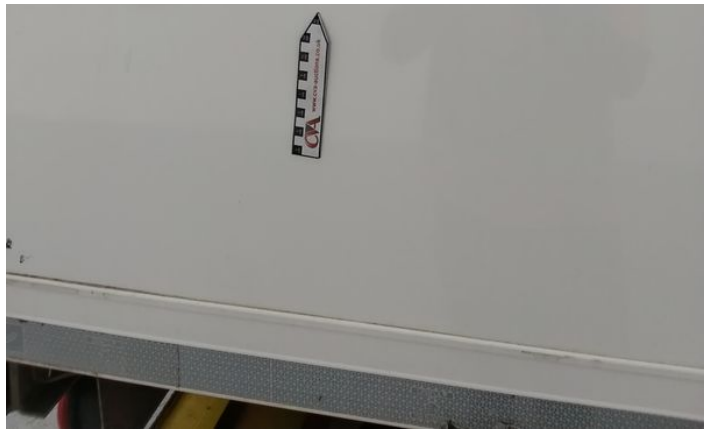
6: Qtr Panel osr  
Poor Previous Repair  
Poor Paint

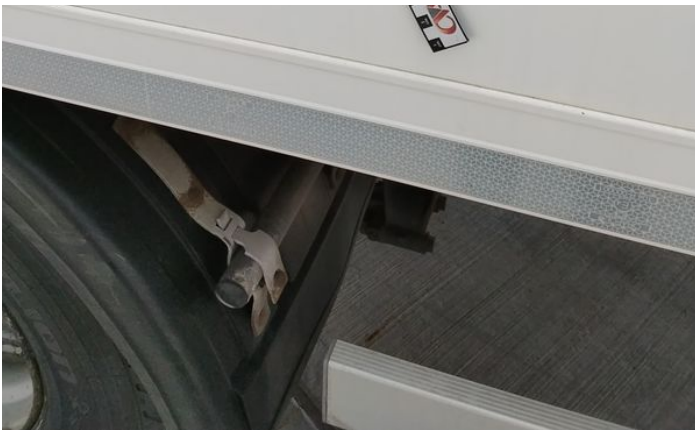
7: Qtr Panel osr  
Scratched  
Over 25mm Thru Paint

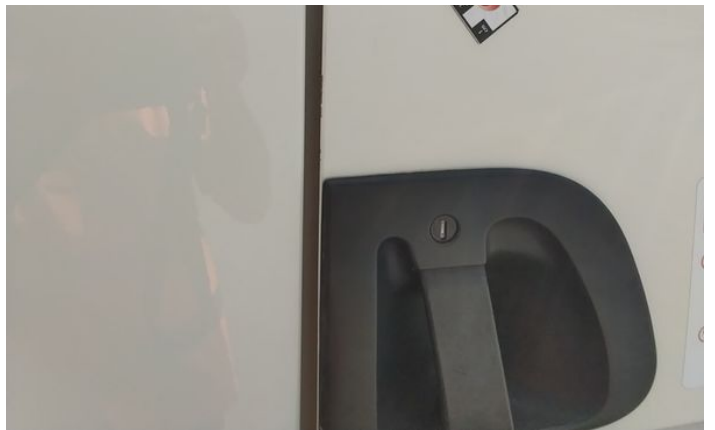
8: Door osf  
Chipped  
Multiple Chips

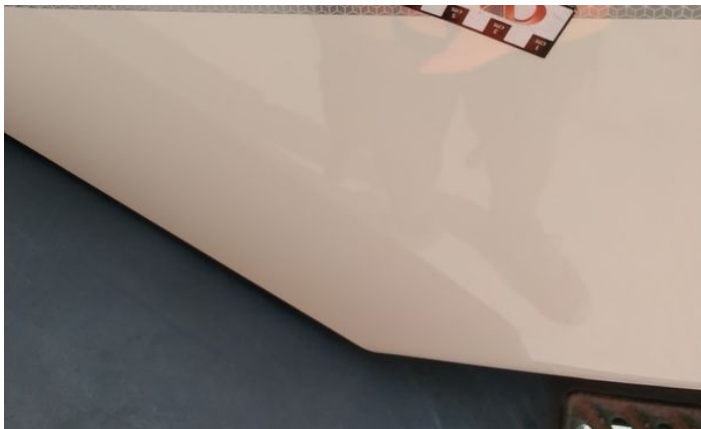
9: Door osf  
Scratched  
Over 25mm Thru Paint

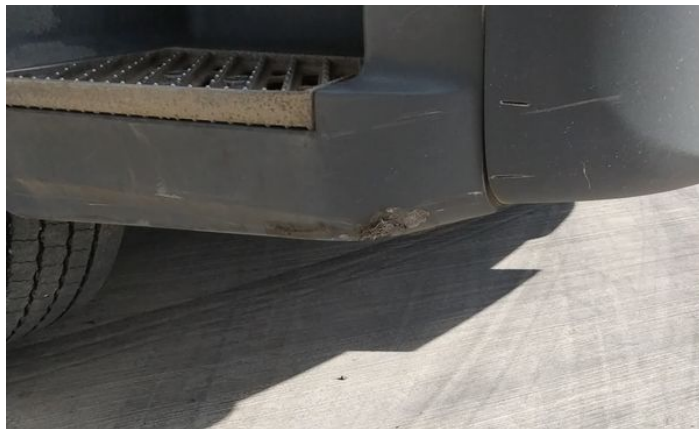
10: Bumper Front  
Cracked  
Over 25mm

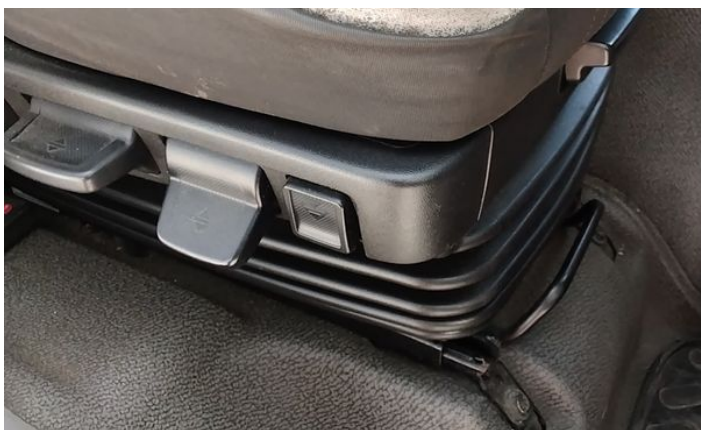
11: Seat Base Cover osf  
Torn  
Over 3mm

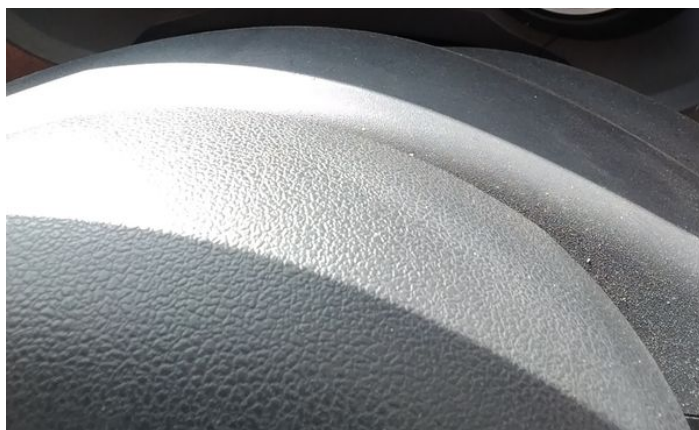
12: Dash Warning Lights  
Displayed  
No Action
