## VEHICLE INSPECTION REPORT

**MM71RWV**

### Ford Ranger Wildtrak 2.0 EcoBlue 213

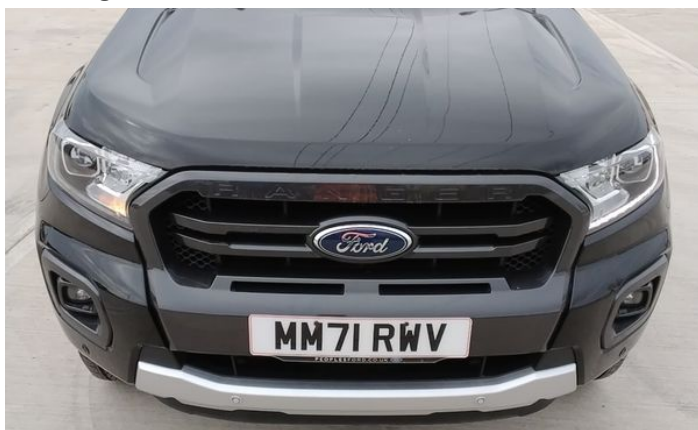
1: Bonnet  
Chipped  
Multiple Chips

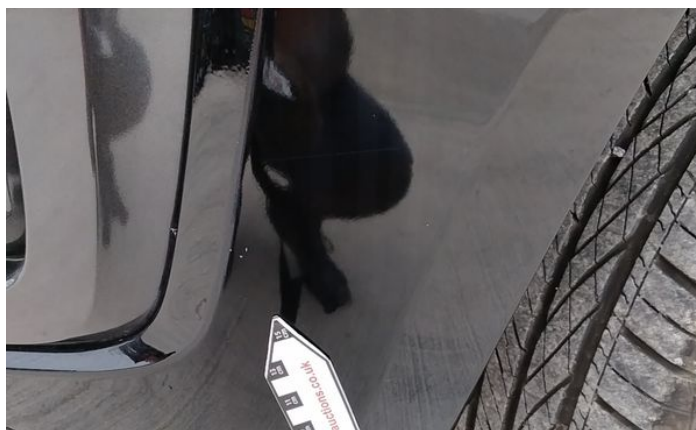
2: Bumper Front  
Chipped  
Multiple Chips

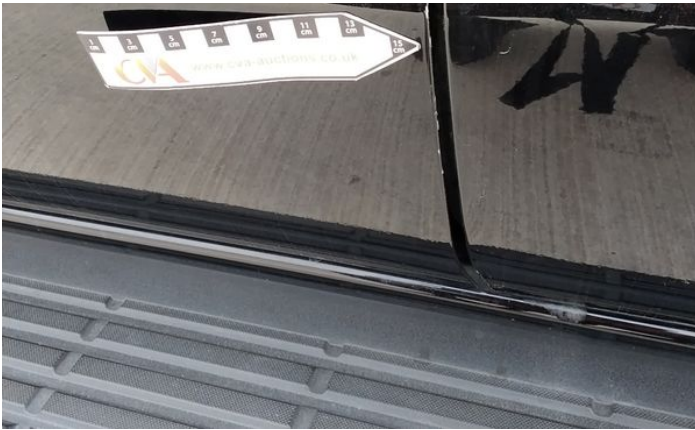
3: Door nsf  
Chipped  
Multiple Chips

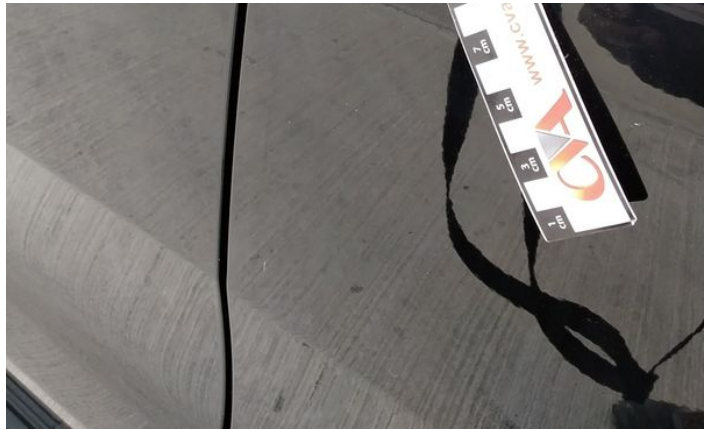
4: Qtr Panel nsr  
Scratched  
Over 25mm Thru Paint

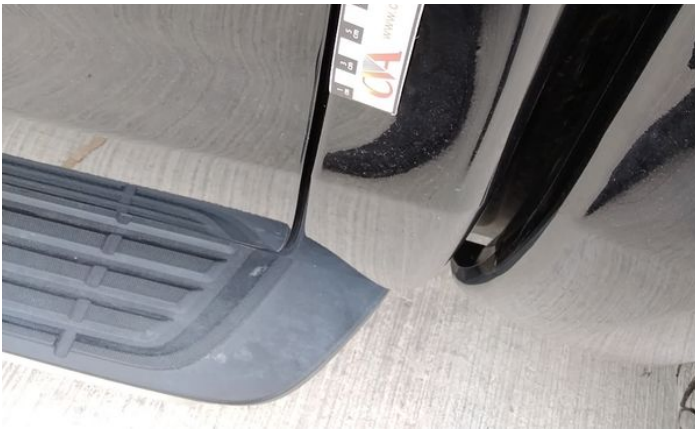
5: Qtr Panel nsr  
Dented  
Over 2 UpTo 10mm

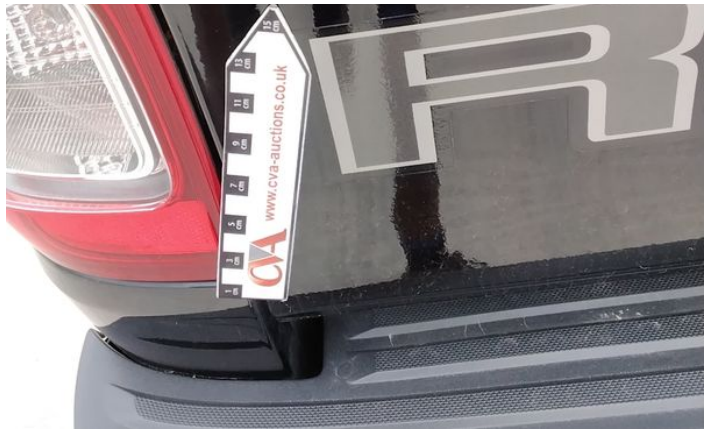
6: Tailgate  
Scratched  
UpTo 25mm Thru Paint

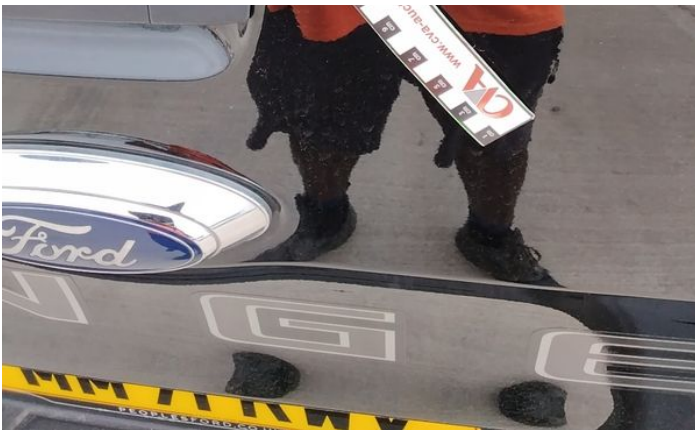
7: Tailgate  
Chipped  
Multiple Chips

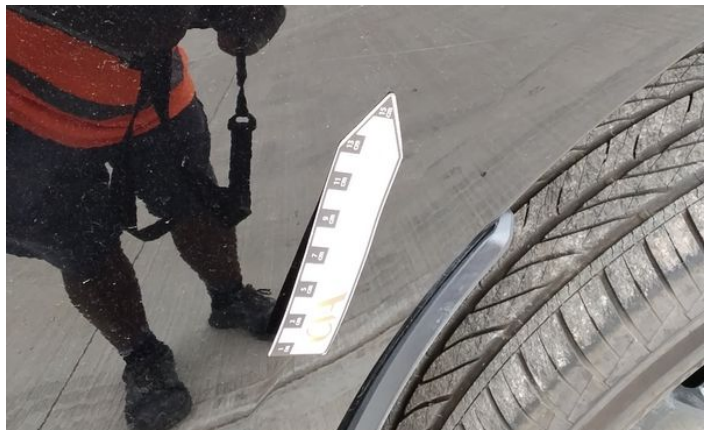
8: Qtr Panel osr  
Scratched  
Over 25mm Thru Paint

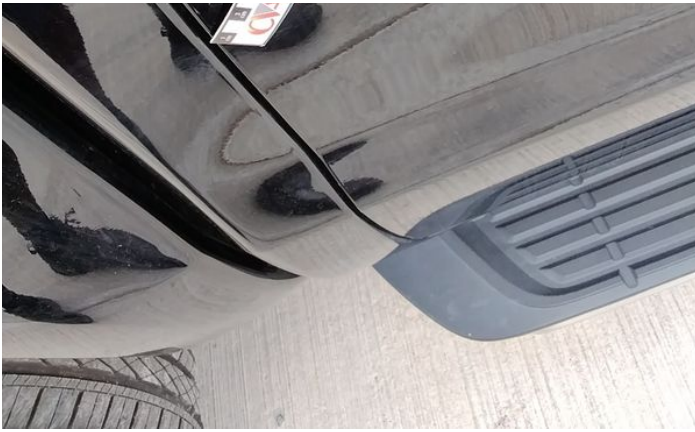
9: Qtr Panel osr  
Scratched  
Over 25mm Thru Paint

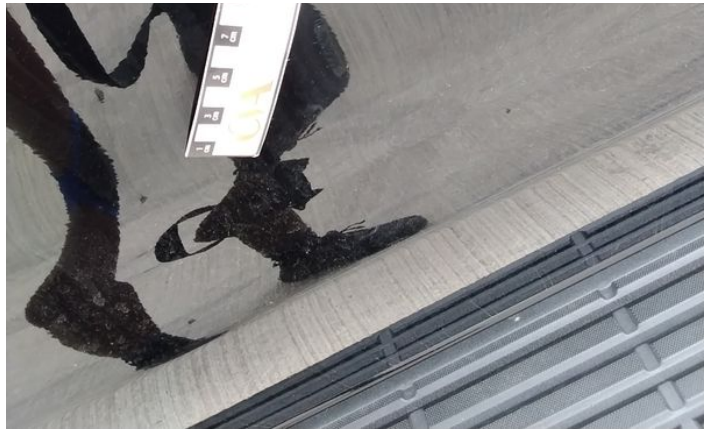
10: Qtr Panel osr  
Scratched  
Over 25mm Thru Paint

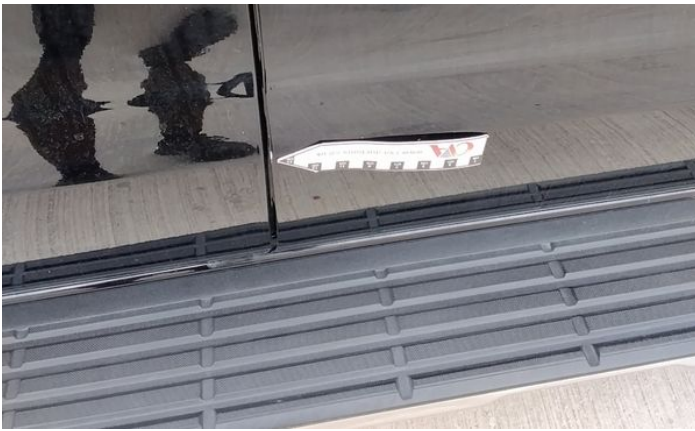
11: Door osf  
Chipped  
Multiple Chips

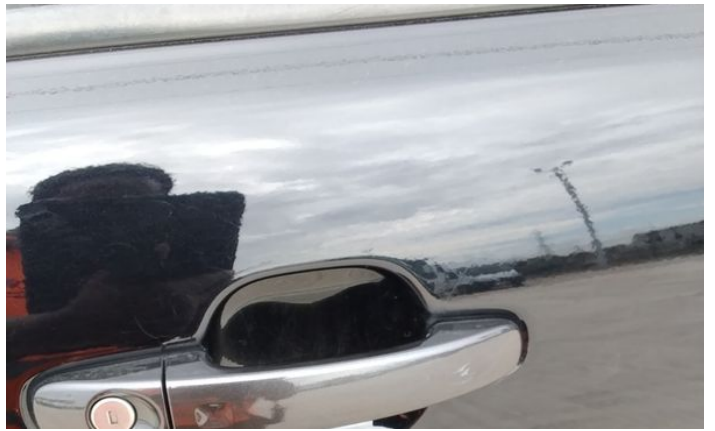
12: Door osf  
Scratched  
Over 25mm Thru Paint

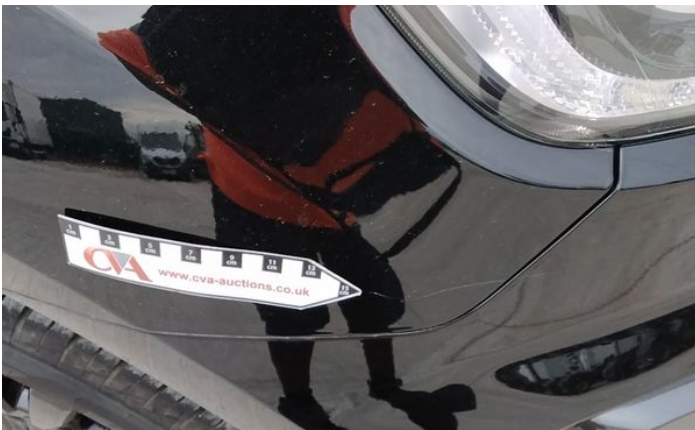
13: Wing osf  
Scratched  
Over 25mm Thru Paint

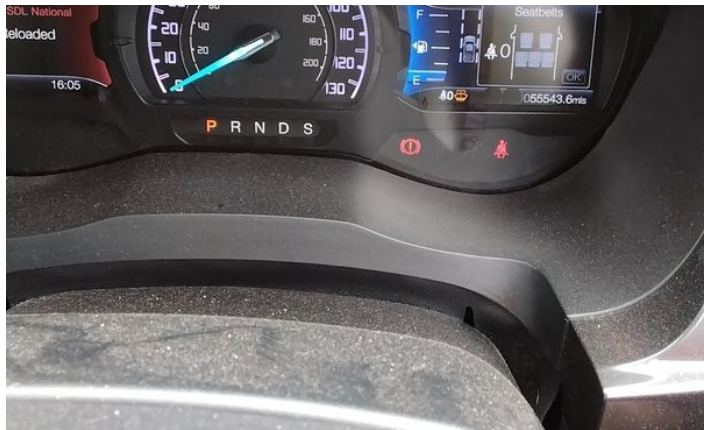
14: Dash Warning Lights  
Displayed  
No Action
