# VEHICLE INSPECTION REPORT

**FP70WJO**

## DAF XF 480

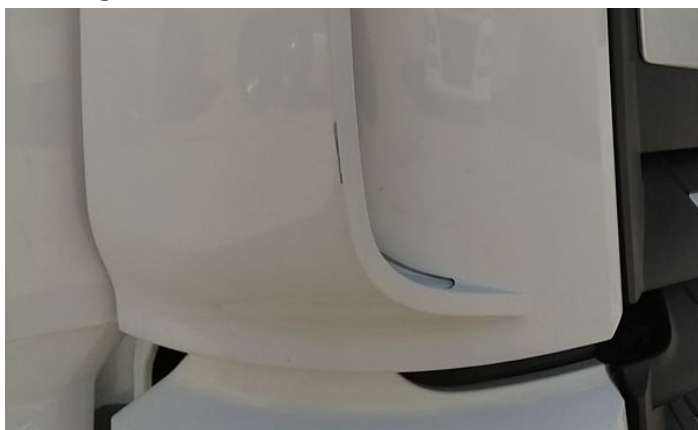
1: Wing osf  
Scratched  
Over 25mm Not Thru Paint

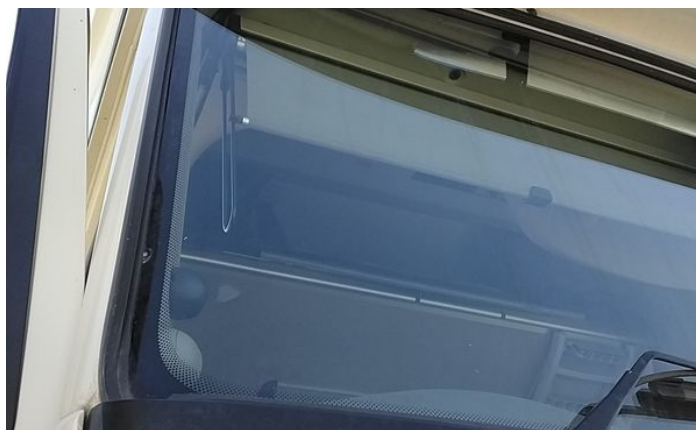
2: Screen Front  
Chipped  
Over 10mm

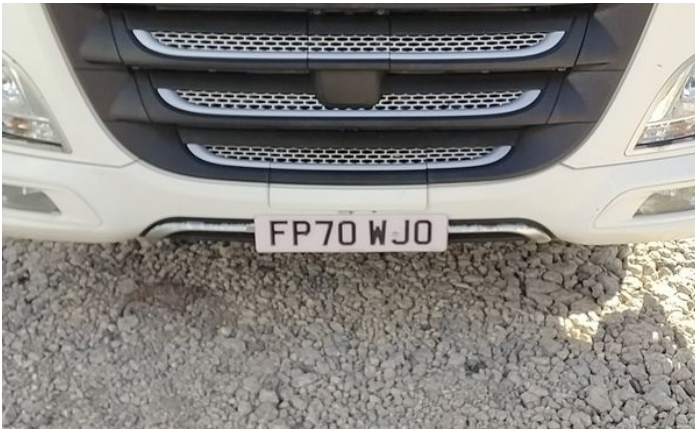
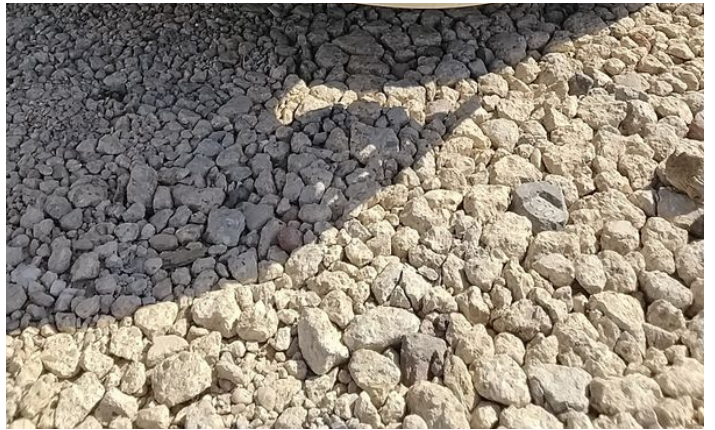
3: Bumper Front  
Chipped  
Multiple Chips

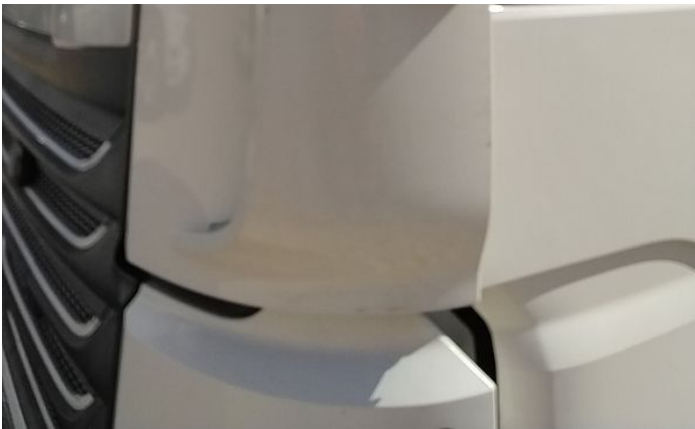
4: Bumper Front  
Scratched  
Over 25mm Not Thru Paint

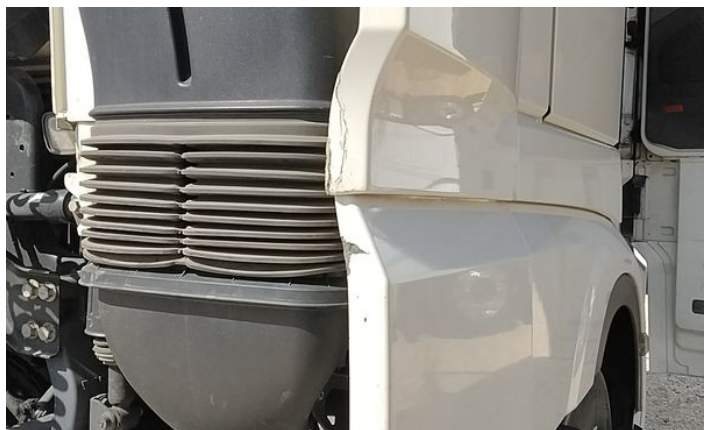
7: Wing Front Arch Extension ns  
Scratched (Painted)  
Over 25mm Thru Paint

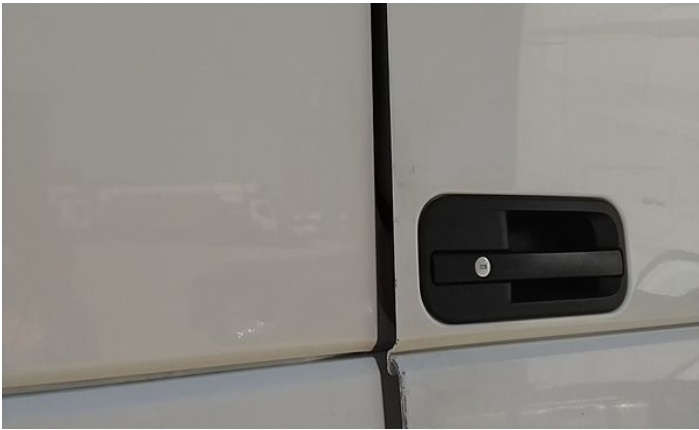
9: Door osf  
Chipped  
Edge Chip

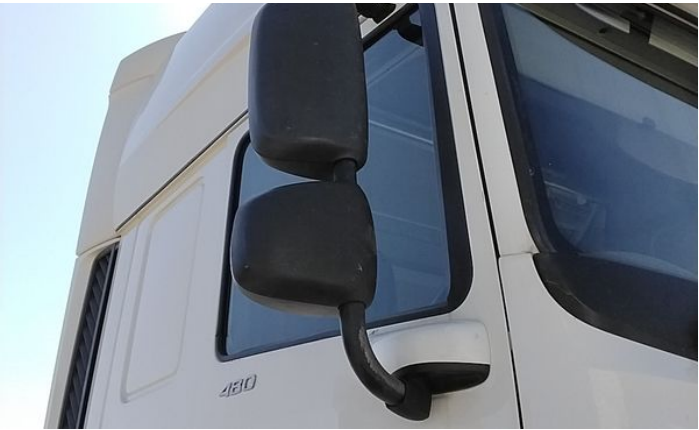
10: Door Mirror Assy osf  
Scuffed (Unpainted)  
Over 100mm
