# VEHICLE INSPECTION REPORT

**FP70WJL**

## Daf XF 480

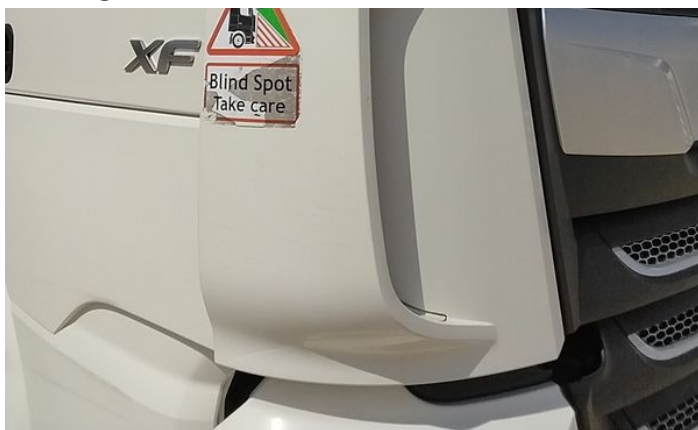
1: Wing osf  
Scratched  
Over 25mm Not Thru Paint

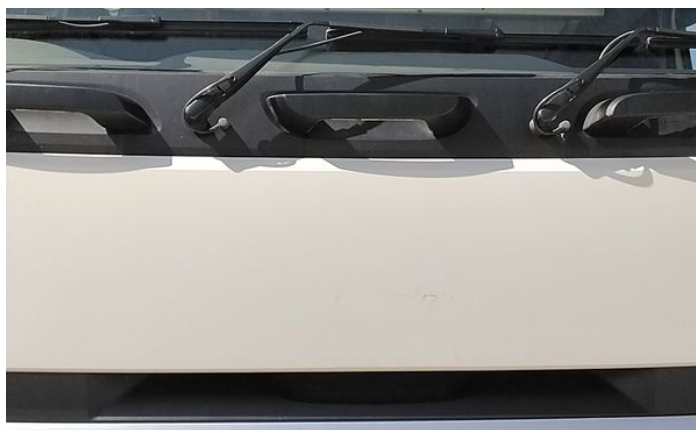
2: Bonnet  
Chipped  
Multiple Chips

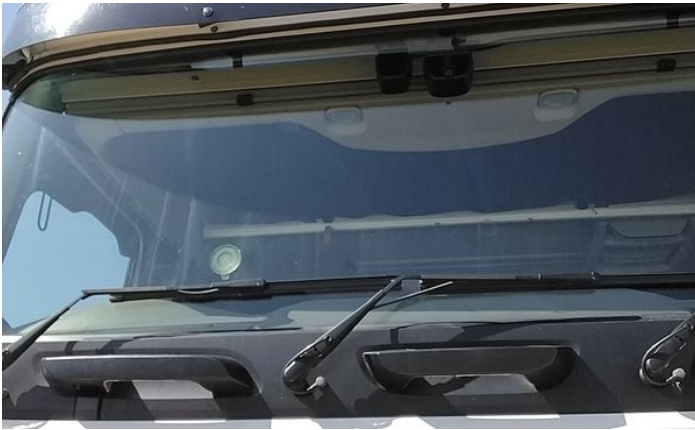
3: Screen Front  
Chipped  
UpTo 10mm

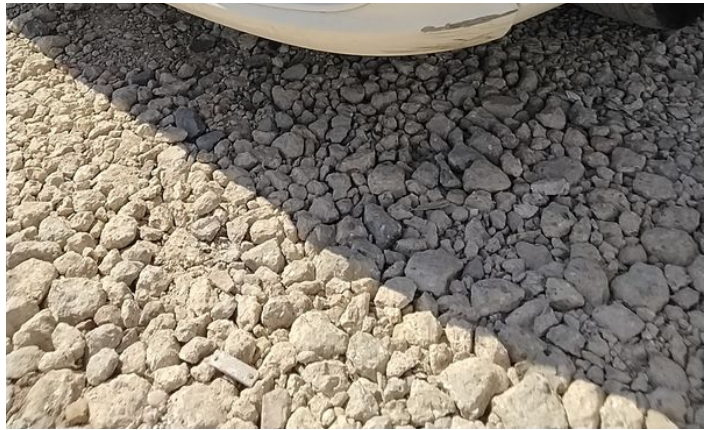
4: Bumper Front  
Scratched  
25 to 100mm Thru Paint

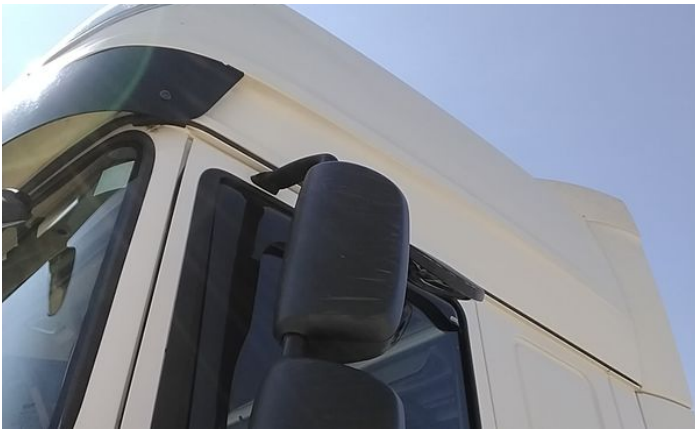
5: Door Mirror Assy nsf  
Scuffed (Unpainted)  
Over 100mm

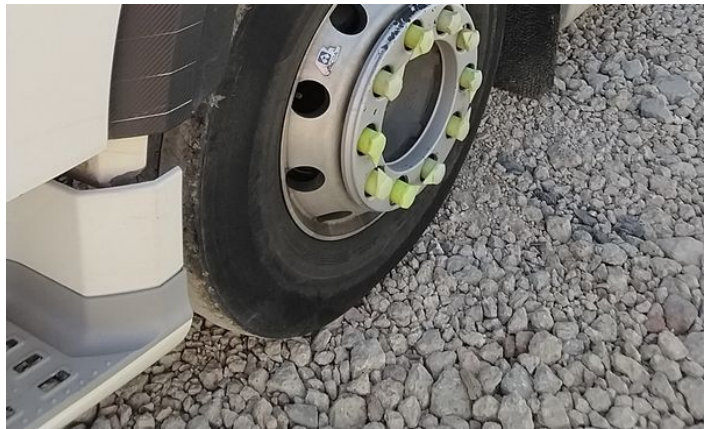
6: Wing Front Arch Extension ns  
Broken  
Replace

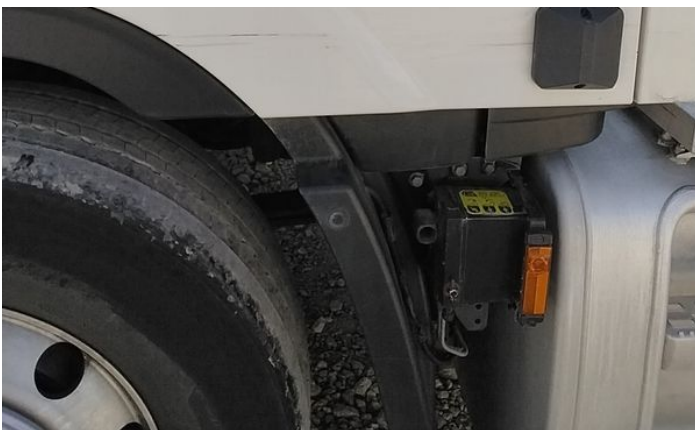
7: Wing Front Arch Extension ns  
Scratched (Painted)  
Over 25mm Thru Paint

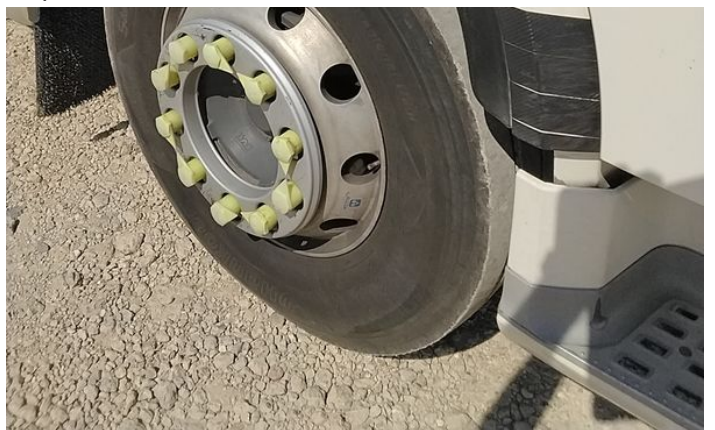
8: Wing Front Arch Extension os  
Broken  
Replace

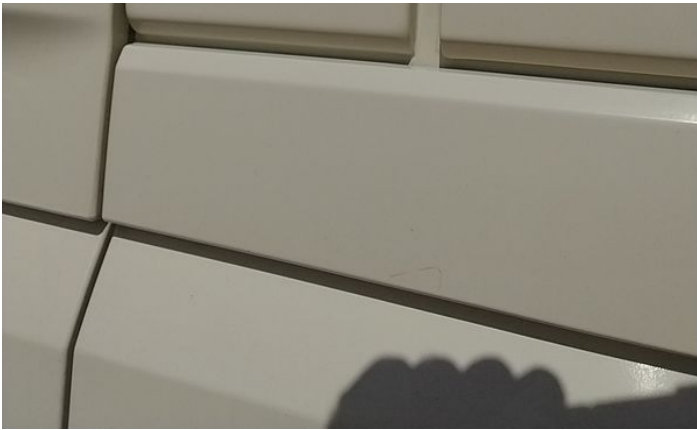
9: Qtr Panel osr  
Rusted  
Over 5mm

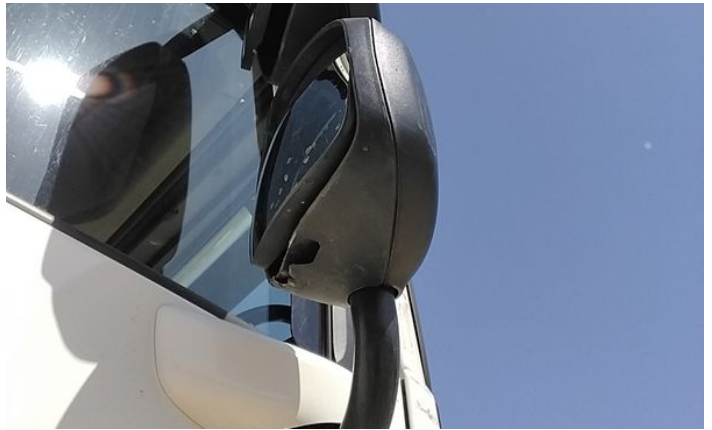
10: Door Mirror Assy osf  
Broken  
Replace

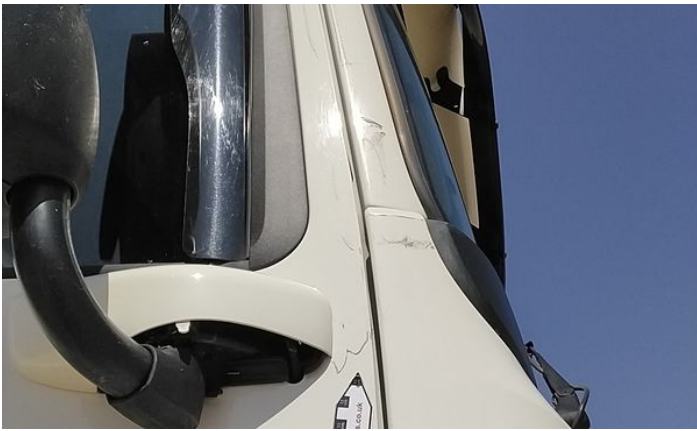
11: A Post os  
Scratched  
Over 25mm Not Thru Paint
