## VEHICLE INSPECTION REPORT

**AK69UWS**

### Ford Transit Custom 320 2.0 EcoBlue 130ps Trend

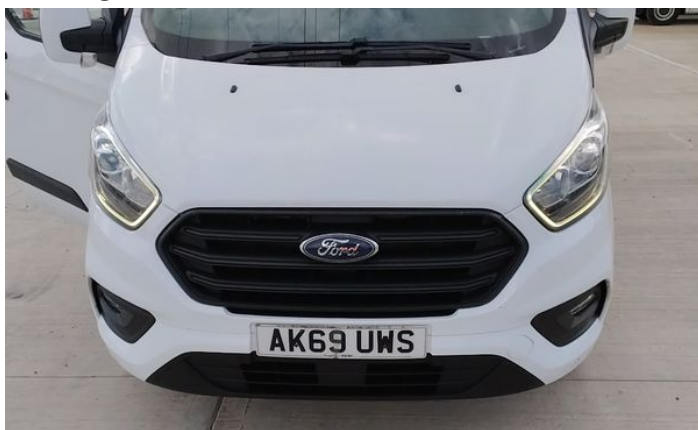
1: Bonnet  
Chipped  
Multiple Chips

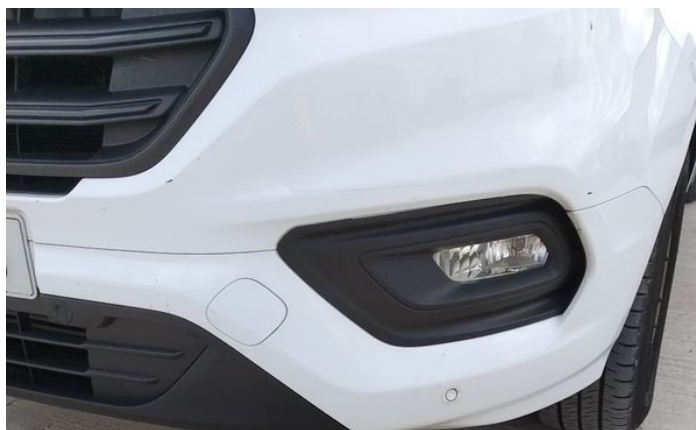
2: Bumper Front  
Scratched  
Over 100mm Thru Paint

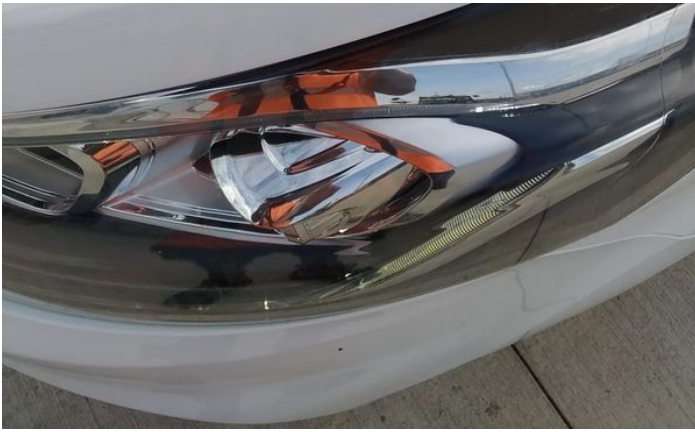
3: Bonnet  
Scratched  
Over 25mm Thru Paint

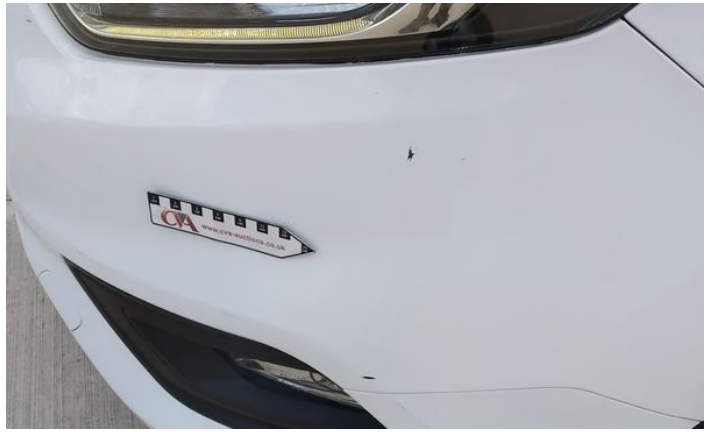
4: Bumper Front  
Scratched  
Over 100mm Thru Paint

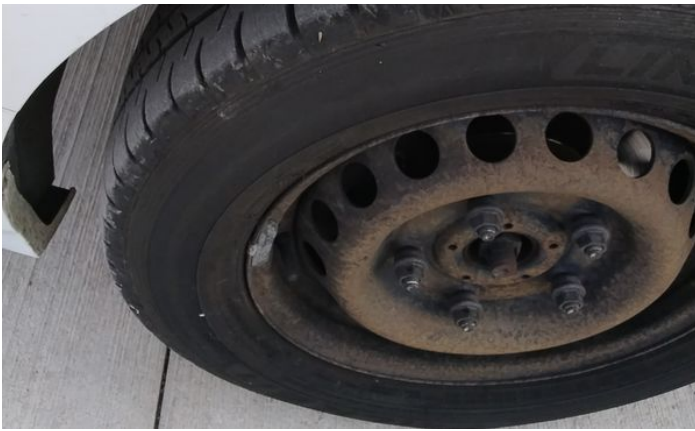
5: Wing nsf  
Chipped  
1 To 5

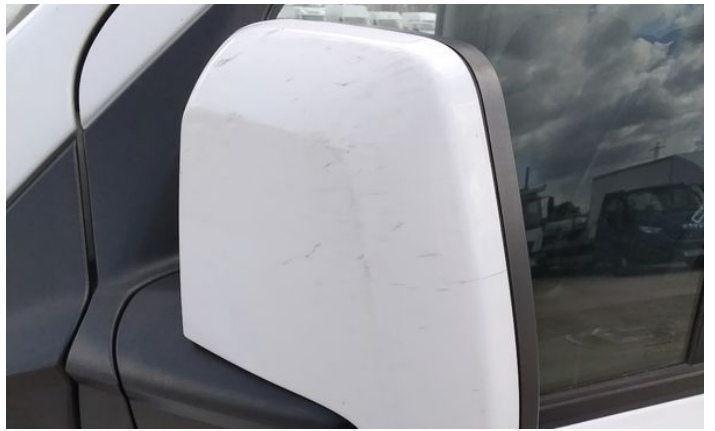
6: Door Mirror Assy nsf  
Scuffed (Unpainted)  
Over 100mm

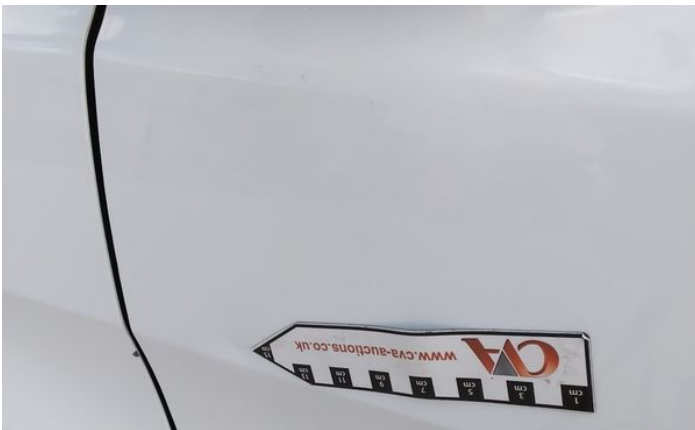
7: Door nsf  
Dented  
Over 2 UpTo 10mm

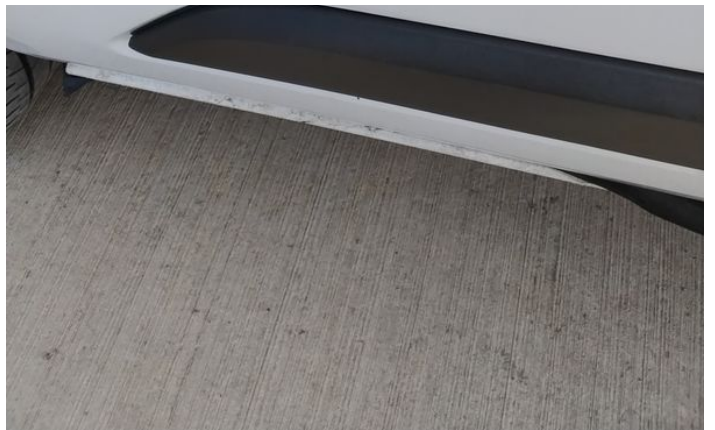
8: Door nsf  
Dented  
2 Or Less UpTo 10mm

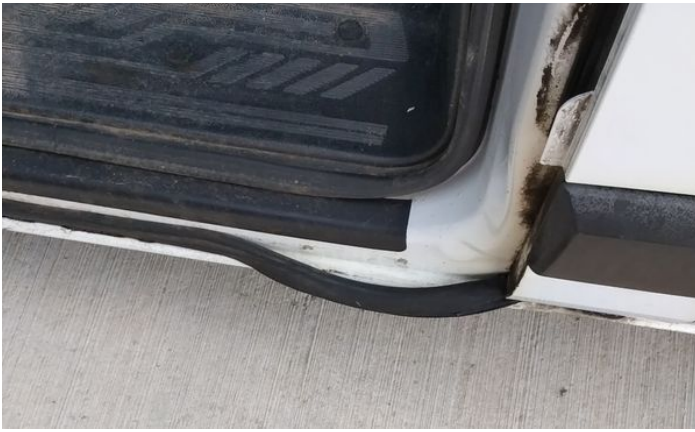
9: Aperture Seal nsf  
Broken  
Replace

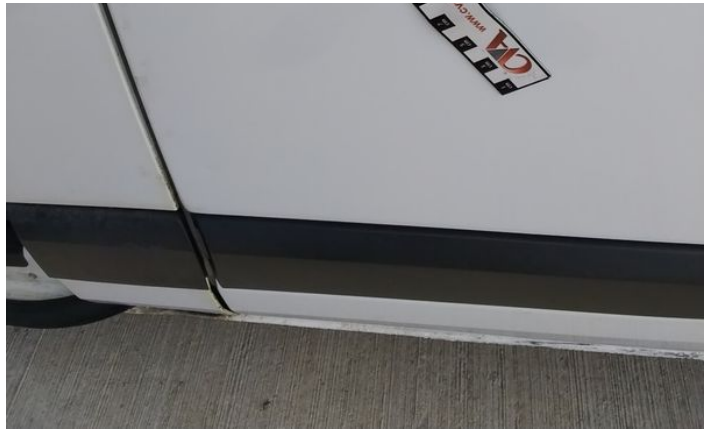
10: Qtr Panel nsr  
Dented  
With Paint Damage

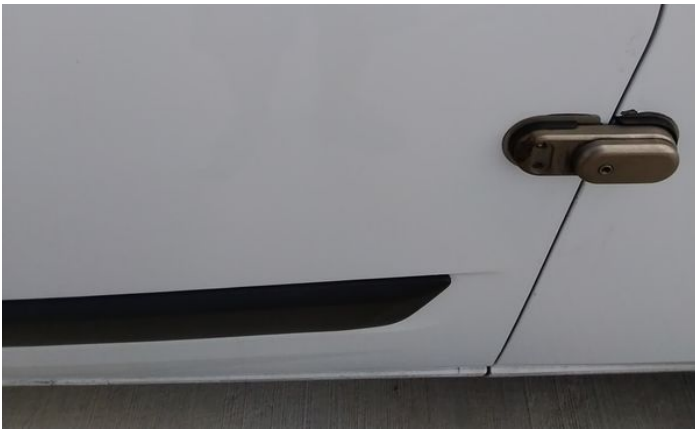
11: Qtr Panel nsr  
Scratched  
Over 25mm Thru Paint

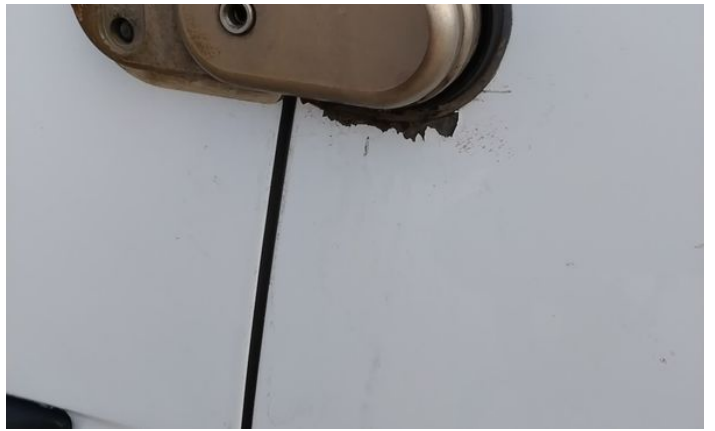
12: Qtr Panel nsr  
Chipped  
Multiple Chips

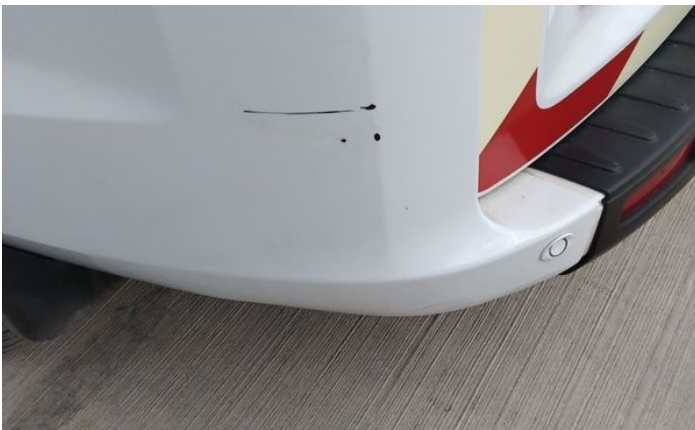
13: Bumper Rear  
Scratched  
Over 100mm Thru Paint

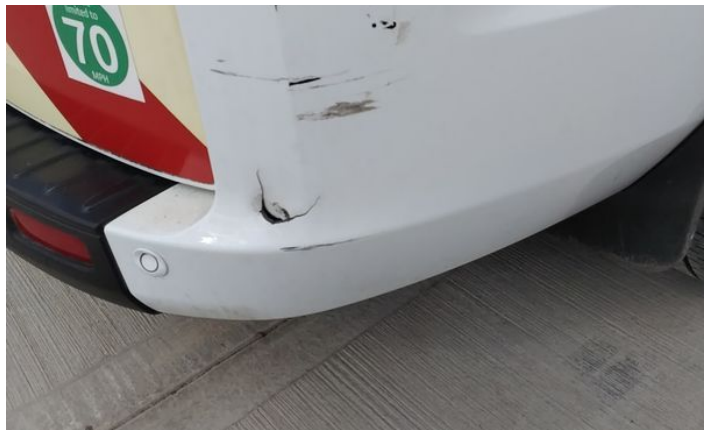
14: Bumper Rear  
Hole  
Over 25mm

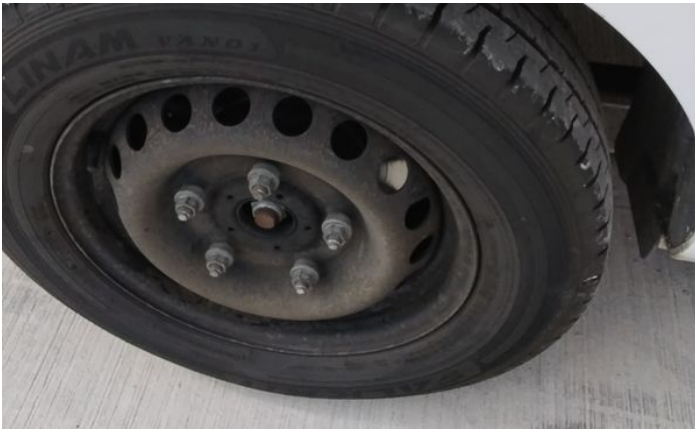
15: Qtr Panel osr  
Chipped  
Multiple Chips

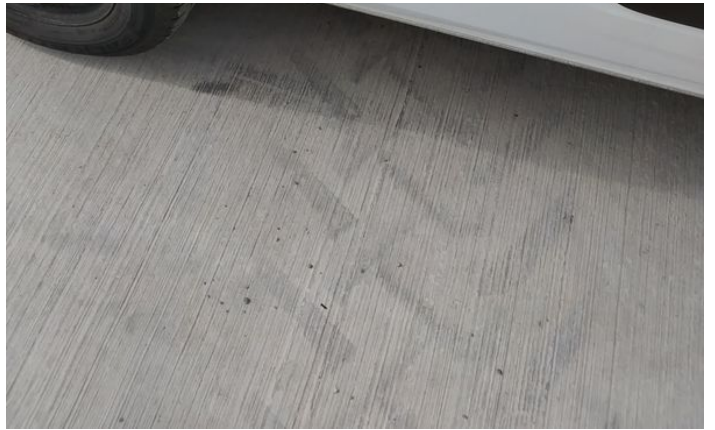
16: Qtr Panel osr  
Dented  
Hail - Moderate

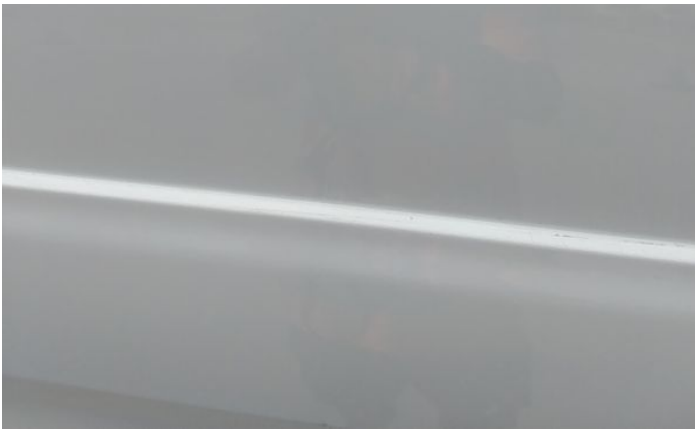
17: Qtr Panel osr  
Dented  
Over 30mm

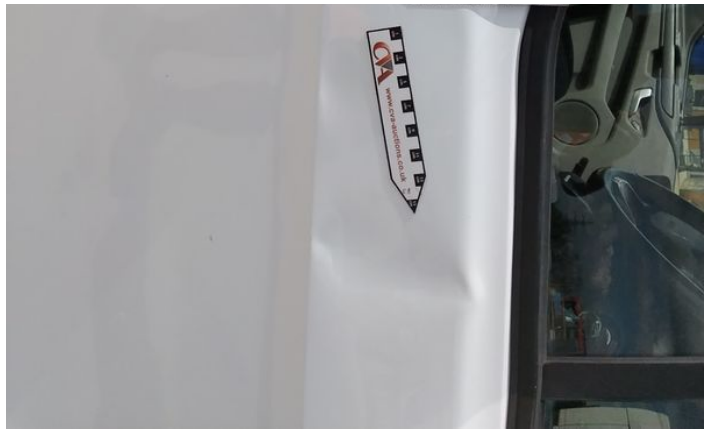
18: Door osf  
Dented  
Hail - Moderate

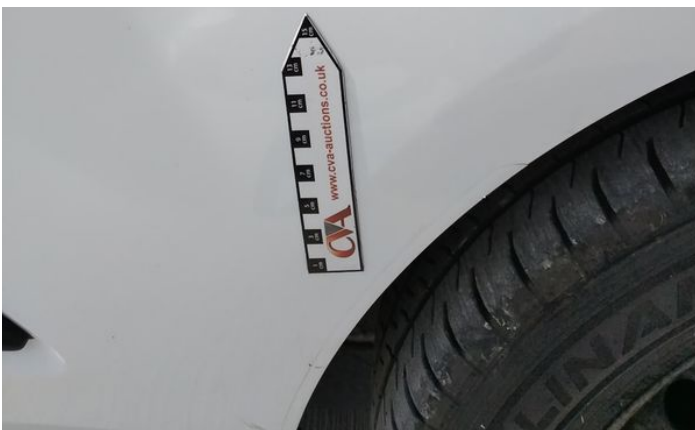
19: Door osf  
Scratched  
Over 25mm Thru Paint

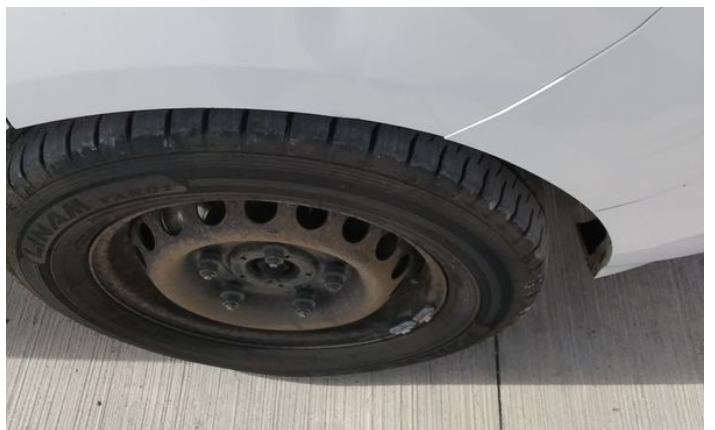
20: Wing osf  
Dented  
Over 30mm

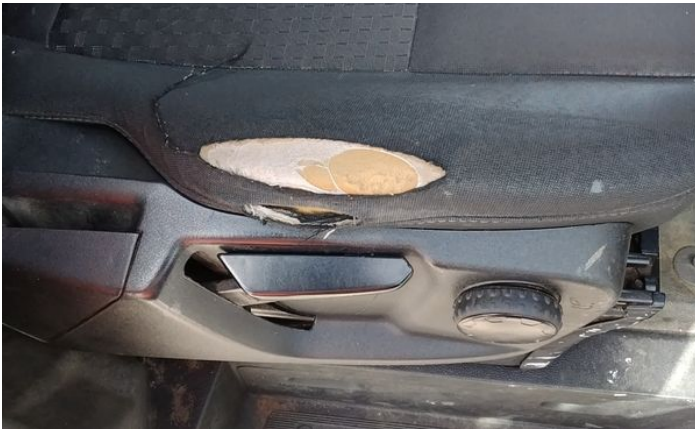
21: Seat Base Cover osf  
Torn  
Over 3mm

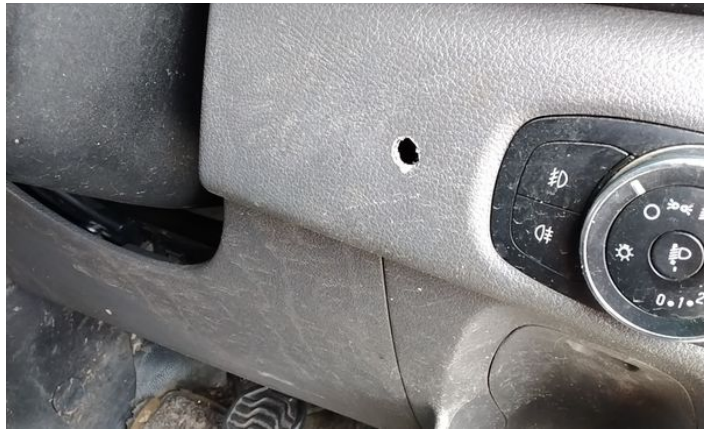
22: Centre Console Front  
Holed  
Over 3mm

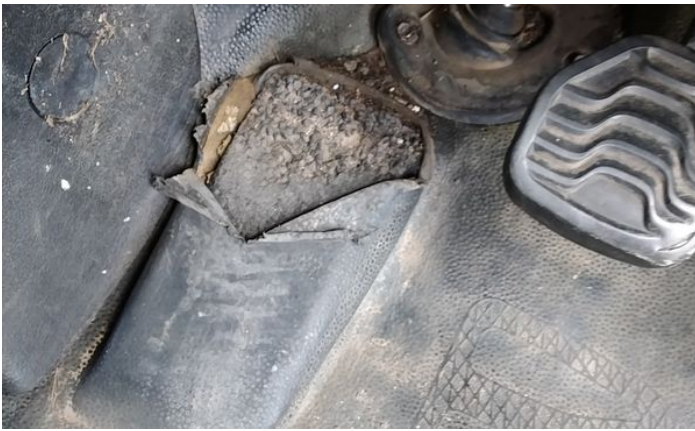
23: Carpets Front  
Torn  
Over 10mm

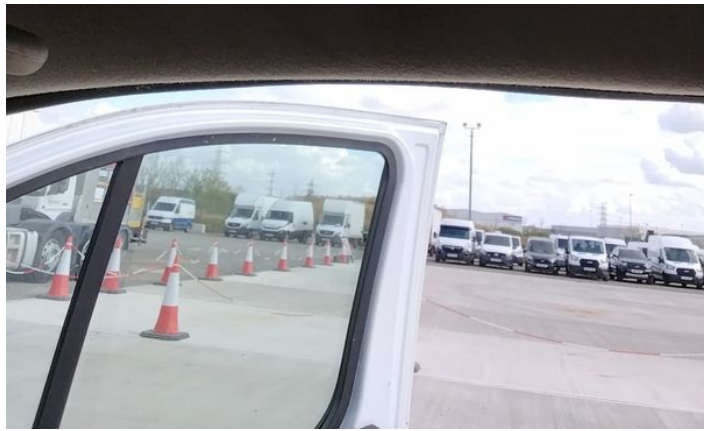
24: Fascia Trim  
Damaged  
Replace

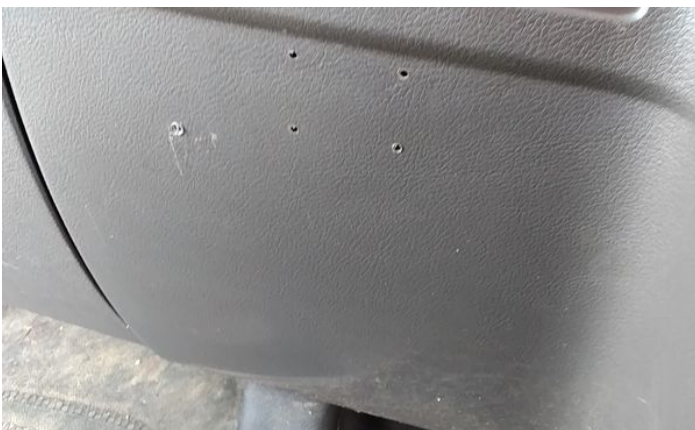
25: Centre Console Front  
Holed  
Over 3mm
