# VEHICLE INSPECTION REPORT

**SG13OEO**

## Peugeot Bipper 1.3 HDi 75 S

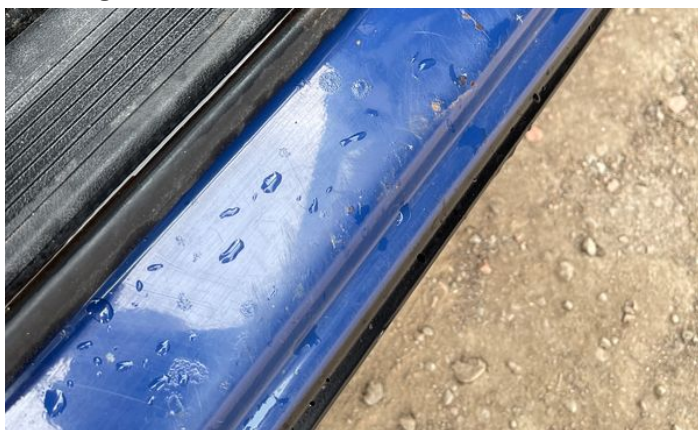
1: Sill os  
Rusted  
Over 5mm

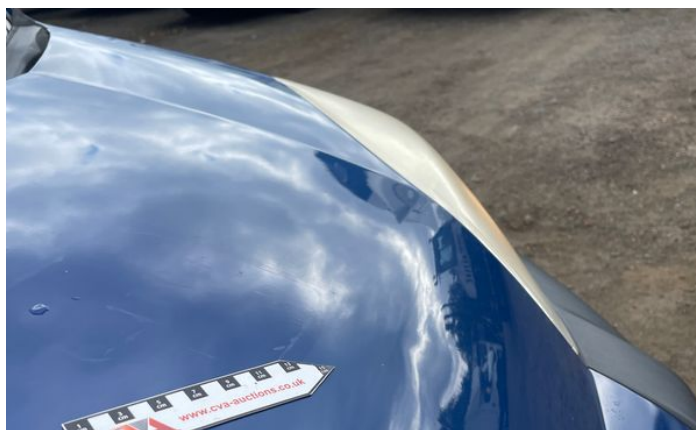
2: Bonnet  
Dented  
With Paint Damage

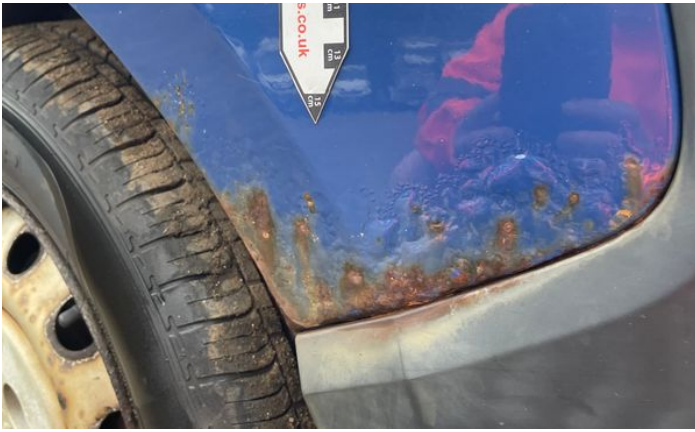
3: Wing osf  
Rusted  
Over 5mm

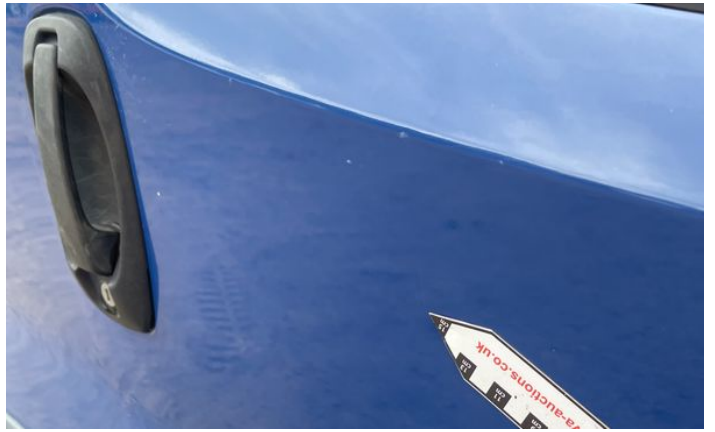
4: Door osf  
Dented  
Over 30mm

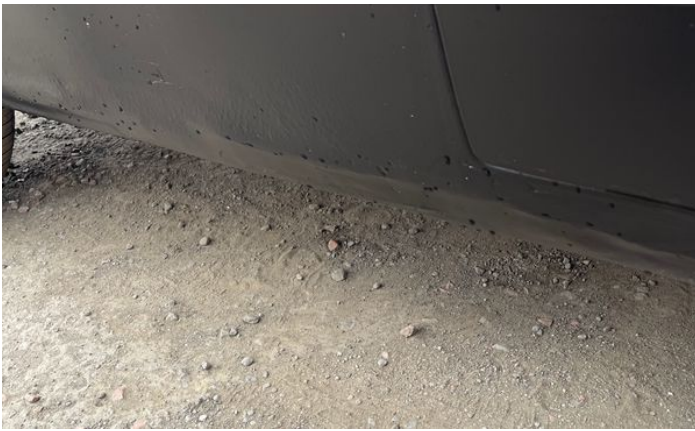
5: Sill os  
Poor Previous Repair  
Paint Flake

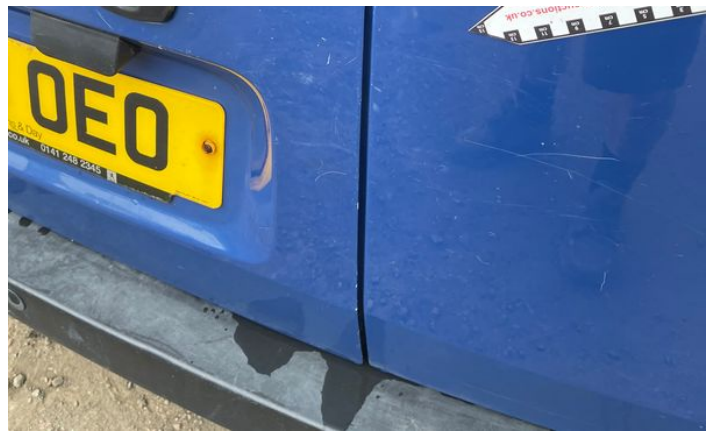
6: Tailgate  
Dented  
With Paint Damage

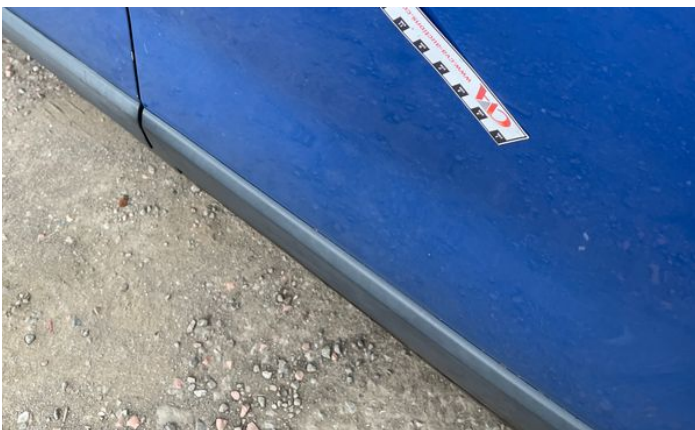
7: Door nsr  
Dented  
With Paint Damage

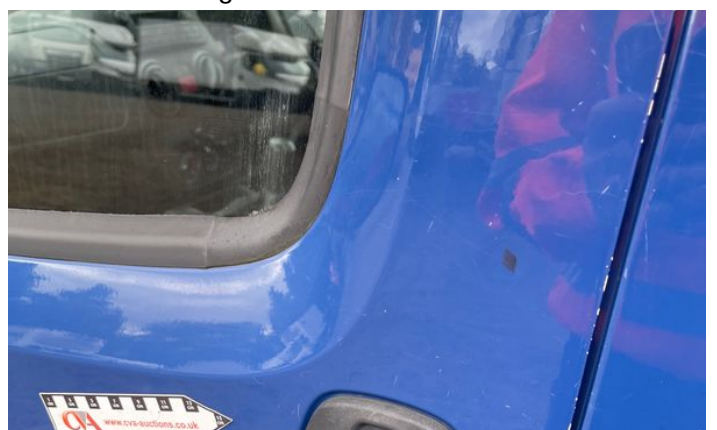
8: Door nsf  
Dented  
Over 30mm

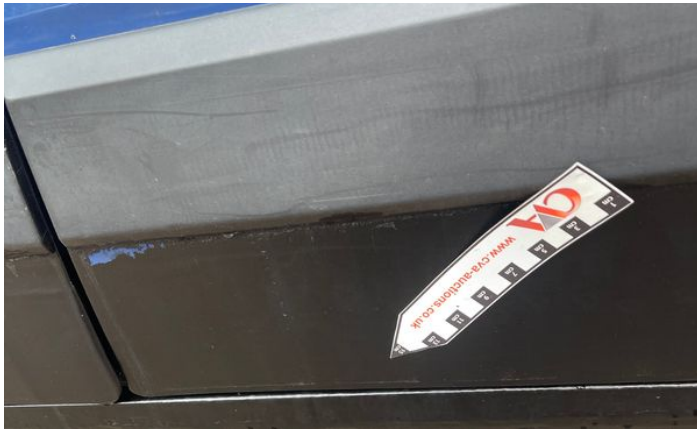
9: Sill ns  
 Poor Previous Repair  
 Poor Paint

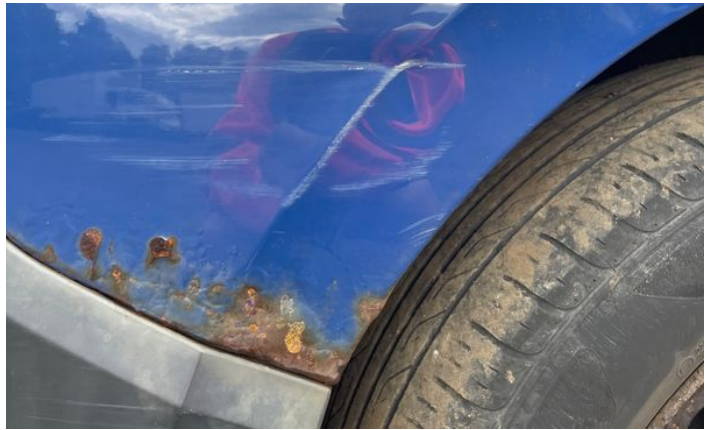
10: Wing nsf  
 Rusted  
 Over 5mm
