# VEHICLE INSPECTION REPORT

**SG13WGX**

## Peugeot Bipper 1.3 HDi 75PS S

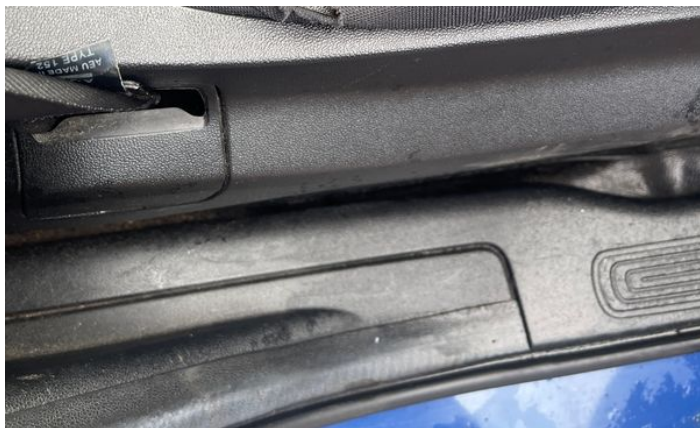
1: Seat Base Cover osf  
Torn  
Over 3mm

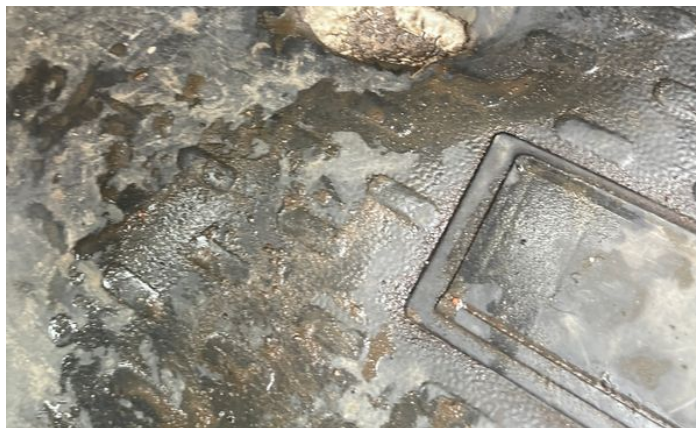
2: Carpets Front  
Torn  
Over 10mm

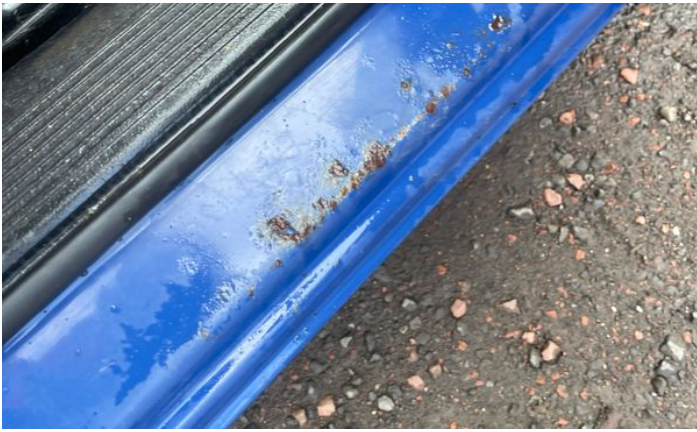
3: Sill os  
Rusted  
Over 5mm

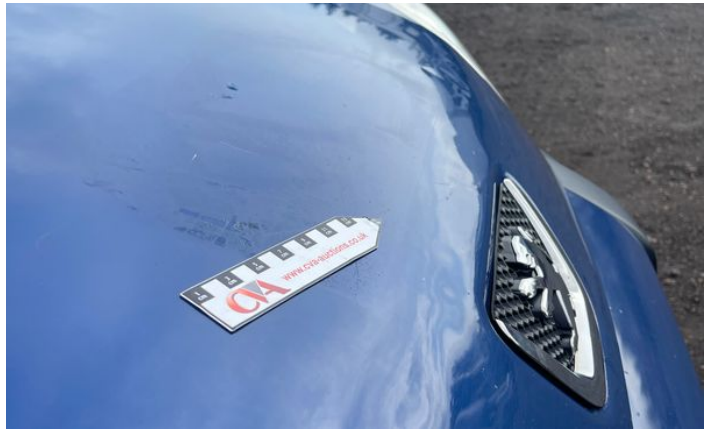
4: Bonnet  
Dented  
Over 30mm

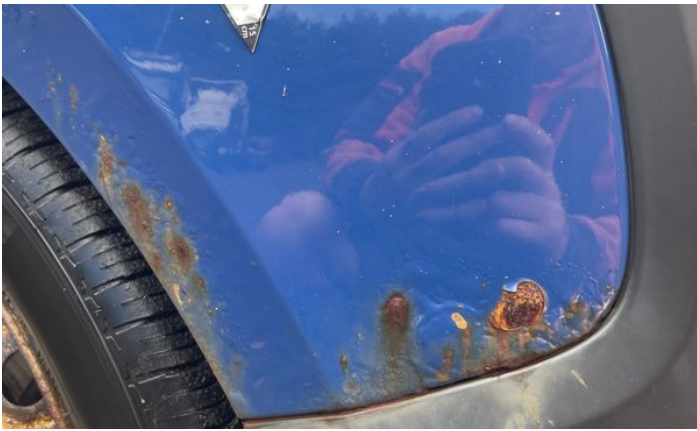
5: Wing osf  
Rusted  
Over 5mm

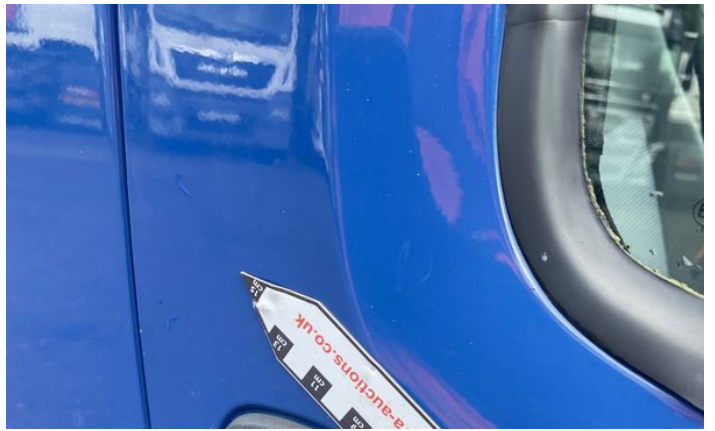
6: Door osf  
Dented  
Over 30mm

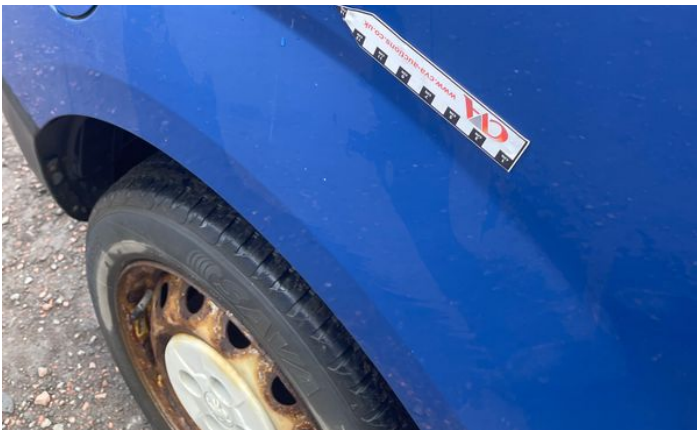
7: Qtr Panel osr  
Dented  
Between 10mm + 30mm

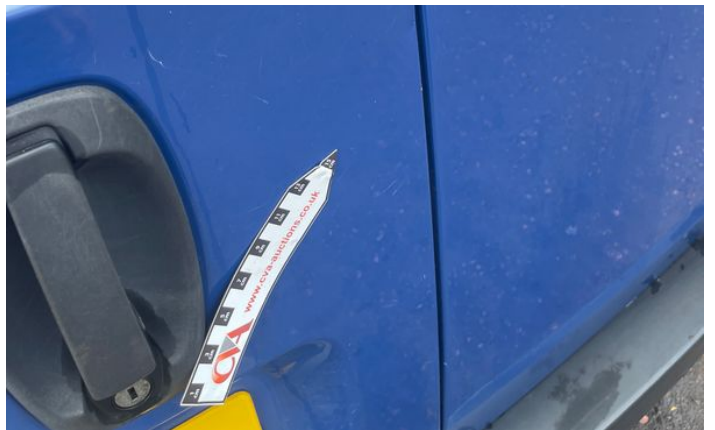
8: Tailgate  
Dented  
With Paint Damage

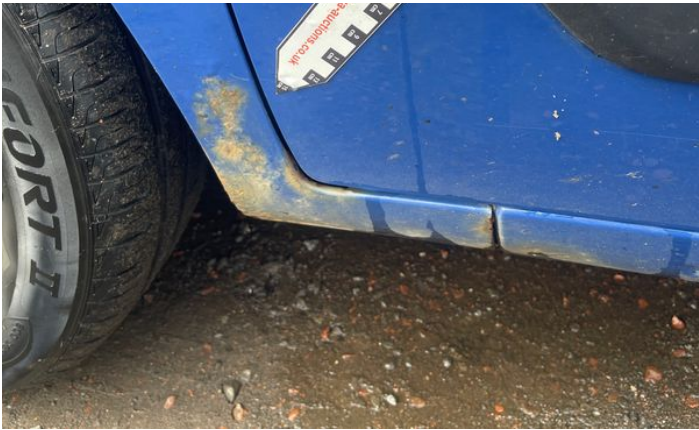
9: Wing nsf  
Rusted  
Over 5mm

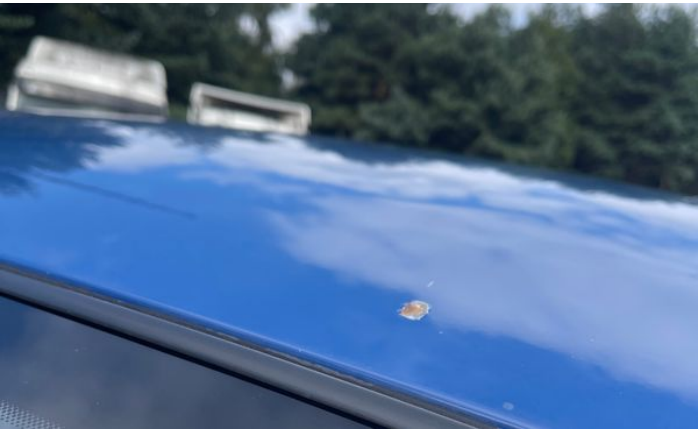
10: Roof  
Rusted  
Over 5mm
