# VEHICLE INSPECTION REPORT

**SG13WGY**

## Peugeot Bipper 1.3 HDi 75PS S

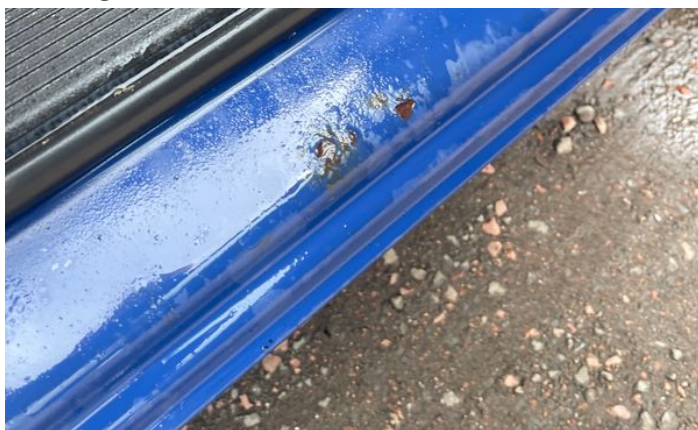
1: Sill os  
Rusted  
Over 5mm

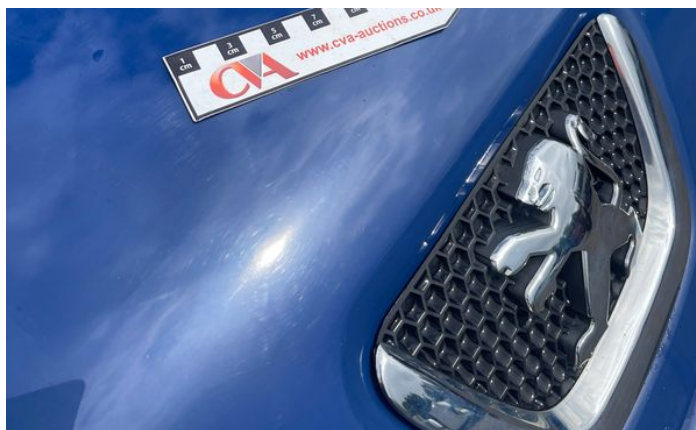
2: Bonnet  
Dented  
Over 2 UpTo 10mm

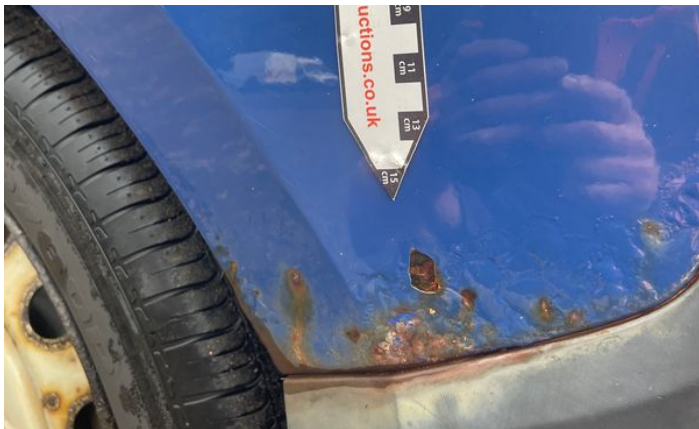
3: Wing osf  
Rusted  
Over 5mm

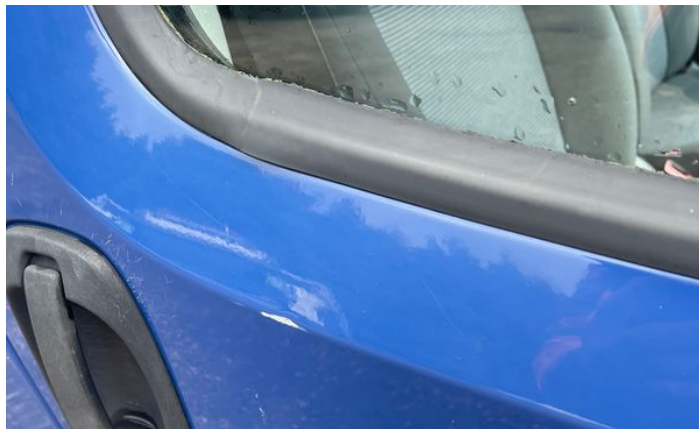
4: Door osf  
Dented  
With Paint Damage

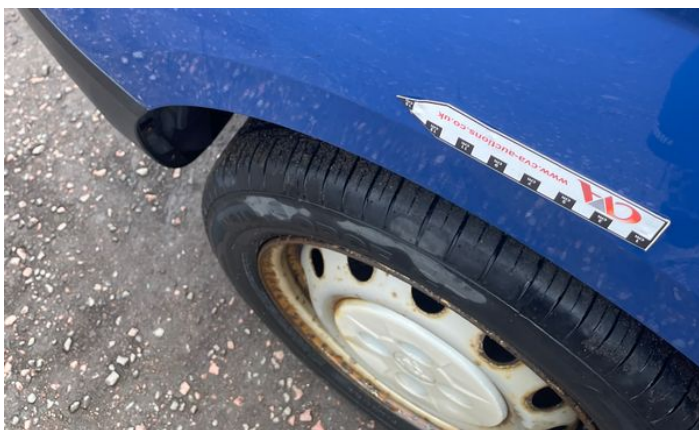
5: Qtr Panel osr  
Dented  
2 Or Less UpTo 10mm

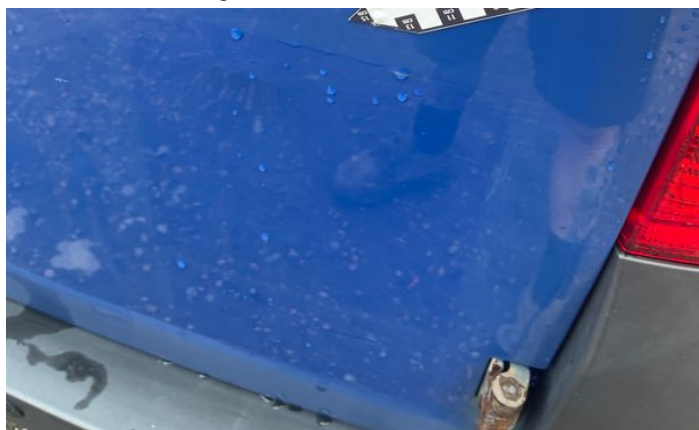
6: Tailgate  
Dented  
With Paint Damage

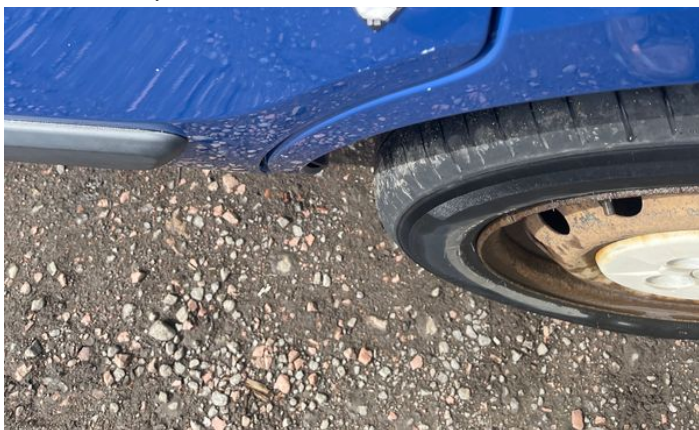
7: Door nsr  
Scratched  
UpTo 25mm Not Thru Paint

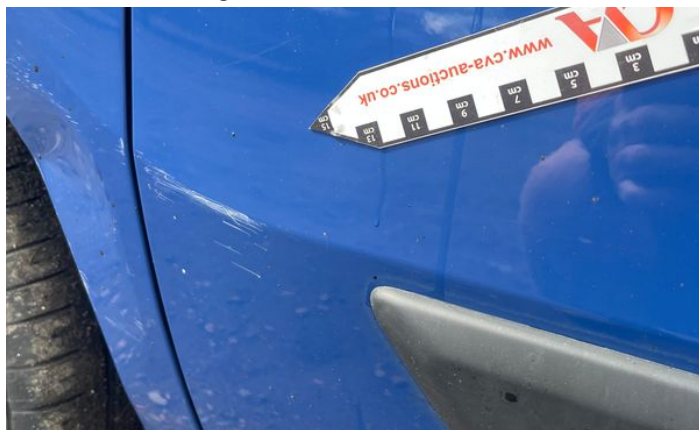
8: Door nsf  
Dented  
With Paint Damage

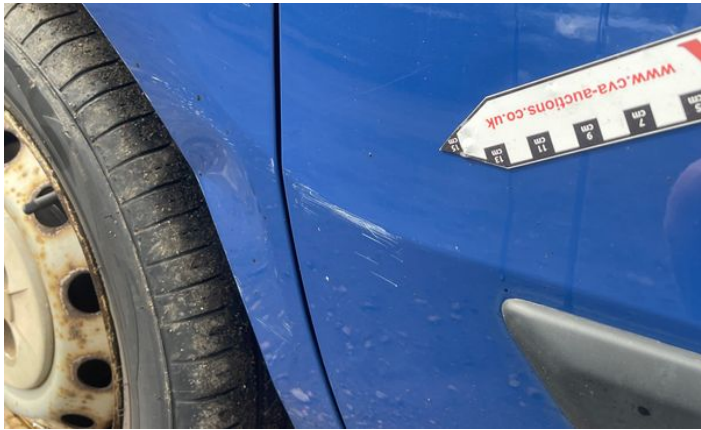
9: Wing nsf  
Dented  
With Paint Damage
