# VEHICLE INSPECTION REPORT

**SG13WHA**

## Peugeot Bipper 1.3 HDi 75PS

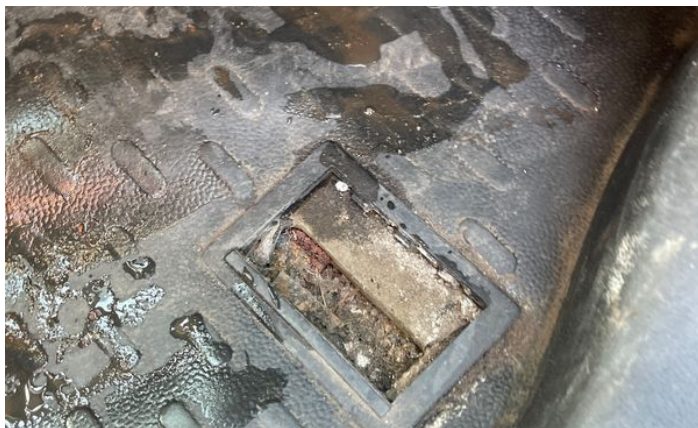
1: Carpets Front  
Missing  
Replace

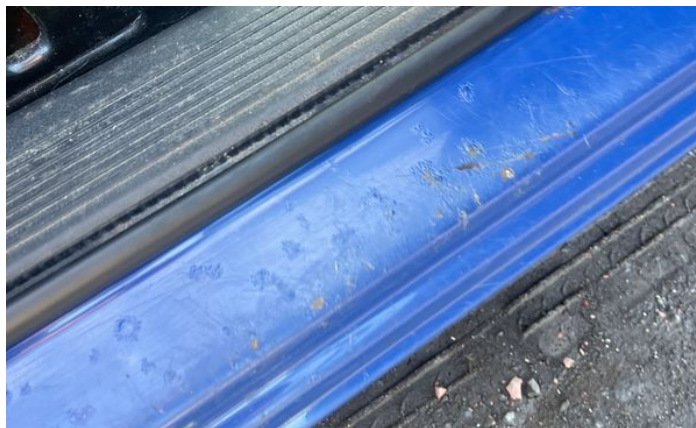
2: Sill os  
Rusted  
Over 5mm

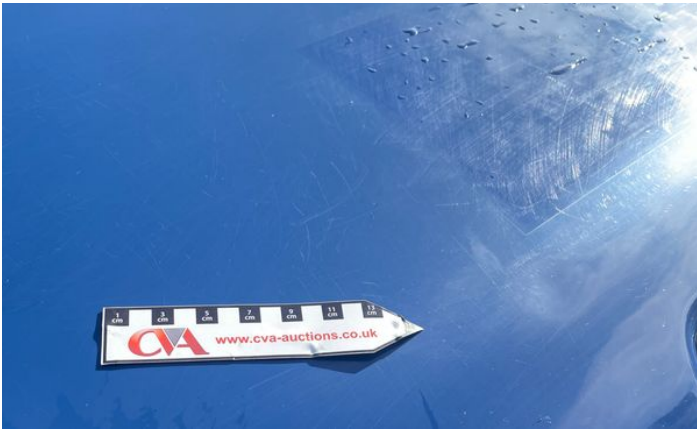
3: Bonnet  
Dented  
Over 30mm

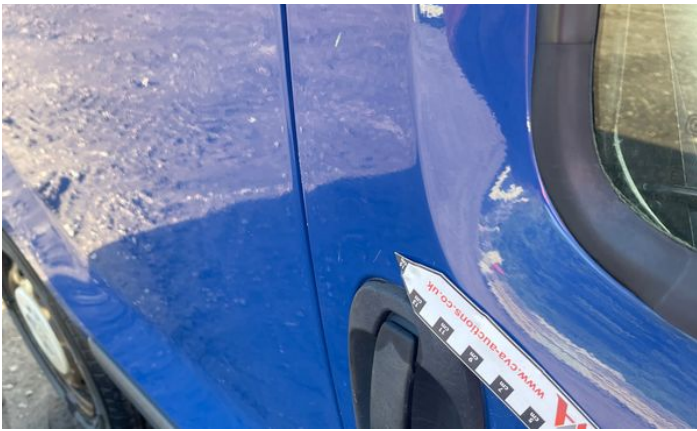
5: Door osf  
Dented  
With Paint Damage

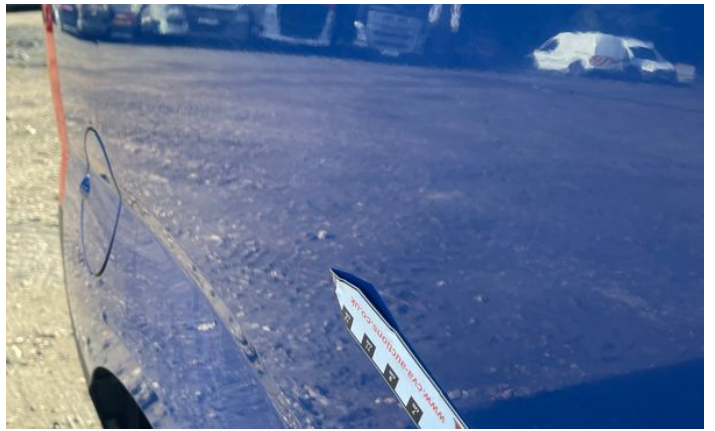
6: Qtr Panel osr  
Dented  
Over 2 UpTo 10mm

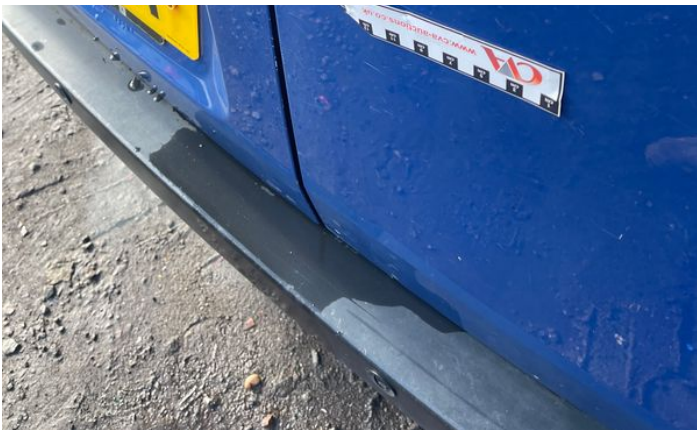
7: Tailgate  
Dented  
Over 30mm

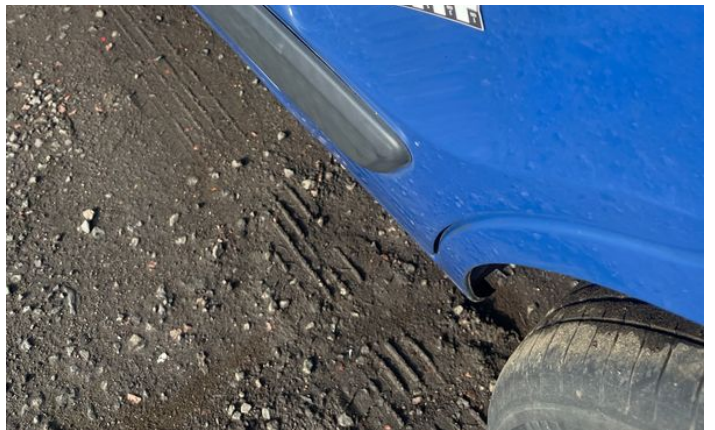
8: Door nsr  
Dented  
With Paint Damage
