# VEHICLE INSPECTION REPORT

**SG13WHP**

## Peugeot Bipper 1.3 HDi 75 S

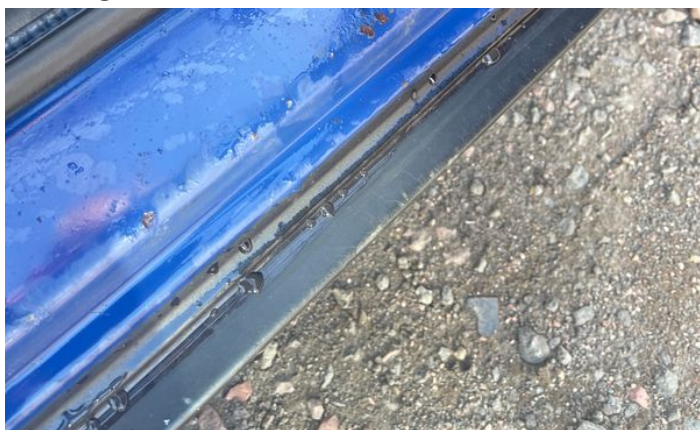
1: Sill os  
Rusted  
Over 5mm

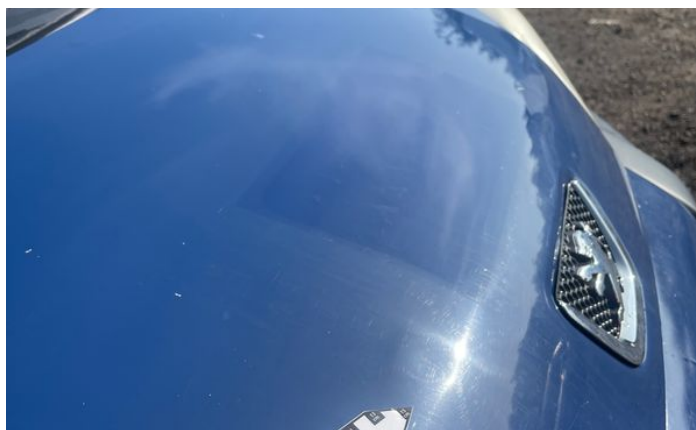
2: Bonnet  
Dented  
With Paint Damage

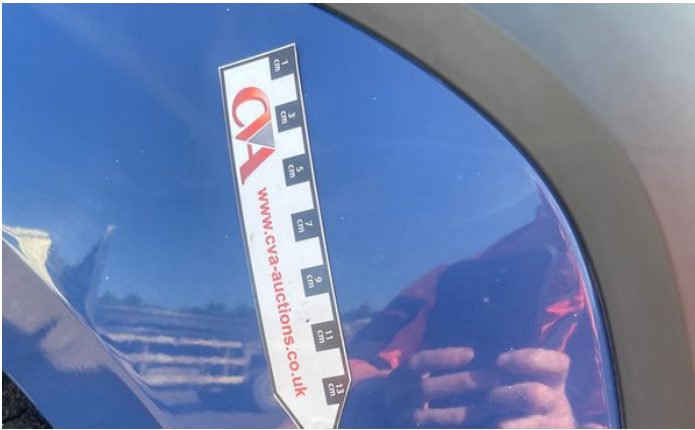
3: Wing osf  
Rusted  
Over 5mm

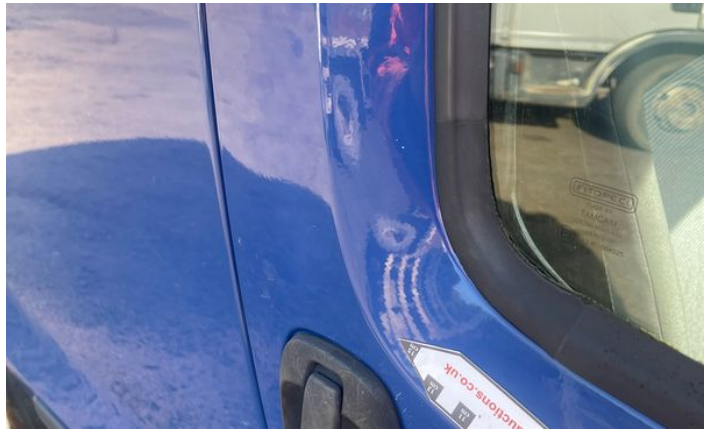
4: Door osf  
Dented  
Over 30mm

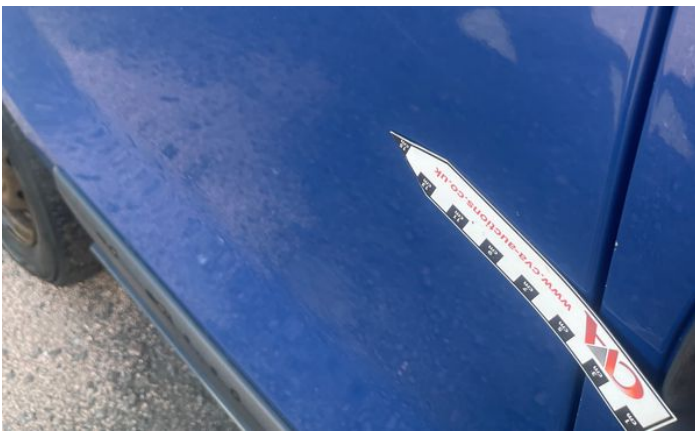
5: Qtr Panel osr  
Dented  
With Paint Damage

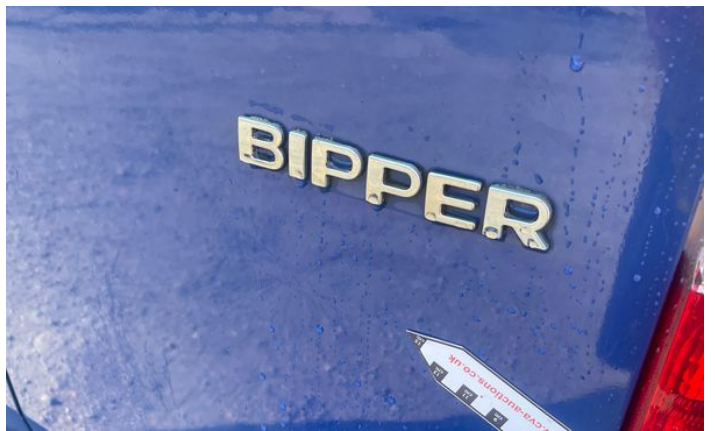
6: Tailgate  
Dented  
With Paint Damage

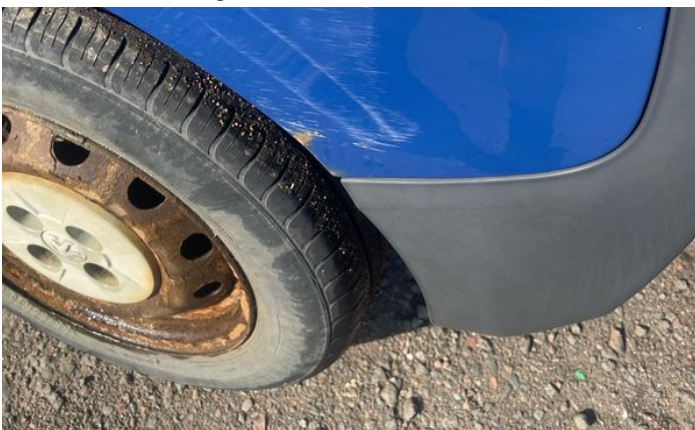
7: Qtr Panel nsr  
Dented  
With Paint Damage

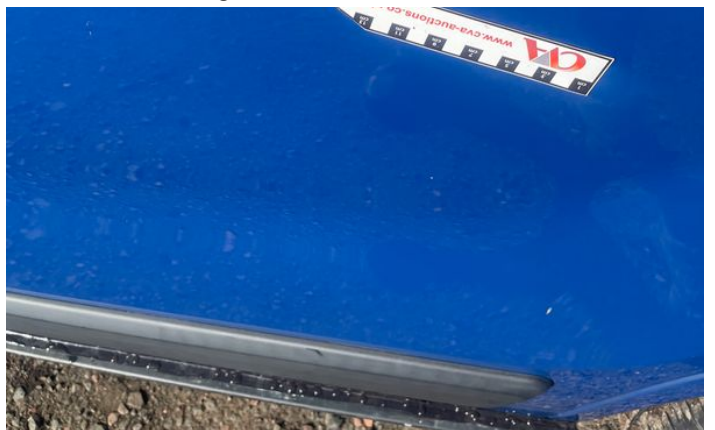
8: Door nsr  
Dented  
2 Or Less UpTo 10mm

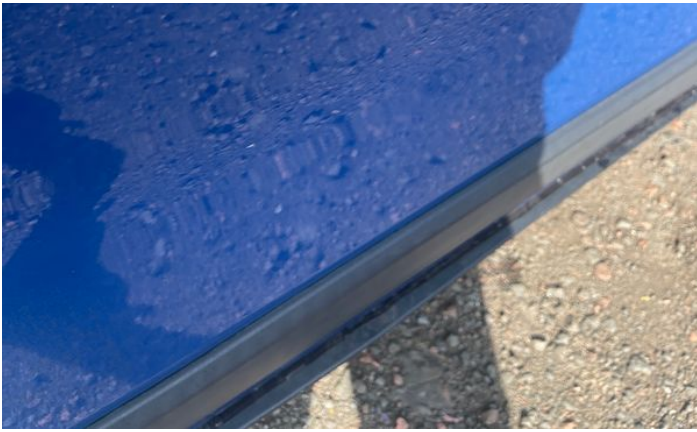
9: Door nsf  
Dented  
Over 2 UpTo 10mm

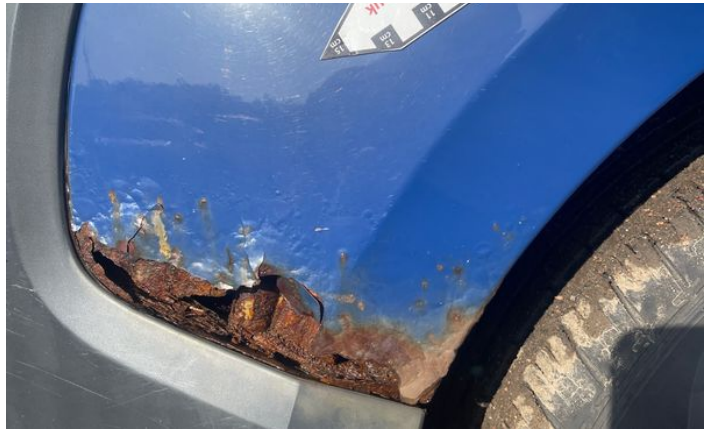
10: Wing nsf  
Hole  
Over 10mm
