# VEHICLE INSPECTION REPORT

**SG13OFM**

## Peugeot Bipper 1.3 HDi 75PS S

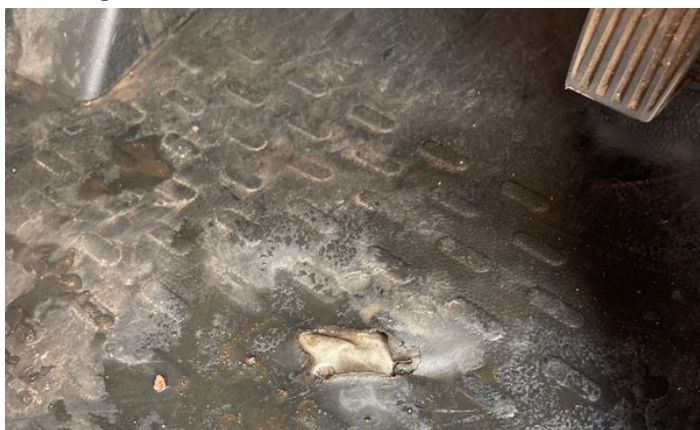
1: Carpets Front  
Torn  
Over 10mm

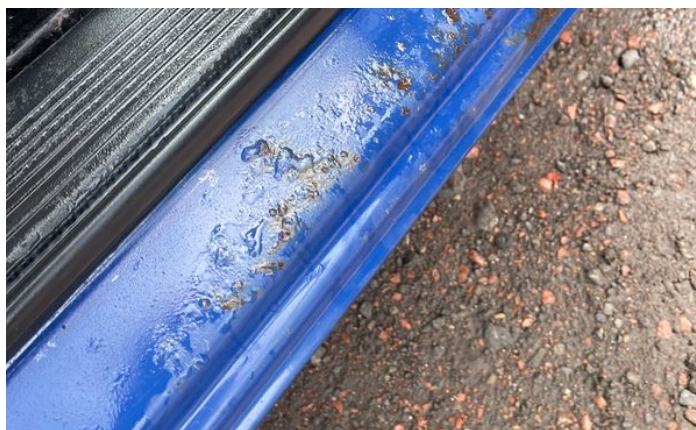
2: Sill os  
Rusted  
Over 5mm

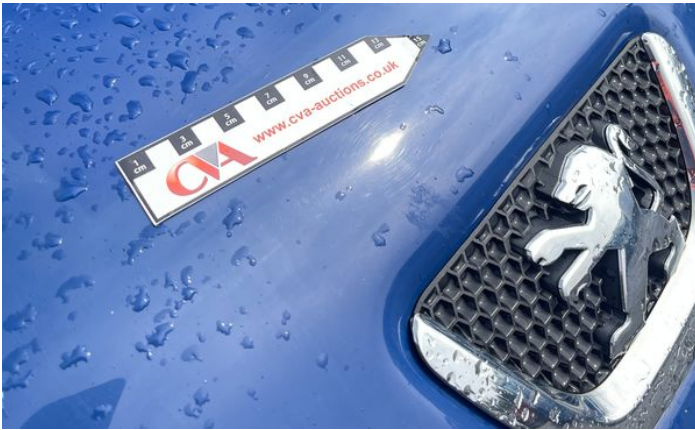
3: Bonnet  
Dented  
Over 30mm

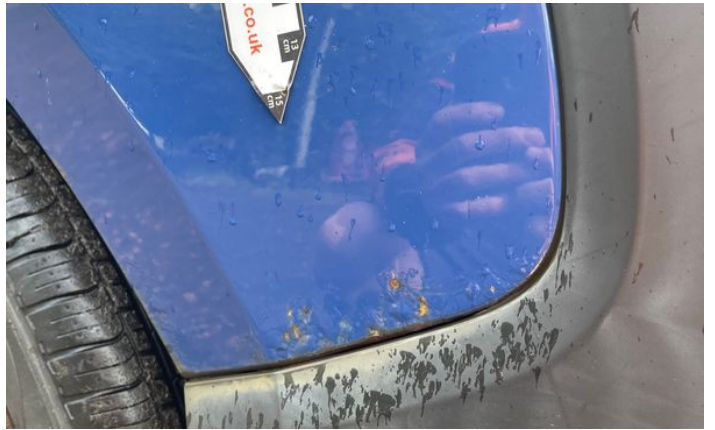
4: Wing osf  
Rusted  
Over 5mm

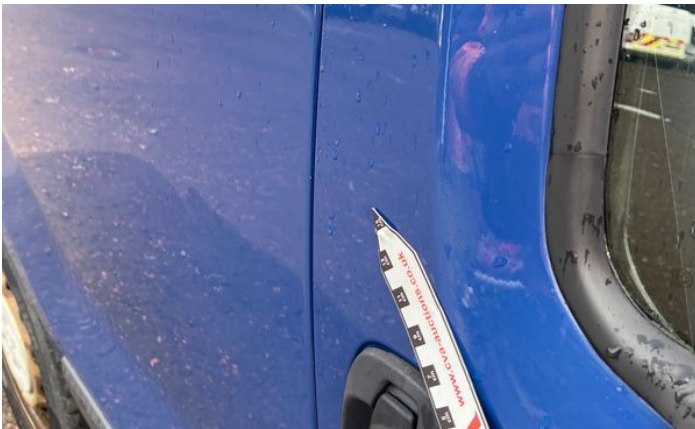
5: Door osf  
Dented  
Over 30mm

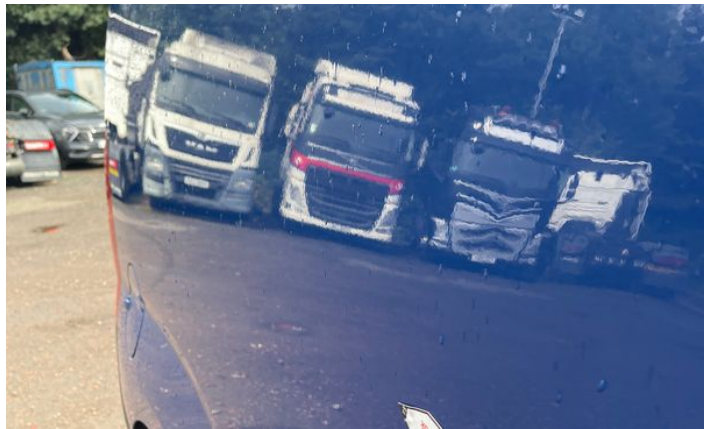
6: Qtr Panel osr  
Dented  
Over 30mm

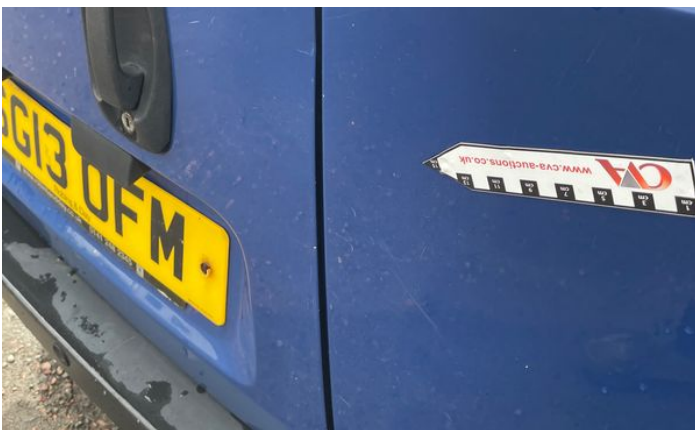
7: Tailgate  
Dented  
With Paint Damage

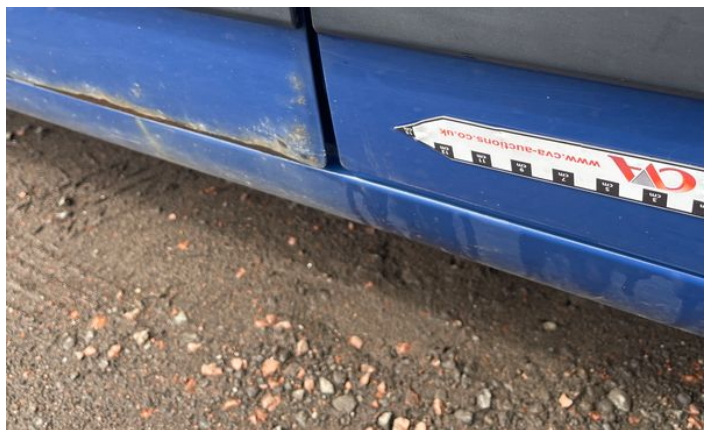
8: Door nsf  
Rusted  
Over 5mm

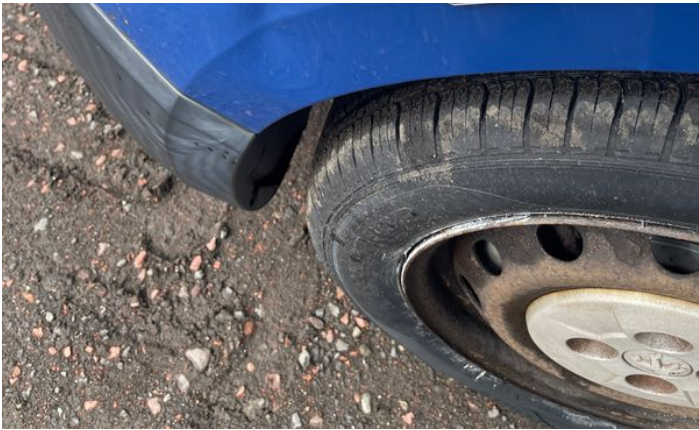
9: Wing nsf  
Dented  
With Paint Damage

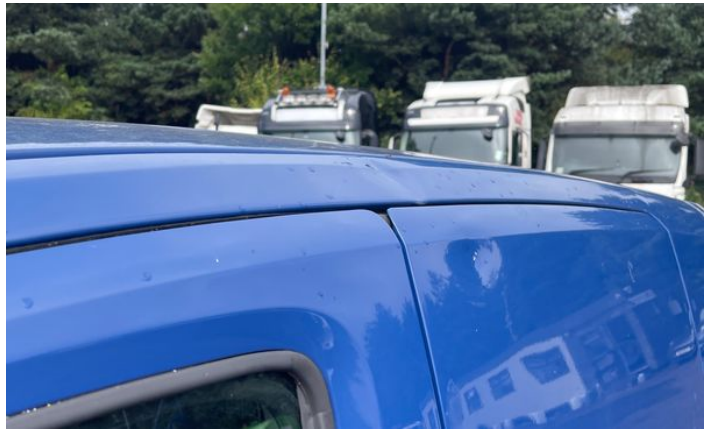
10: Door nsr  
Dented  
With Paint Damage

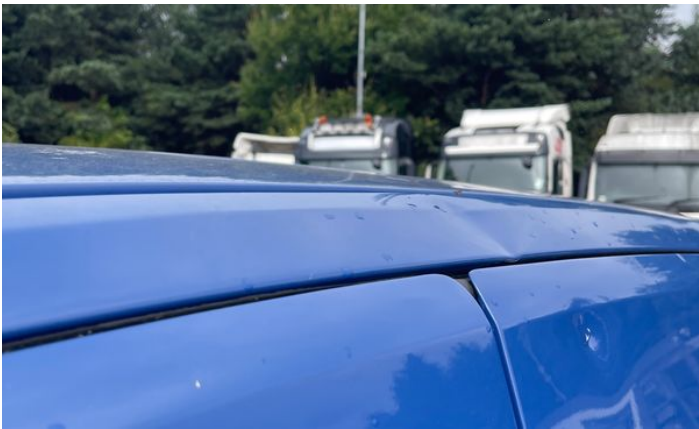
11: Roof  
Dented  
With Paint Damage
