# VEHICLE INSPECTION REPORT

**SG13WHR**

## Peugeot Bipper 1.3 HDi 75PS S

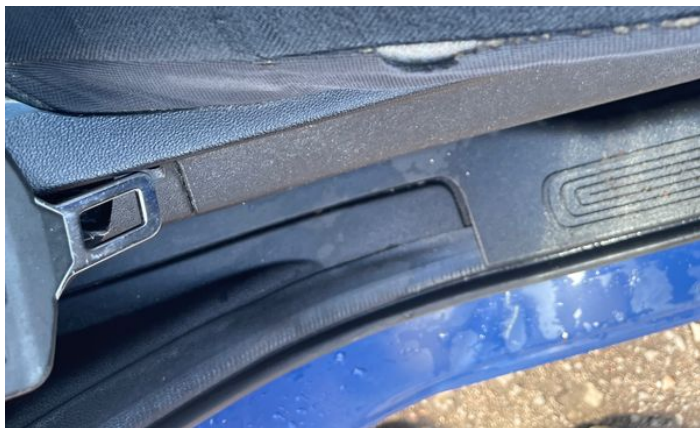
1: Seat Base Cover osf  
Torn  
Over 3mm

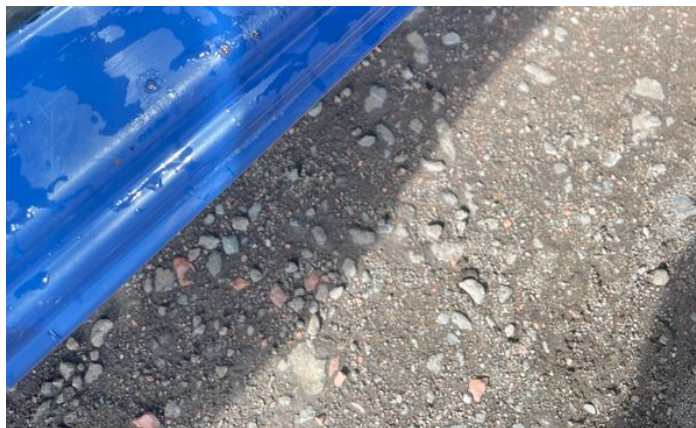
2: Sill os  
Rusted  
Over 5mm

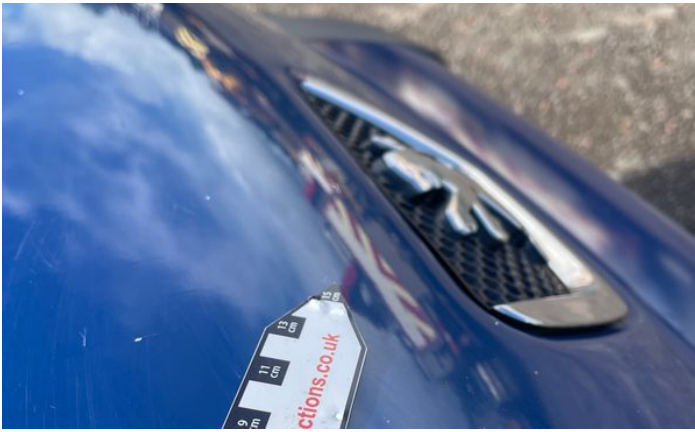
3: Bonnet  
Dented  
Over 2 UpTo 10mm

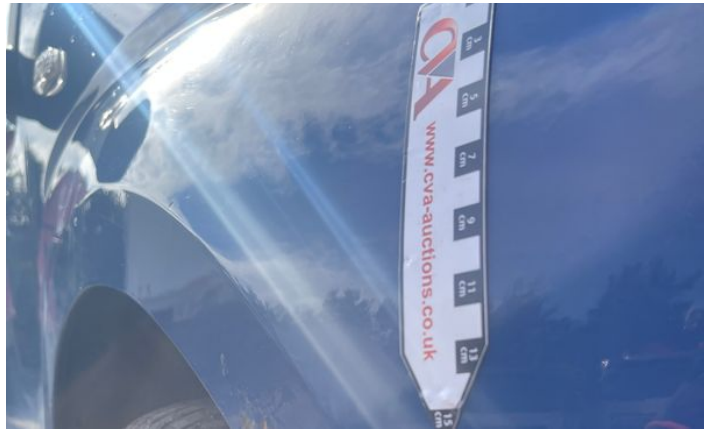
4: Wing of  
Rusted  
Over 5mm

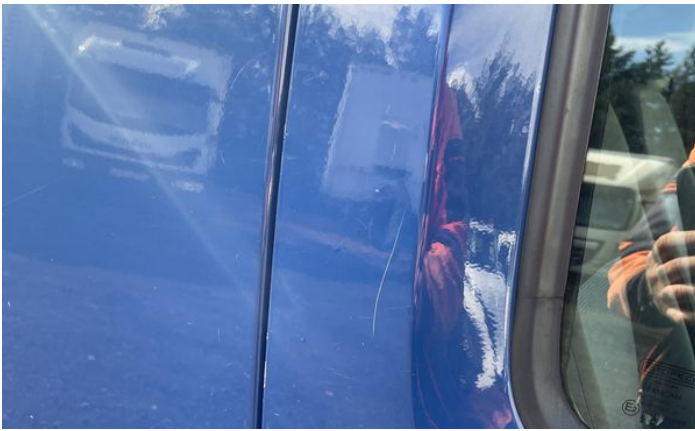
5: Door of  
Dented  
With Paint Damage

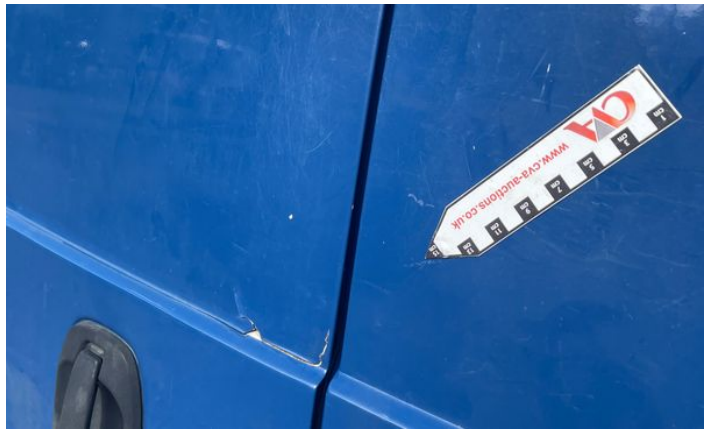
6: Tailgate  
Poor Previous Repair  
Poor Paint

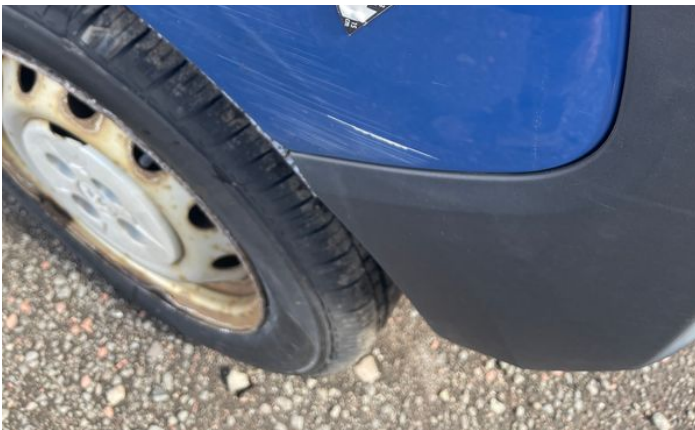
7: Qtr Panel nr  
Dented  
With Paint Damage

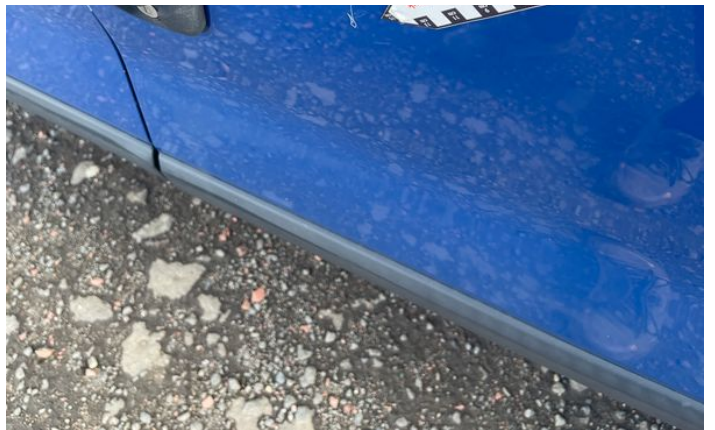
8: Door nr  
Scratched  
UpTo 25mm Thru Paint

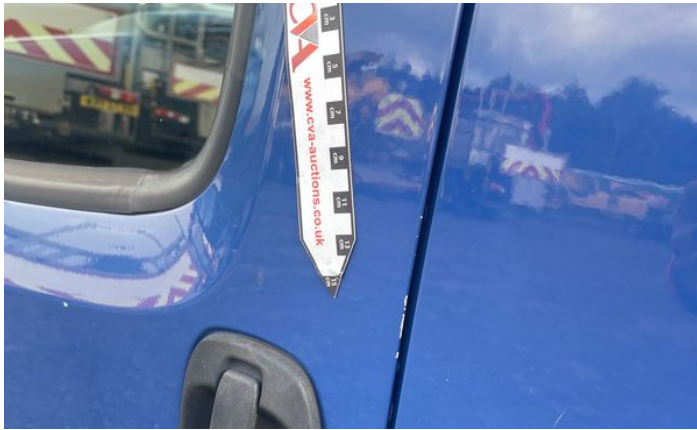
9: Door nsf  
Dented  
Over 30mm

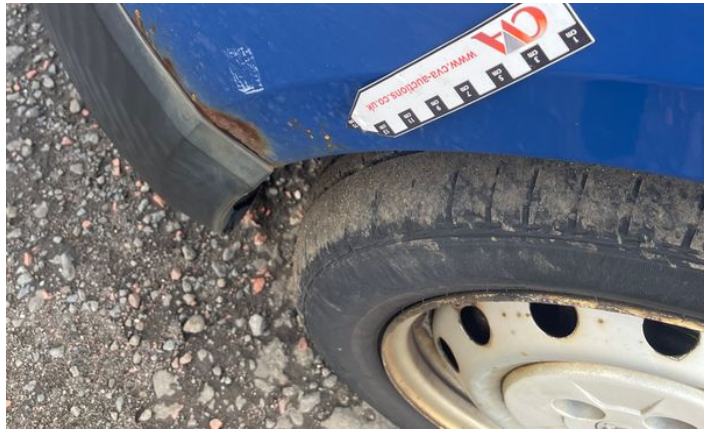
10: Wing nsf  
Rusted  
Over 5mm
