# VEHICLE INSPECTION REPORT

**DG66PNJ**

## Man Tgs 26.360

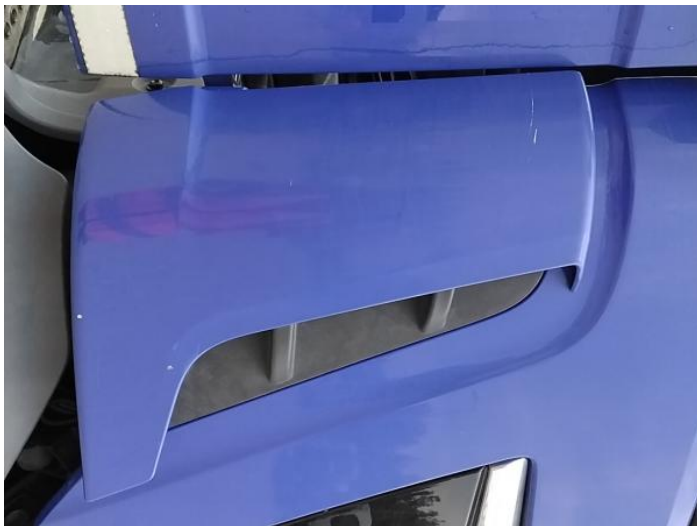
1: Moulding on Wing  
Scratched (Painted)  
Over 25mm Thru Paint

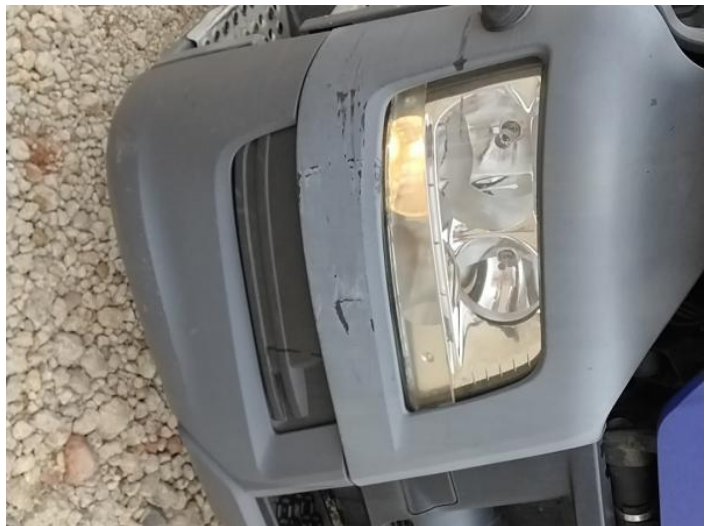
2: Fog Lamp Surround is  
Scuffed (Unpainted)  
Over 100mm

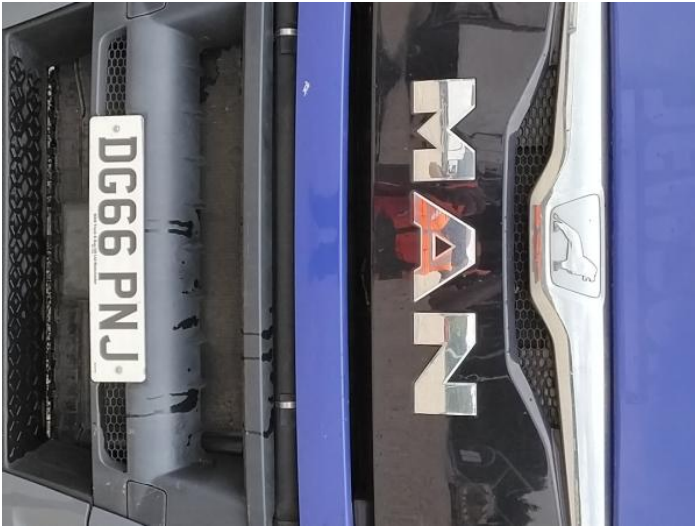
3: Bonnet  
Scratched  
Over 25mm Thru Paint

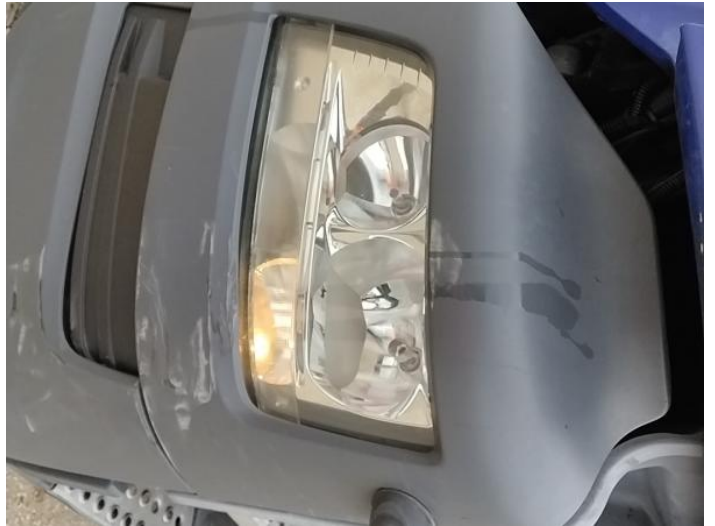
4: Fog Lamp Surround ns  
Scuffed (Unpainted)  
Over 100mm

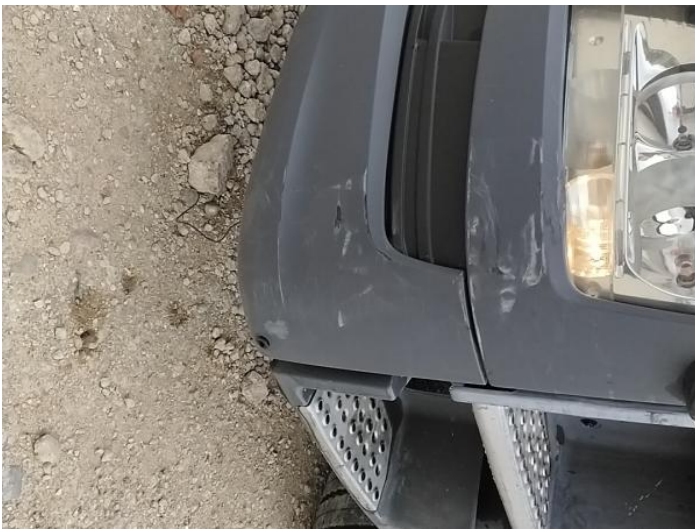
5: Bumper Front  
Scratched  
Over 25mm Not Thru Paint

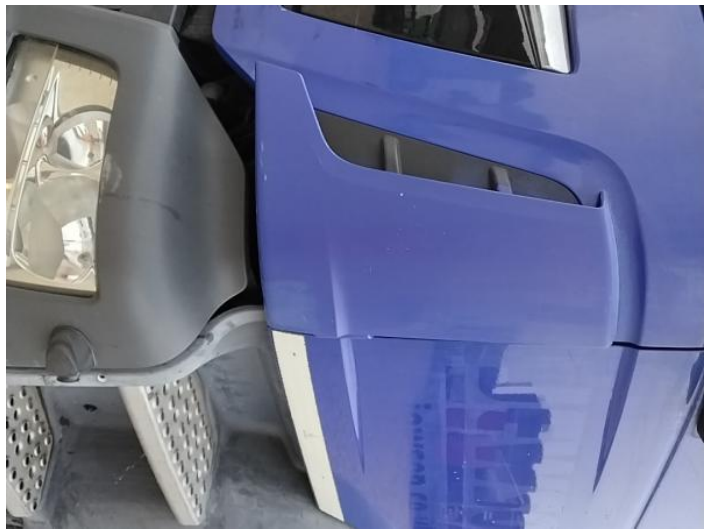
6: Moulding nsf Wing  
Scratched (Painted)  
Over 25mm Thru Paint

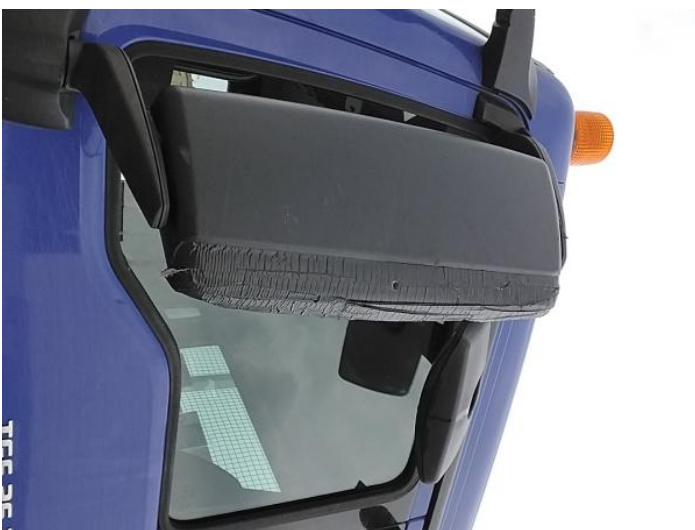
7: Door Mirror Assy nsf  
Broken  
Replace

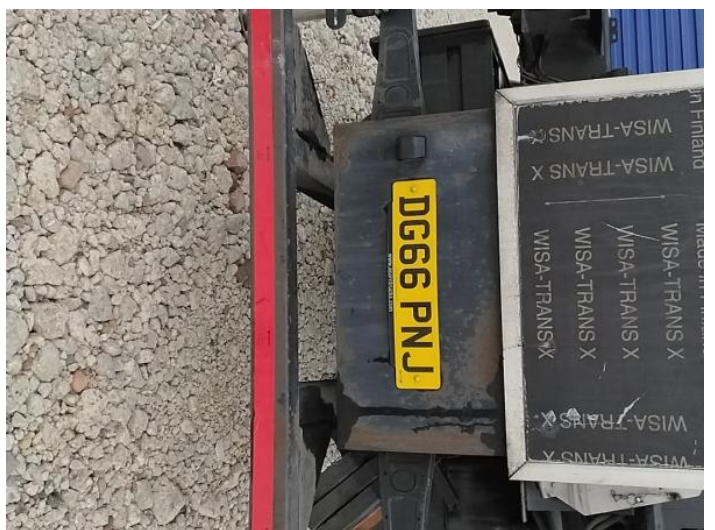
8: Bumper Rear  
Dented  
Over 30mm

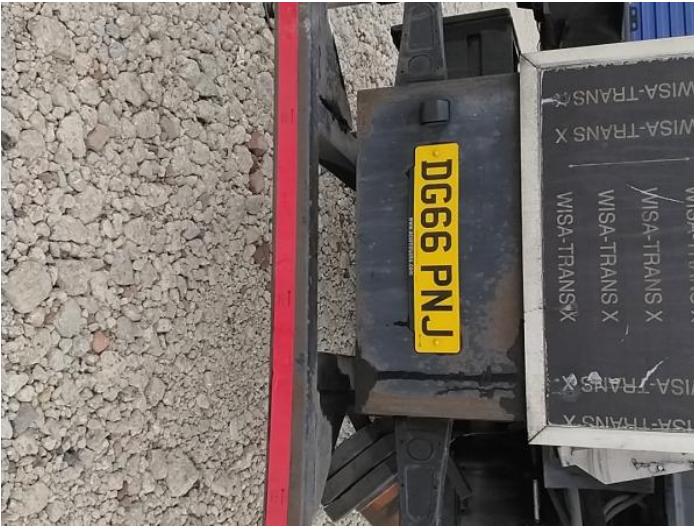
9: Bumper Rear  
Rusted  
Over 5mm

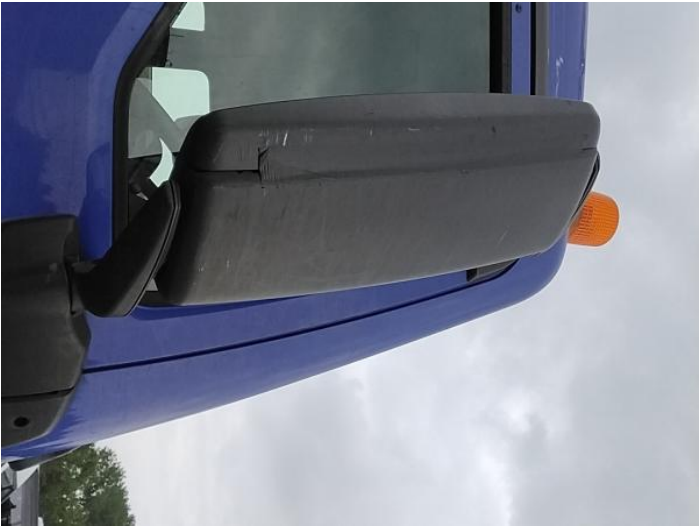
10: Door Mirror Assy osf  
Broken  
Replace

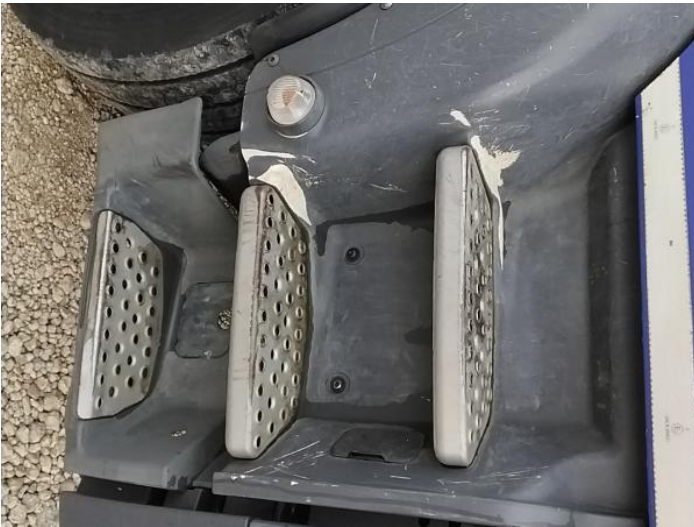
11: General Exterior  
Soiled  
Light

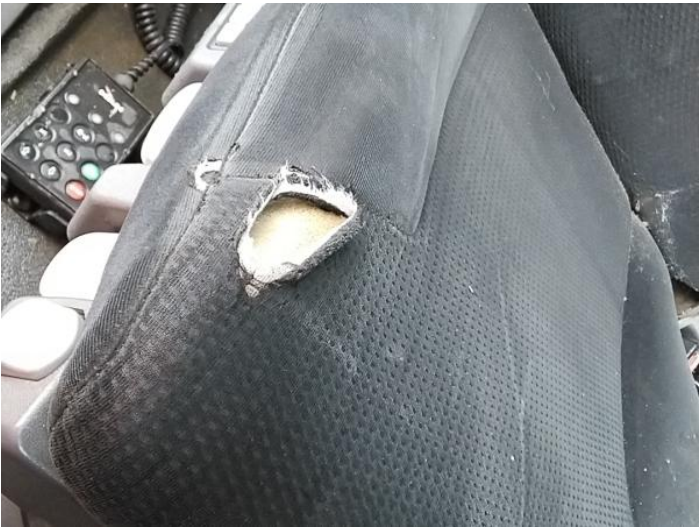
12: Seat Base Cover osf  
Holed  
Over 3mm

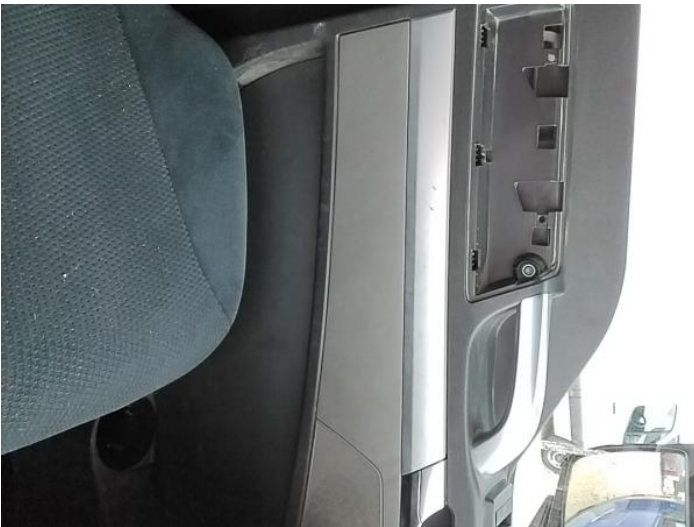
13: Door Pad nsf  
Missing  
Replace
