# VEHICLE INSPECTION REPORT

**HV69WPT**

## Mercedes-Benz Atego 821

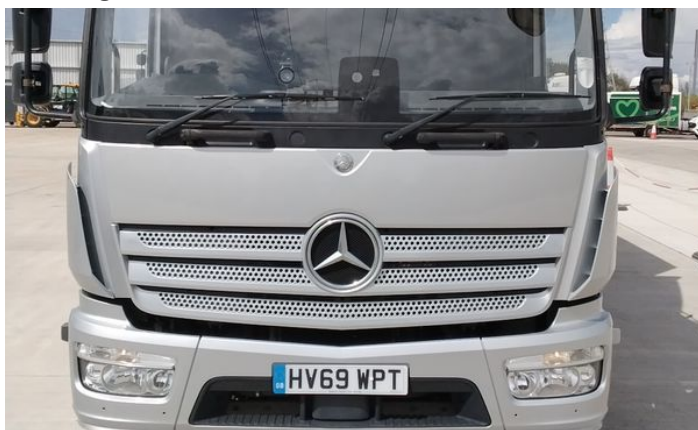
1: Bonnet  
Chipped  
Multiple Chips

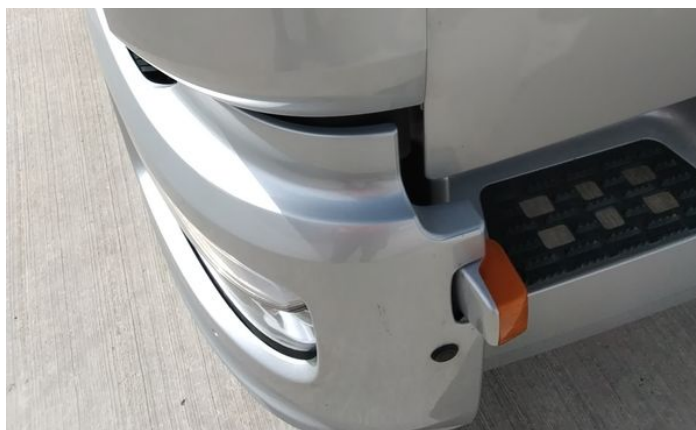
2: Moulding nsf Wing  
Missing  
Replace

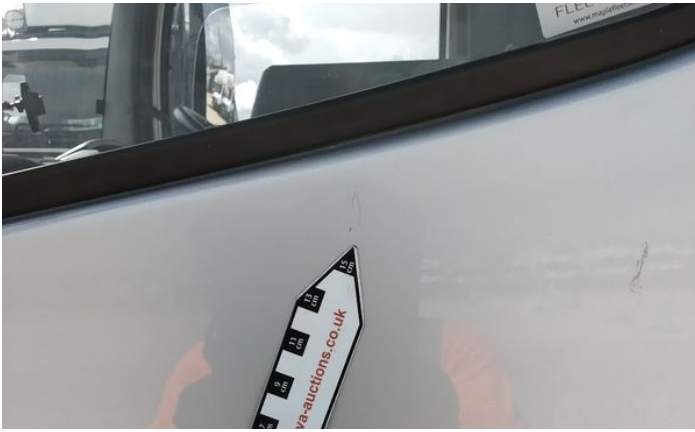
3: Door nsf  
Scratched  
Over 25mm Thru Paint

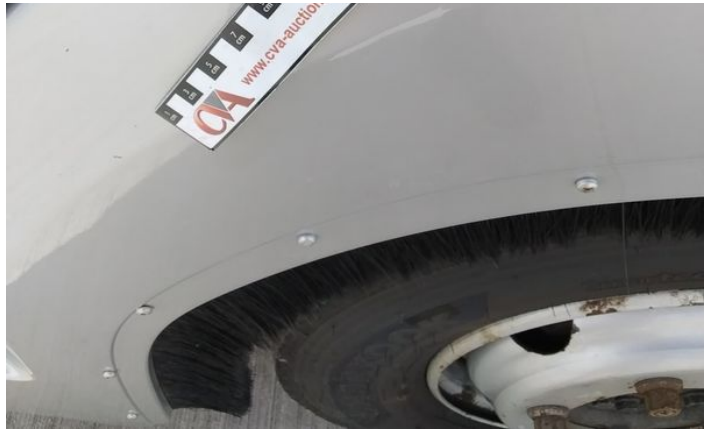
4: Wing Front Arch Extension ns  
Scratched (Painted)  
UpTo 25mm Thru Paint

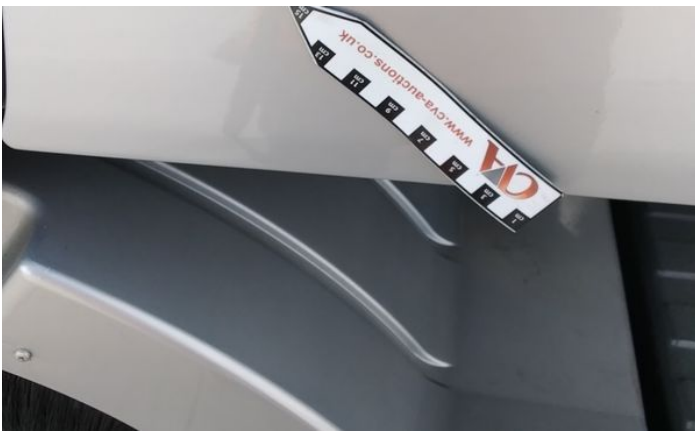
5: Qtr Panel nsr  
Scratched  
Over 25mm Thru Paint

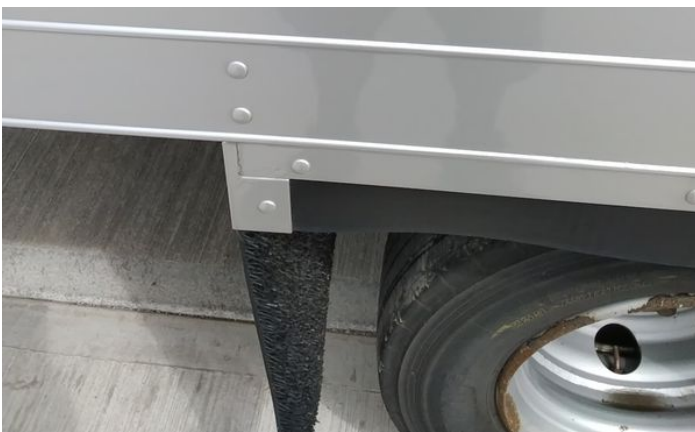
7: Qtr Panel osr  
Scratched  
Over 25mm Thru Paint

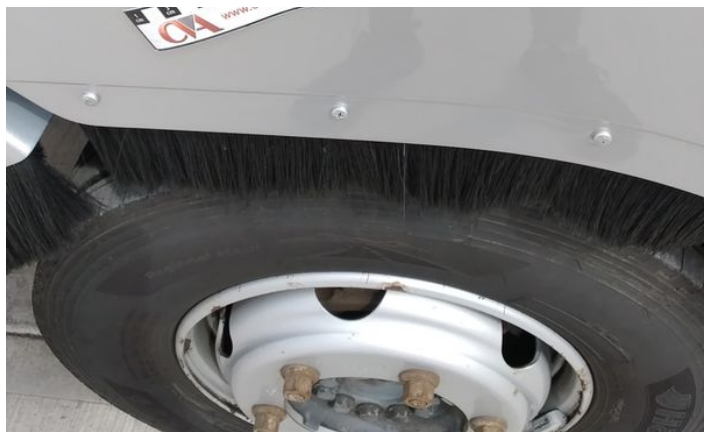
8: Wing Front Arch Extension os  
Scratched (Painted)  
Over 25mm Thru Paint

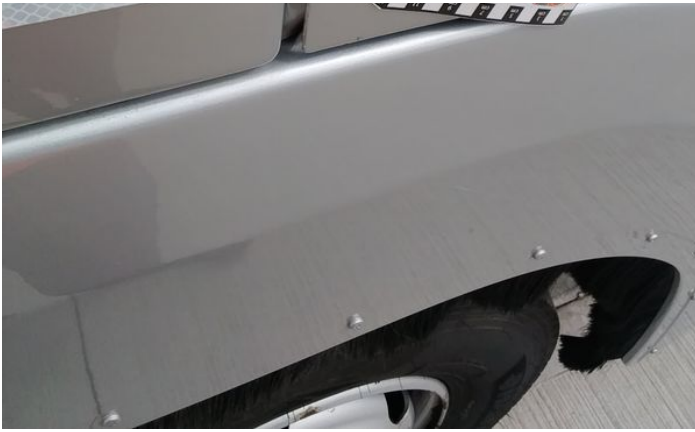
9: Door osf  
Chipped  
Multiple Chips

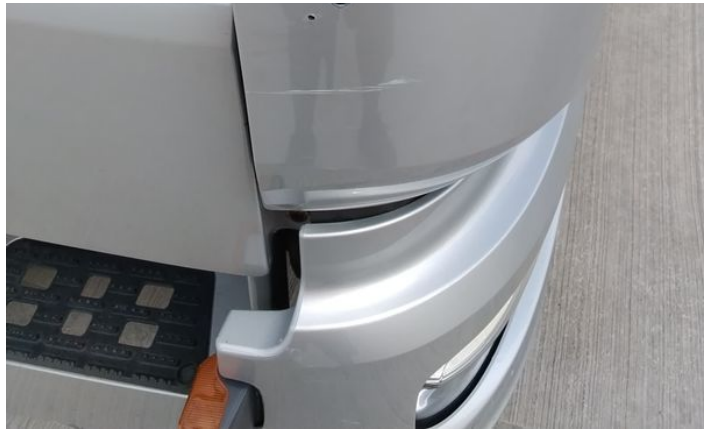
10: Moulding osf Wing  
Missing  
Replace

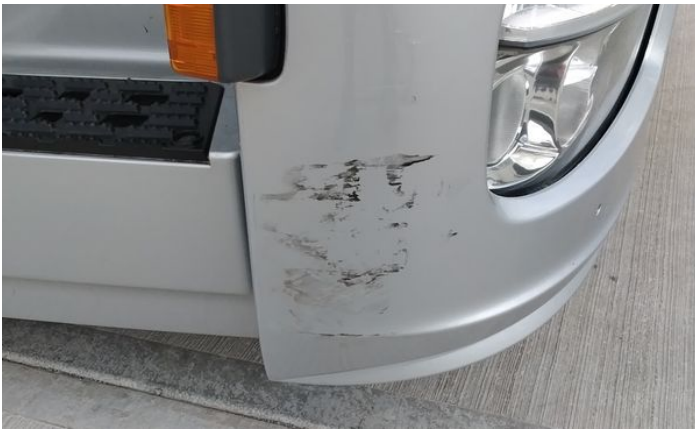
11: Bumper Front  
Scratched  
Over 100mm Thru Paint

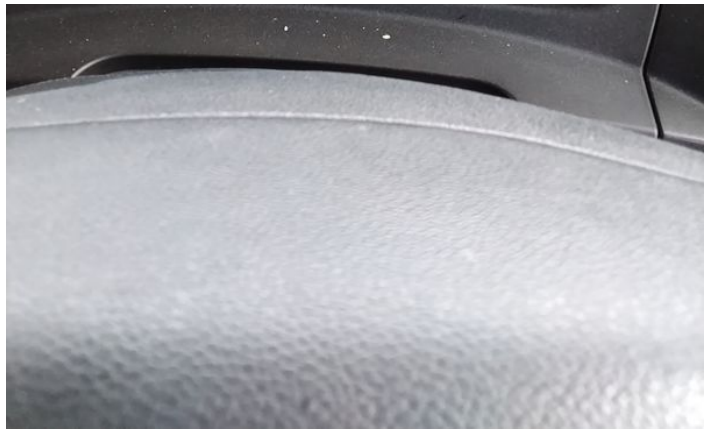
12: Dash Warning Lights  
Displayed  
No Action

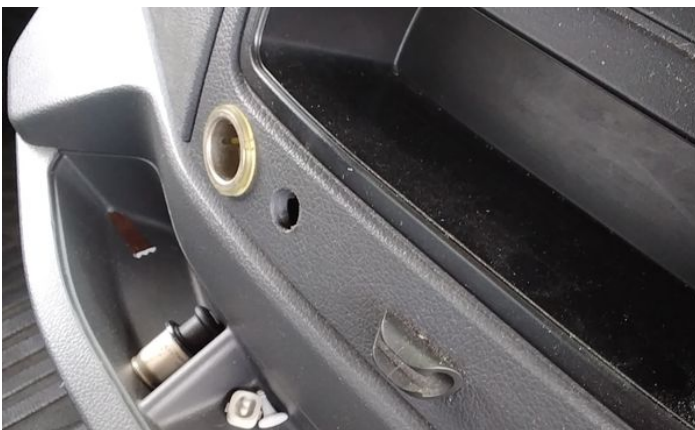
13: Centre Console Front  
Holed  
Over 3mm
