# VEHICLE INSPECTION REPORT

**YJ69ZTV**

## Mercedes-Benz Actros 2543

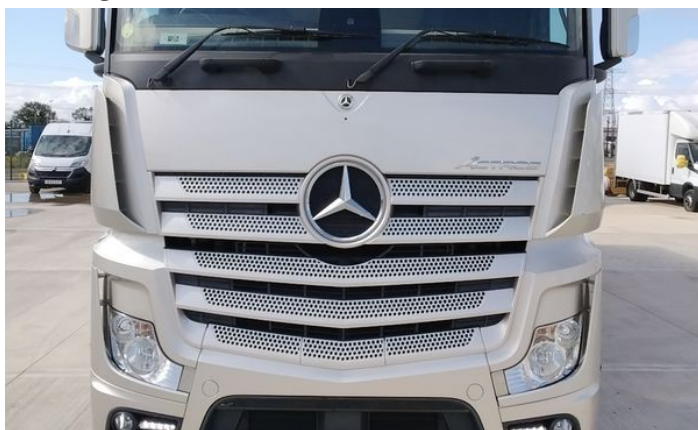
1: Bonnet  
Chipped  
Multiple Chips

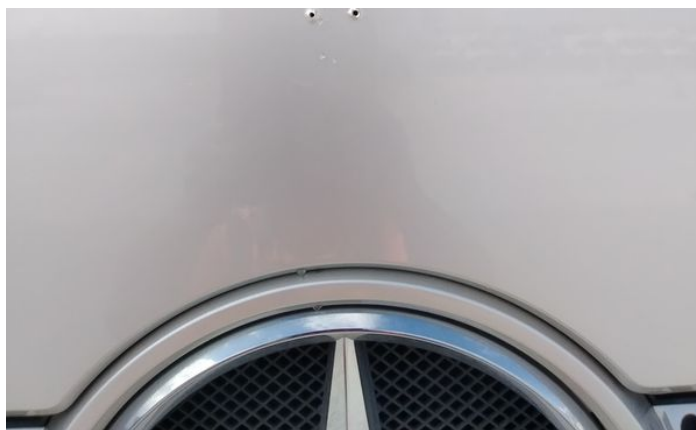
2: Badgedecal Front  
Missing  
Replace

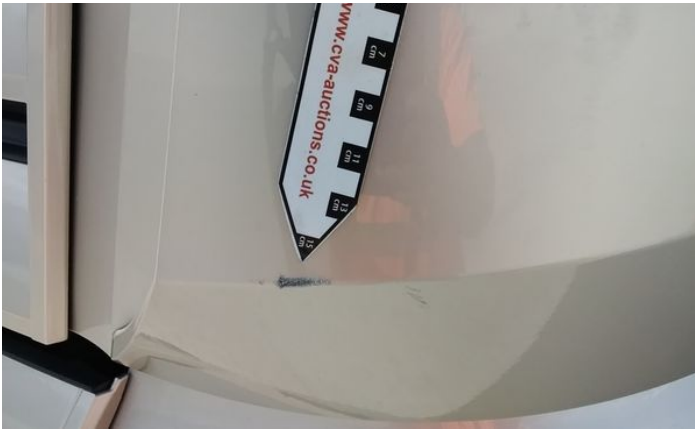
3: Moulding nsf Wing  
Scratched (Painted)  
Over 25mm Thru Paint

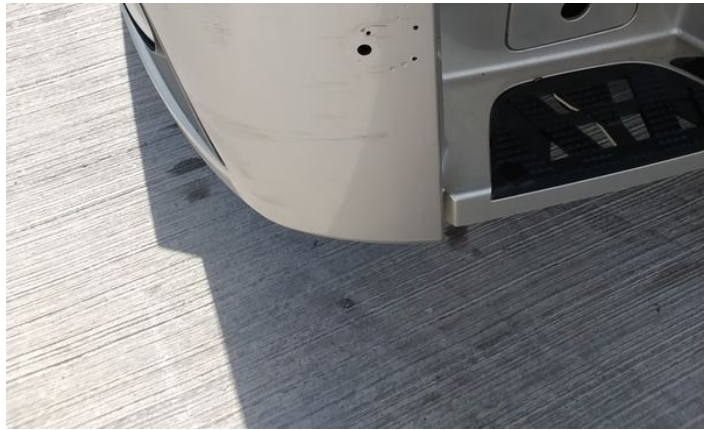
4: Bumper Front Moulding  
Missing  
Replace

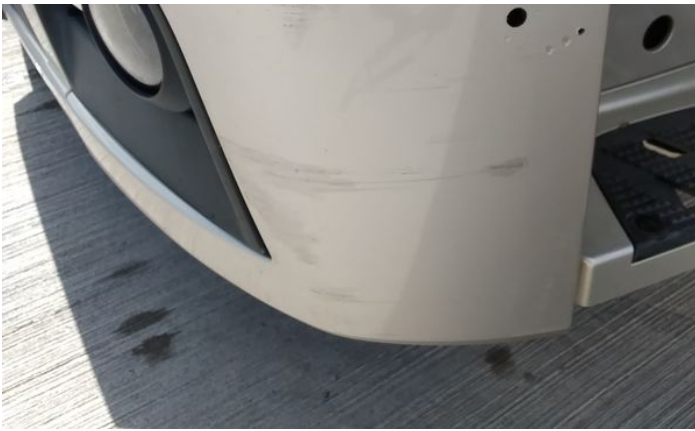
5: Bumper Front  
Scratched  
Over 100mm Thru Paint

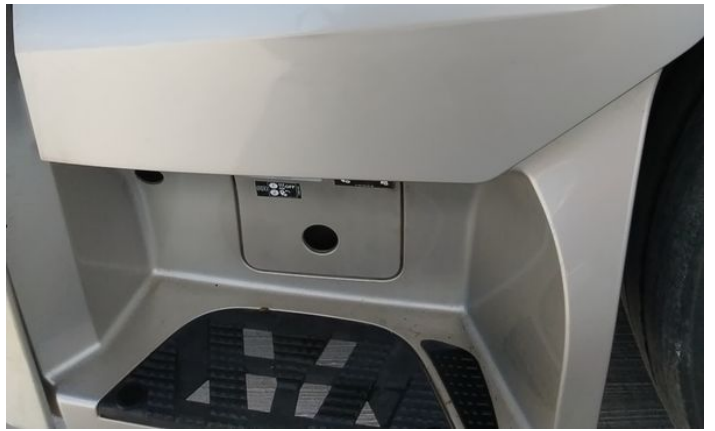
6: Door nsf  
Scratched  
Over 25mm Thru Paint

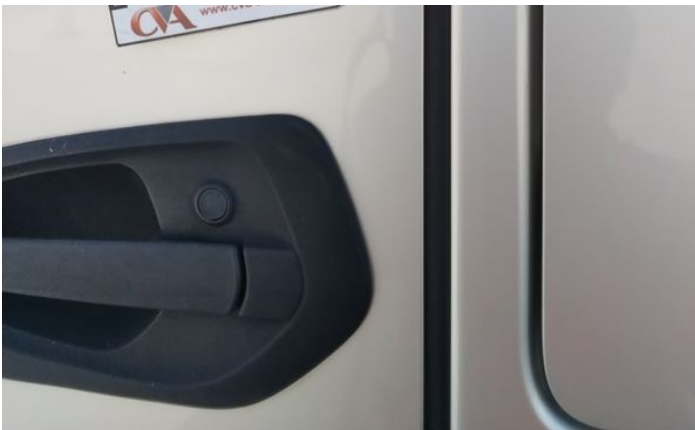
7: Door nsf  
Chipped  
Multiple Chips

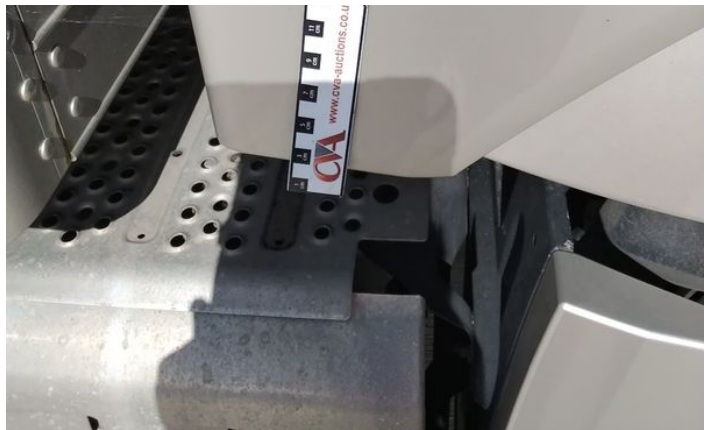
8: Qtr Panel osr  
Scratched  
Over 25mm Thru Paint

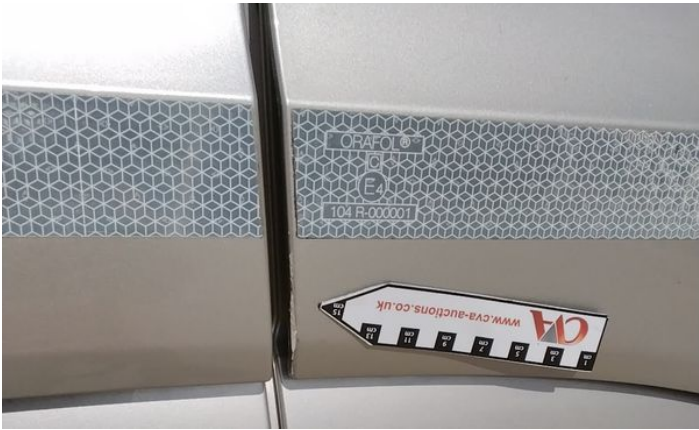
9: Door osf  
Chipped  
Multiple Chips

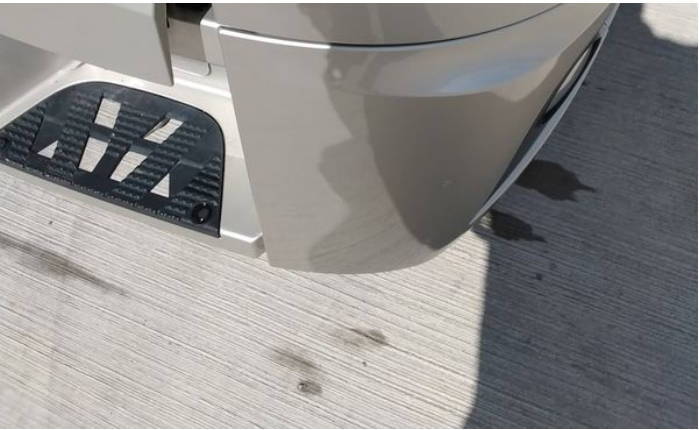
10: Bumper Front Moulding  
Missing  
Replace

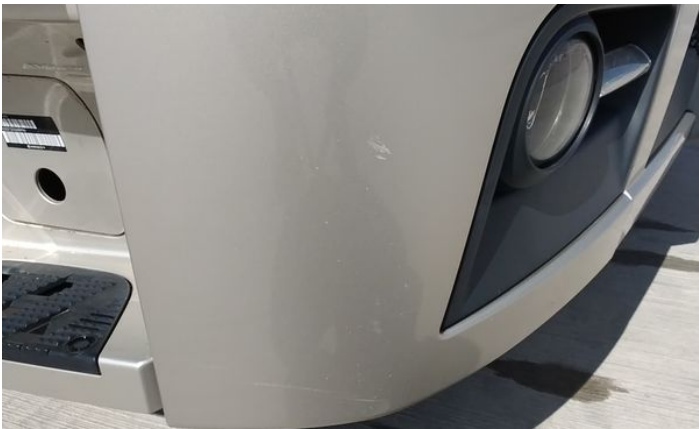
11: Bumper Front  
Scratched  
Over 100mm Thru Paint

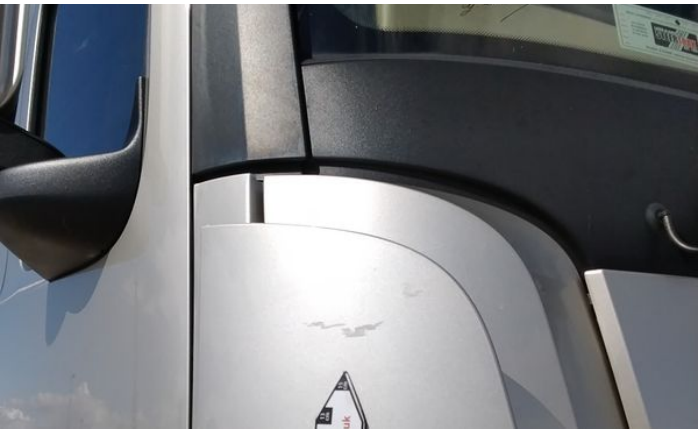
12: Moulding osf Wing  
Scratched (Painted)  
Over 25mm Thru Paint
