# VEHICLE INSPECTION REPORT

**YA17SUH**

## Daf LF 150

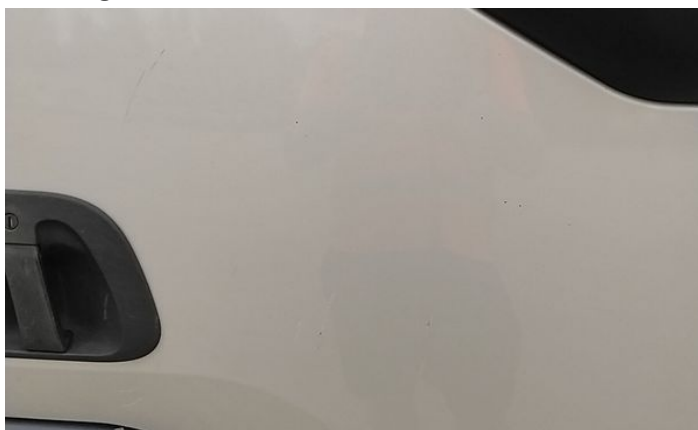
1: Door osf  
Chipped  
Multiple Chips

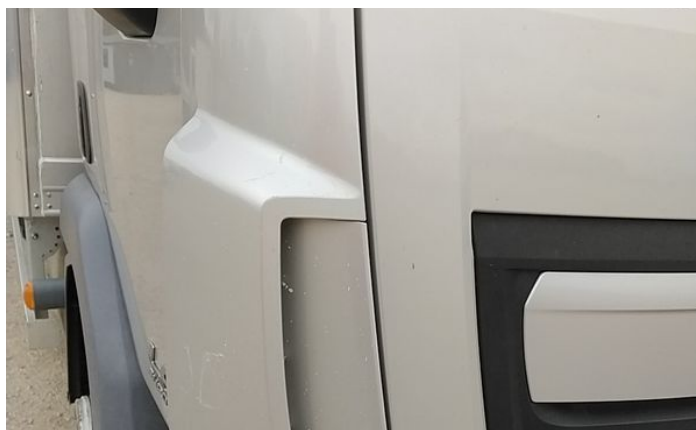
2: Wing osf  
Chipped  
Multiple Chips

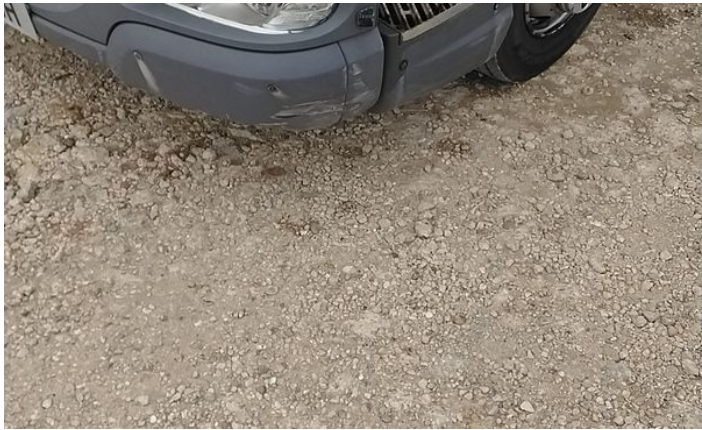
3: Bumper Front  
Scratched  
25 to 100mm Thru Paint
