# VEHICLE INSPECTION REPORT

**HX24WRW**

## Mercedes-Benz Atego 816

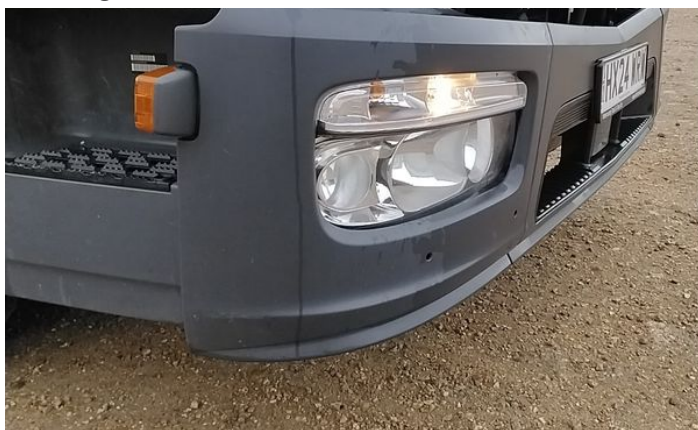
1: Bumper Front Moulding  
Scuffed (Unpainted)  
UpTo 100mm

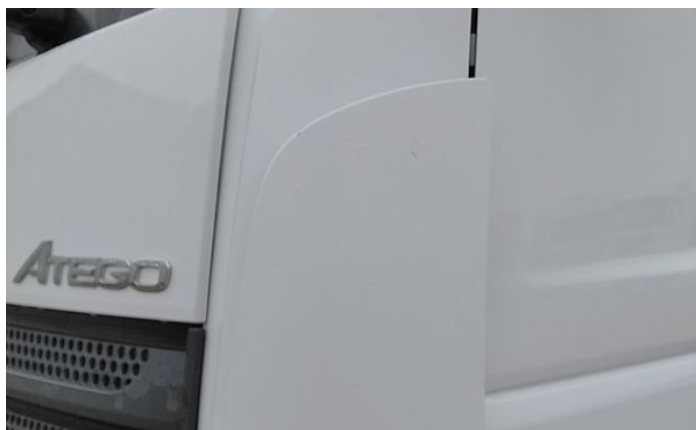
2: Wing nsf  
Scratched  
UpTo 25mm Not Thru Paint

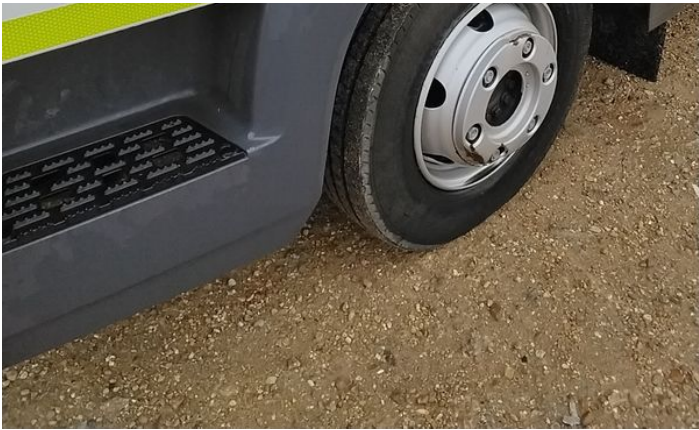
3: Wing Front Arch Extension ns  
Scuffed (Unpainted)  
UpTo 100mm

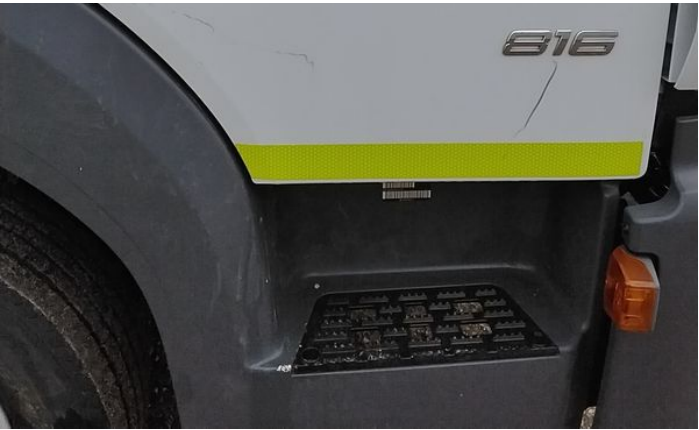
4: Door osf  
Scratched  
Over 25mm Not Thru Paint
