# VEHICLE INSPECTION REPORT

**LN72UTS**

## Mercedes-Benz Sprinter 315 CDI PROGRESSIVE

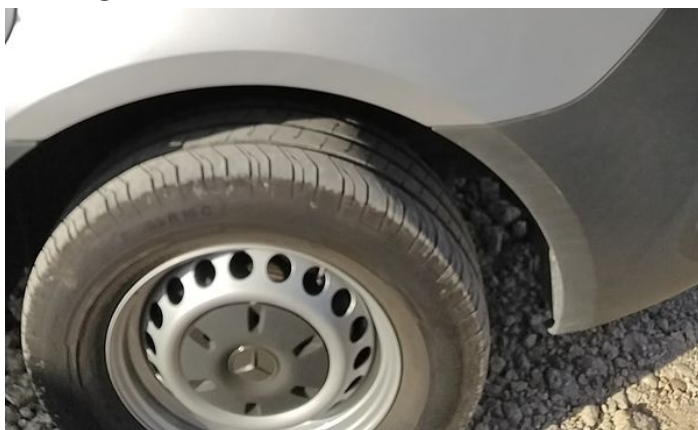
1: Wing of  
Scratched  
Over 25mm Thru Paint

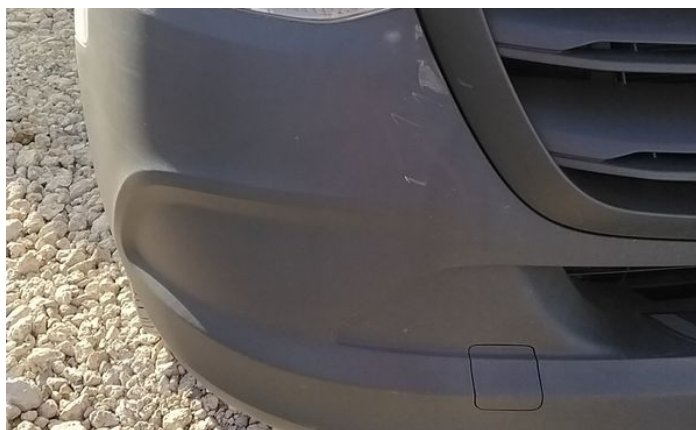
2: Bumper Front Moulding  
Scuffed (Unpainted)  
Up To 100mm

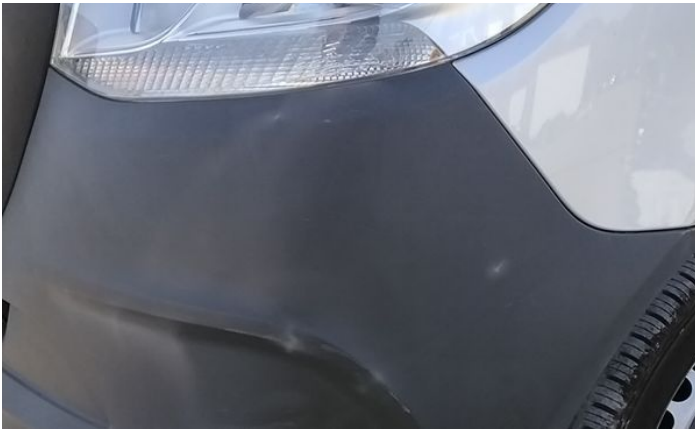
3: Bumper Front  
Dented  
Over 30mm

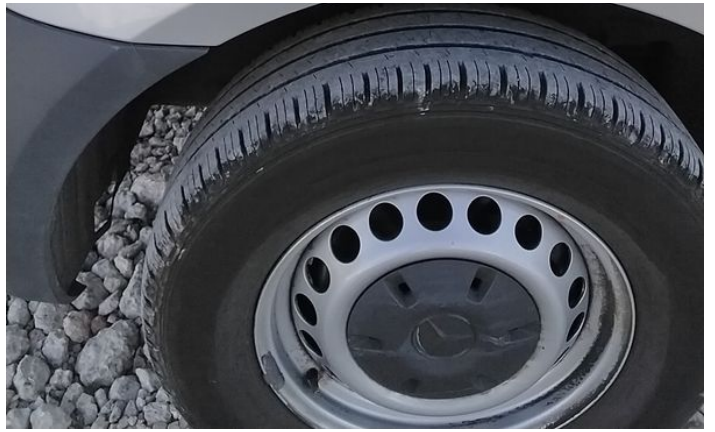
4: Wing nsf  
Dented  
Over 30mm

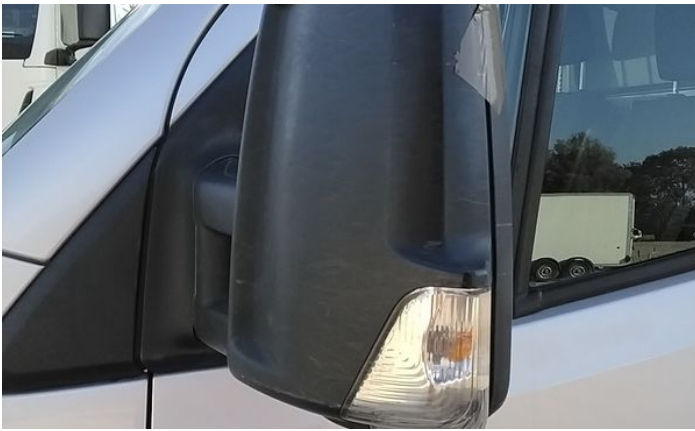
5: Door Mirror Assy nsf  
Broken  
Replace

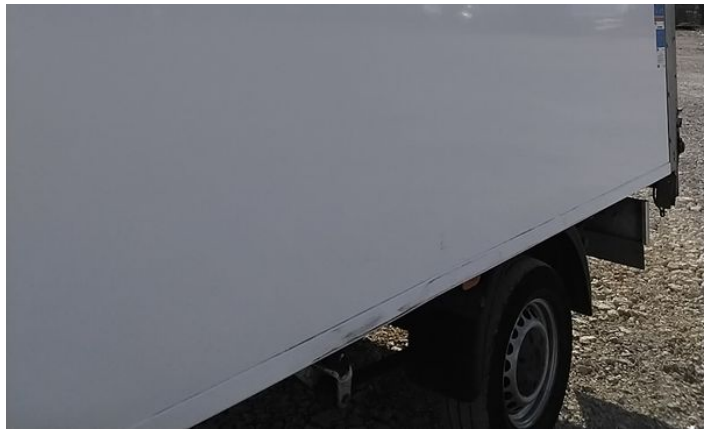
6: Qtr Panel nsr  
Scratched  
Over 25mm Not Thru Paint

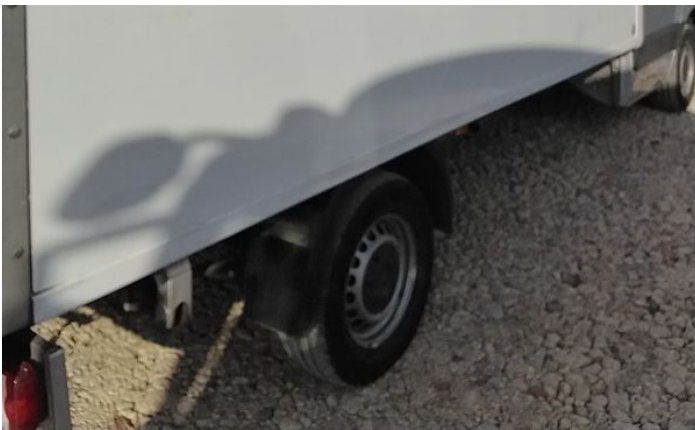
7: Qtr Panel osr  
Scratched  
Over 25mm Not Thru Paint

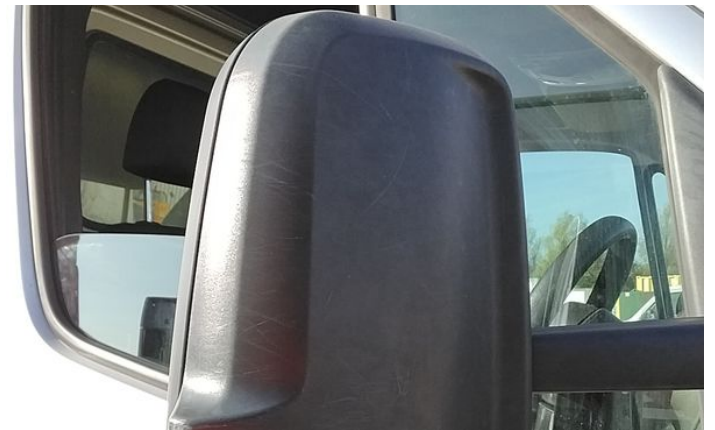
8: Door Mirror Assy osf  
Scuffed (Unpainted)  
Over 100mm

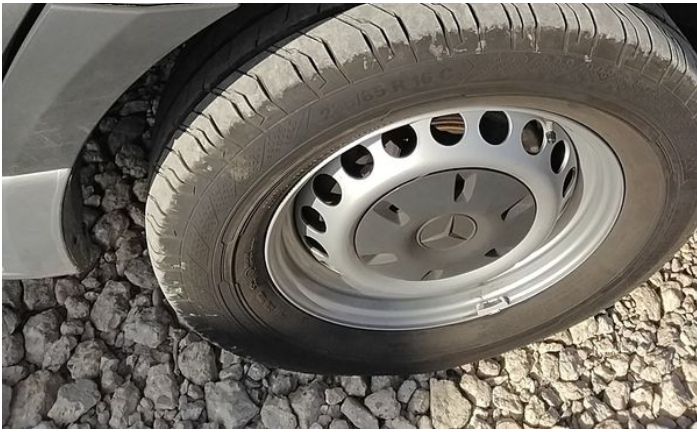
9: Wing osf  
Dented  
Between 10mm + 30mm

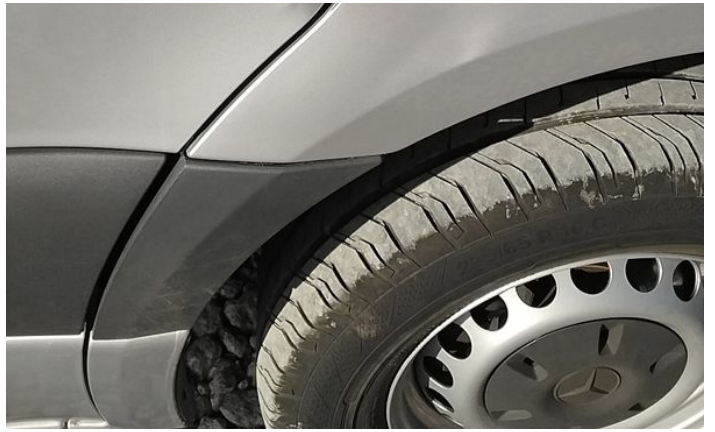
10: Wing osf  
Scratched  
Over 25mm Thru Paint

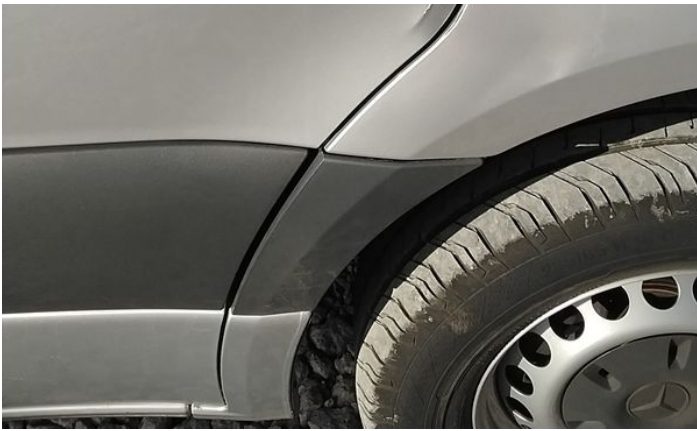
11: Door osf  
Dented  
With Paint Damage

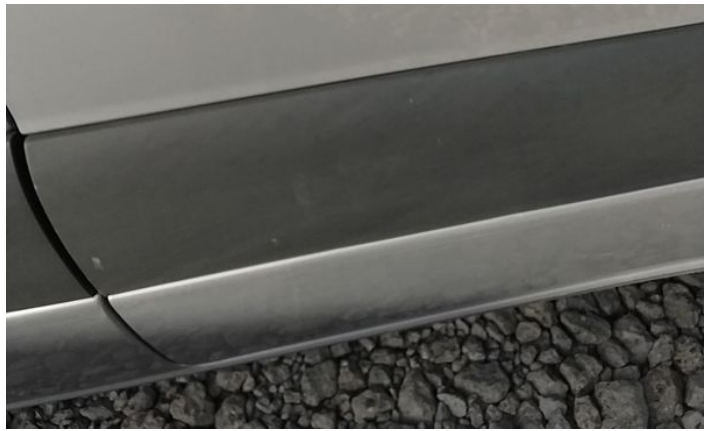
12: Door osf  
Scratched  
UpTo 25mm Thru Paint

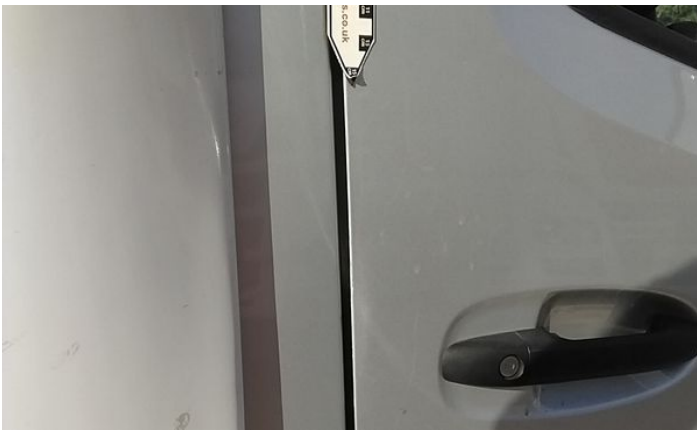
13: Door osf  
Chipped  
Edge Chip

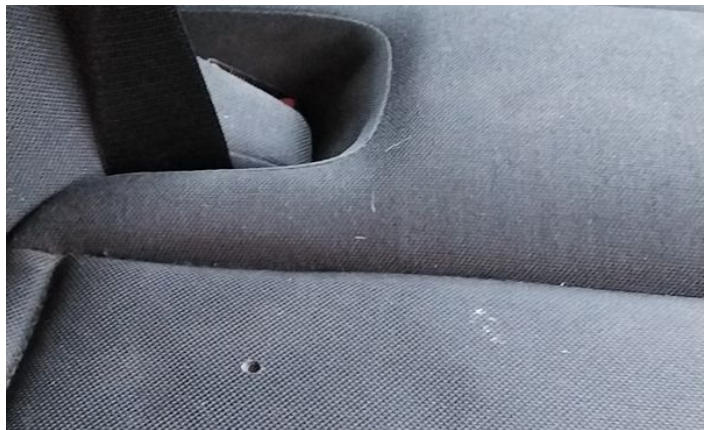
14: Seat Base Cover nsf  
Burn  
Over 3mm
